# HUNGRY HORSE, LLC

To: Mike Bratcher, New Mexico Oil Conservation Division, Dist. II  
Reference: Flare Over-Spray  
Operator: Devon Energy Production Company  
Location: Diamond PWU 22 #1H  
API: 30-015-38334  
Legals: UL. D, Sec. 22, 19S, R29E, Eddy County  
GPS: 32.6523 -104.0697  
NM OCD: 2RP 3482

RE: DIAMOND PWU 22 #1H

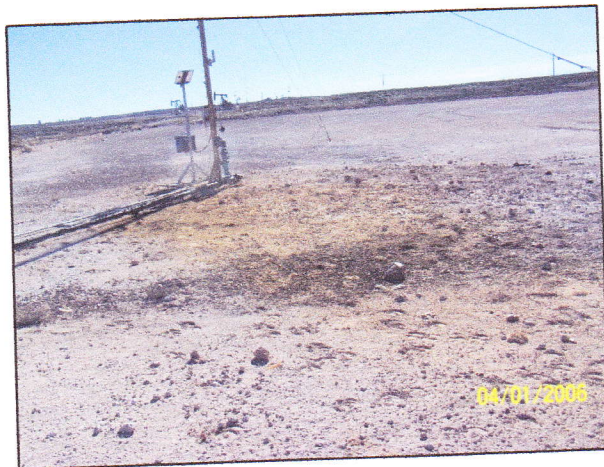
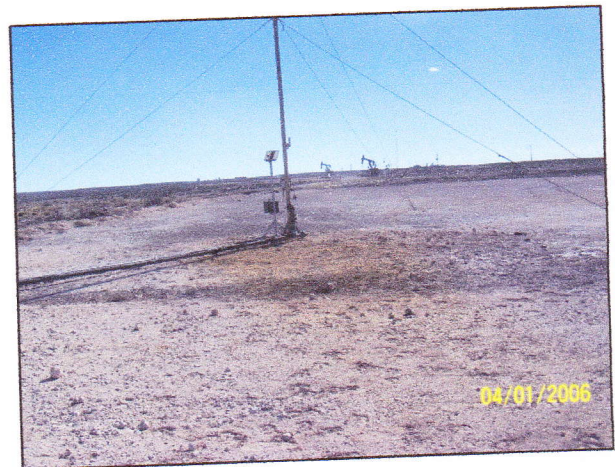
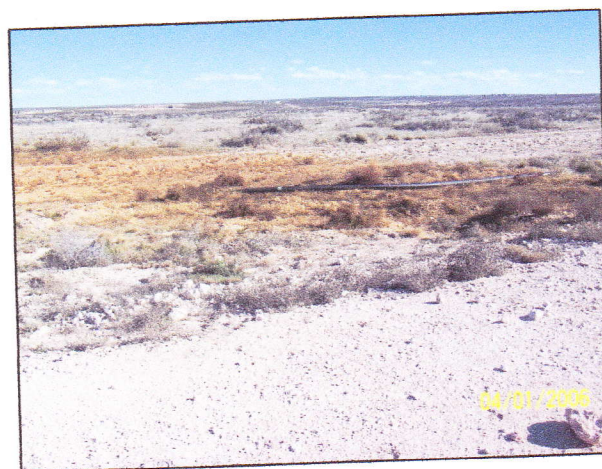
Devon Energy Production Company-Diamond PWU 22 #1H

This location is on Curry Comb Road approximately .70 miles east of the intersection of Curry Comb Road (CR 235) and South Old loco Road (CR 210). A flare overspray occurred that impacted both the caliche pad and the pasture on the southeast corner of the location. Approximately .5 bbl of fluids was released. The impacted area is approximately 40' x 130'. There was/is no free standing liquid. The impact is a very thin hydrocarbon crust in the pasture with a crust and discoloration on the caliche pad.

I propose to treat the impacted area with a liberal application of MicroBlaze and then use large landscape rakes to rake and blend the impacted soil. This action will "break the crust" of the hydrocarbons and aid the microbes in remediation. This proposal will cause the least amount of surface disturbance, while assuring remediation of the hydrocarbons.

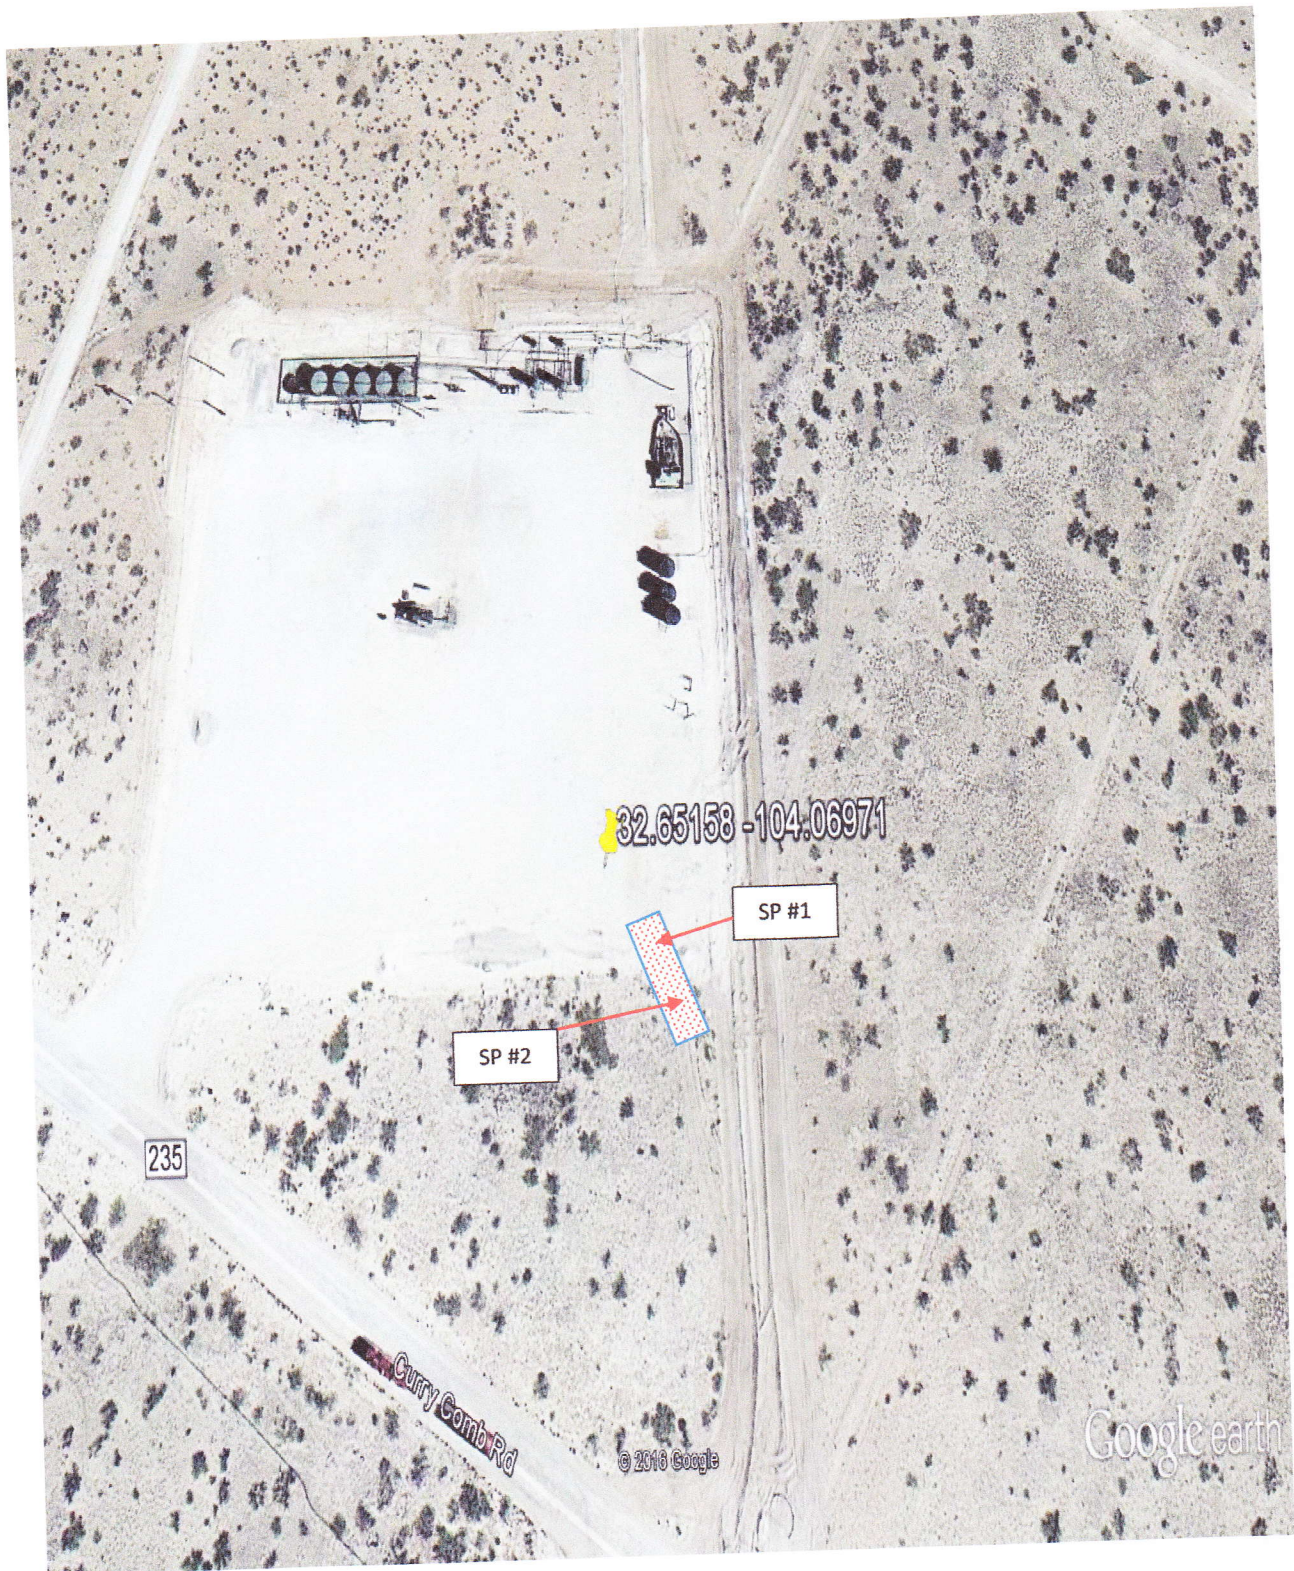
Impacted are is approximately 20' x 40'.
