Wigeon 23 Fed Com #2

REMEDIATION WORK PLAN

UL/H Sec 23, T25 south, R26 east, Eddy county NM

RE: Cimarex, Wigeon 23 Fed Com #2 – Remediation Work Plan
UL/H, Section 23, T25S, R26E
API No. 30-015-33684

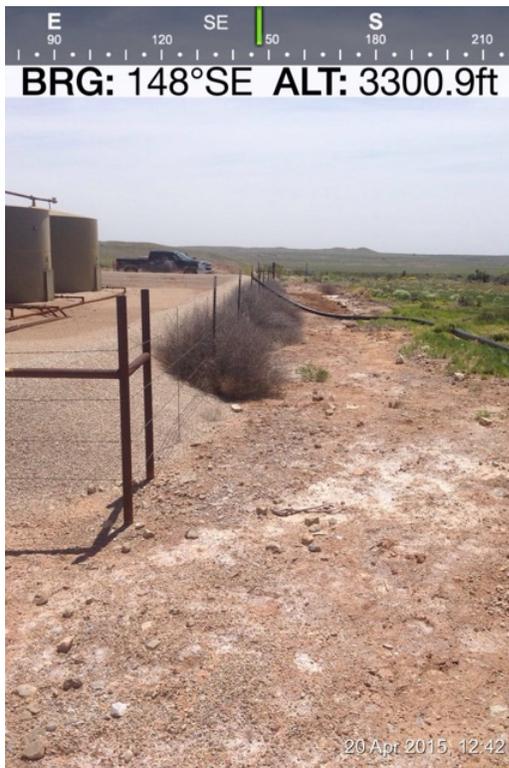
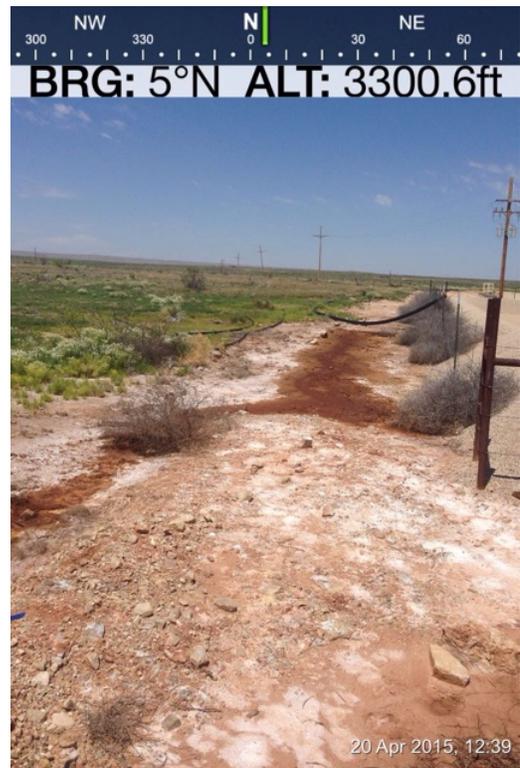
PHOTO PAGE

The site is located east of White City NM, in Eddy County. The leak site resulted from a valve being open and a check valve failure. The impacted area is on the back site of the battery west into pasture. Approx. 15 bbls of produced water was released, and 1 bbl recovered. A C-141 was submitted to the NMOCD on April 17th, 2015. The C-141 is attached.

Remove 4' bgs of the contaminated soil on the backside of the bermed facility. Haul all contaminated material to an approved NM state disposal. Because the spill path is narrow we will use the surrounding terrain for backfill. We will re seed using a BLM approved seed mix.

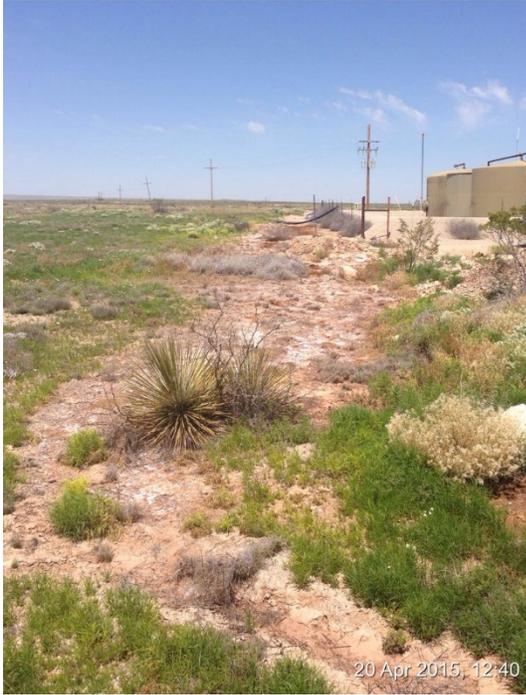
Site Diagram

**Cimarex, Wigeon 23 Fed Com 2
UL/H, Sec. 23 T25S R26E
Eddy County, NM
Drafted By: Lance Crenshaw, 4-21-15**

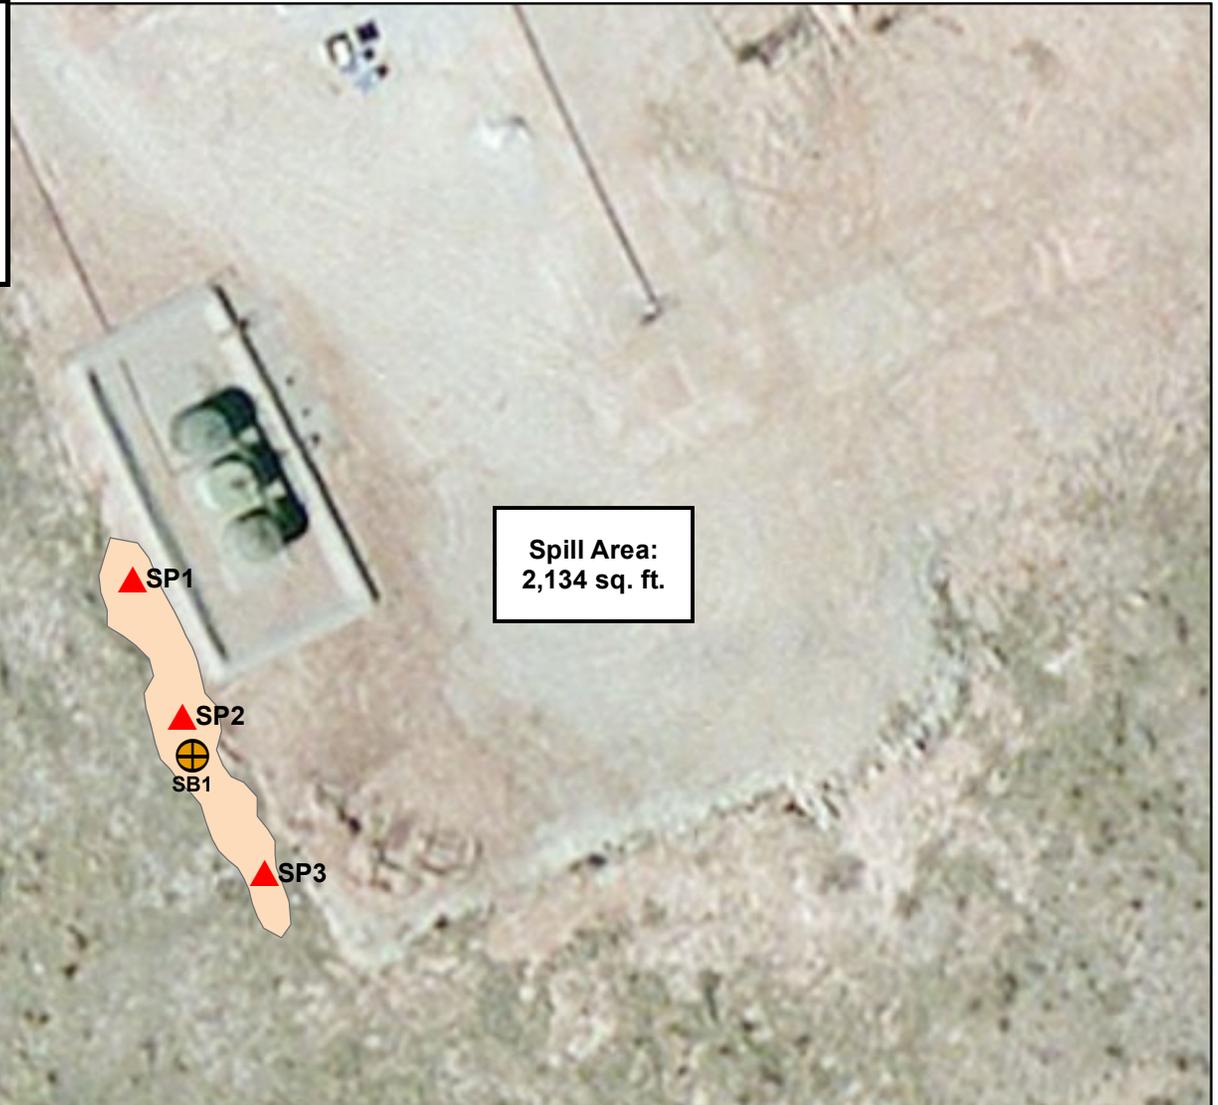
**Spill Area:
2,134 sq. ft.**
