To: Heather Patterson, New Mexico Oil Conservation Division, District 2
Jim Amos, Bureau of Land Management
Reference: Remediation Work Plan
Operator: Devon Energy Production Company
Location: Ross Ranch 10 Fed #1 SWD
API: 30-015-29605
Legals: UL. H, Sec. 10, T26S, R31E, Eddy County
GPS: 32.0592, -103.7590
NM OCD: 2RP 3427

Release Notification and Corrective Action

Devon Energy Production Company-Ross Ranch 10 Fed #1

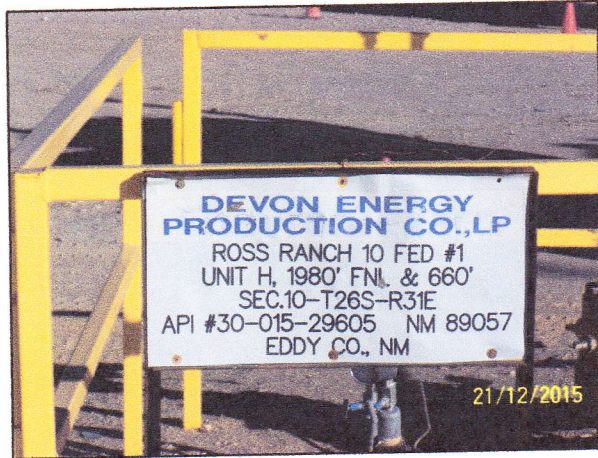
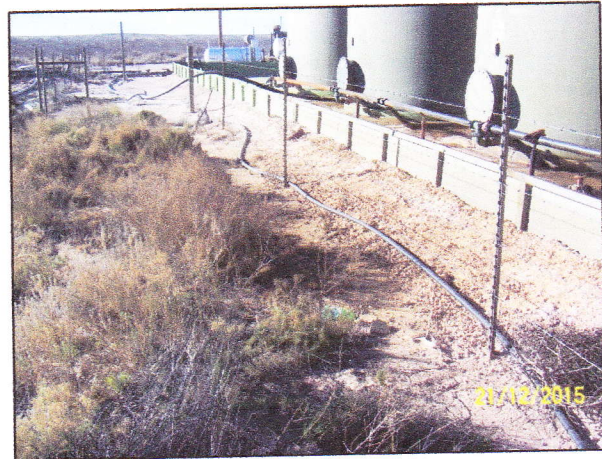
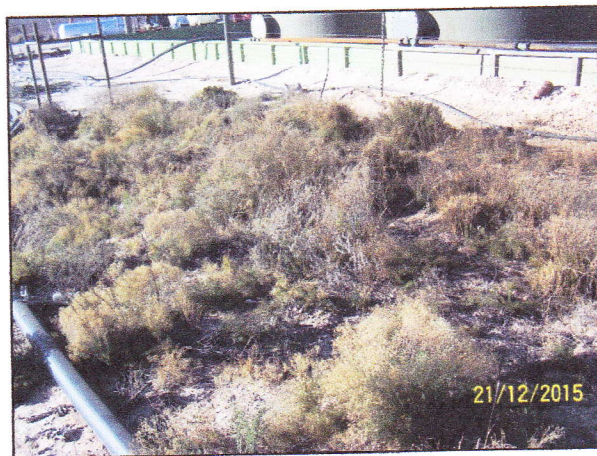
The impacted area is on the south side of the battery at the edge of the pad and is approximately 15' x 20'. The release is the result of a failed fitting.

I propose to excavate the impacted area, approximately 15' x 20', to a depth of 3' BGS and install a synthetic liner in order to prevent the downward migration of the Chlorides. Due to the low chloride level between the surface and 3' BGS, I propose to use the excavated material for backfill.

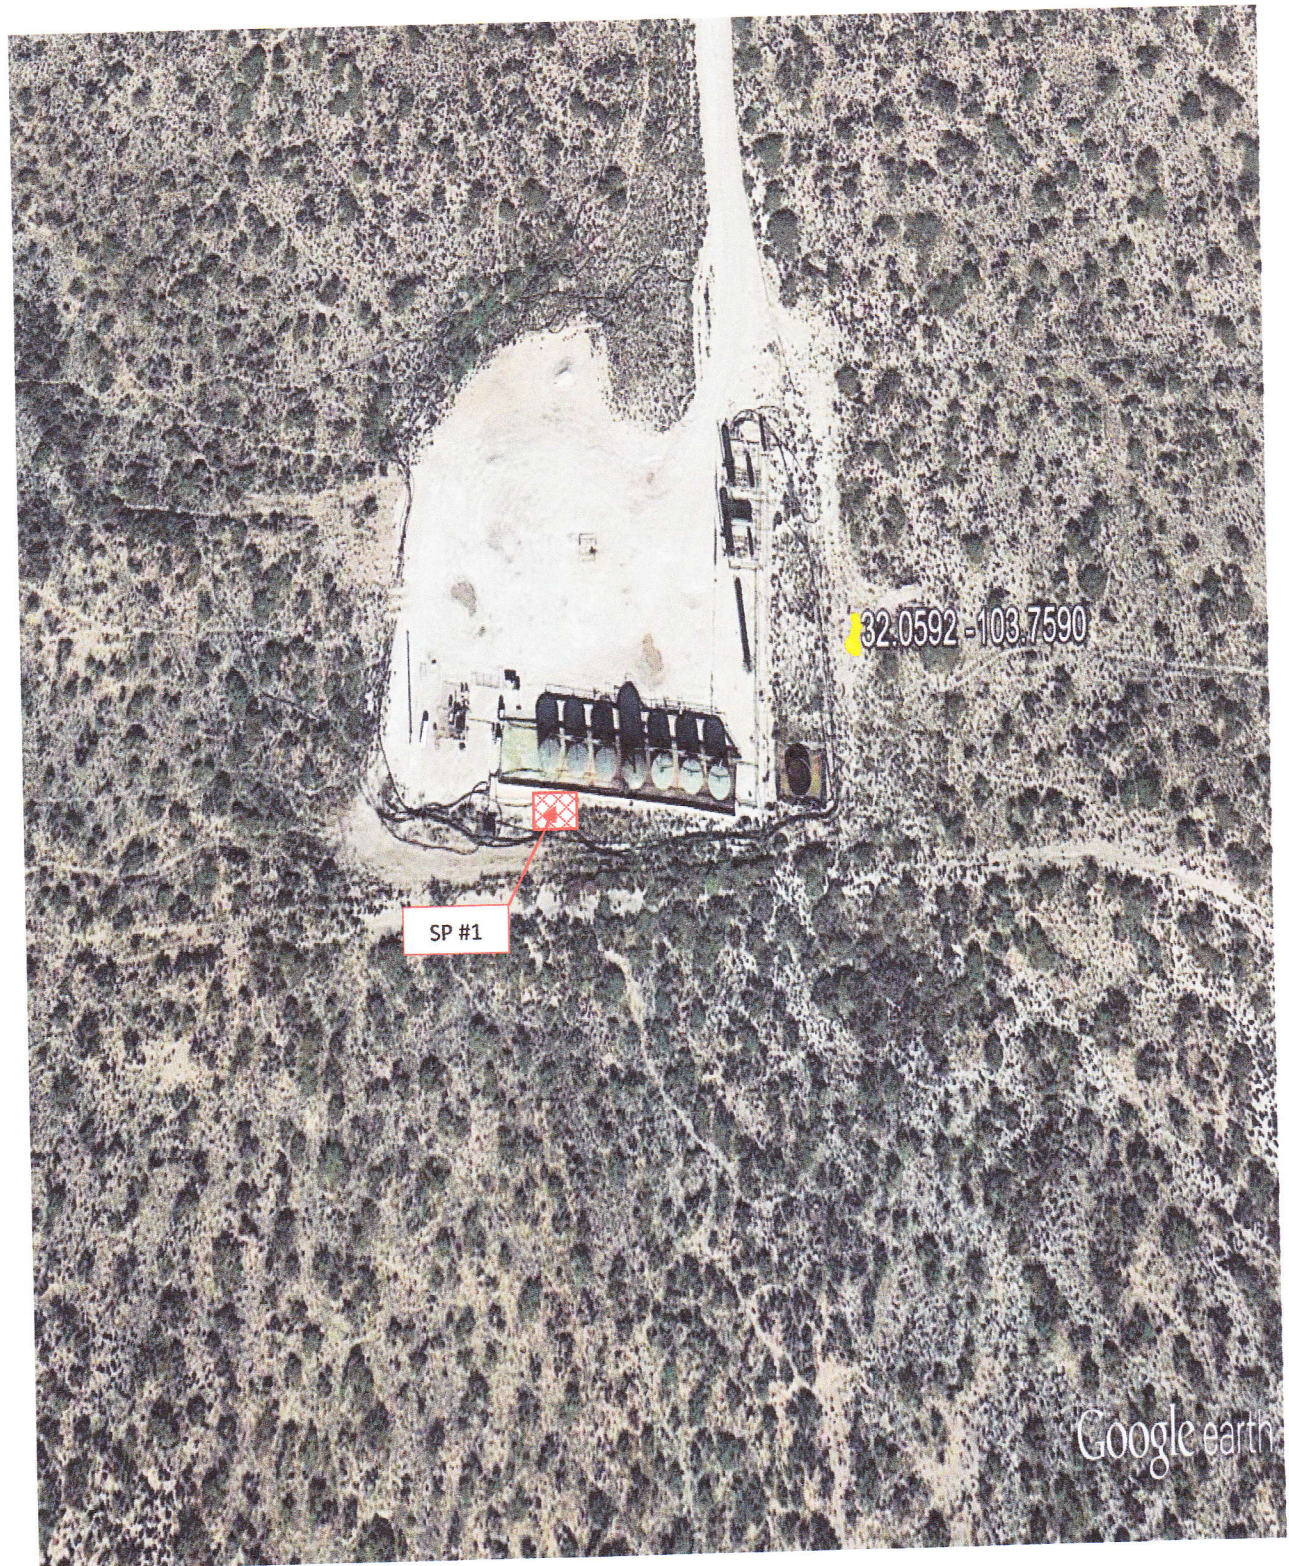
Devon Energy Production Company-Ross Ranch 10 Fed #1

Impacted area is approximately 15' x 20' .
