# HUNGRY HORSE, LLC

To: Heather Patterson, New Mexico Oil Conservation Division, District 2  
Jim Amos, Bureau of Land Management  
Reference: Remediation Work Plan  
Operator: Devon Energy Production Company  
Location: Ross Ranch 10 Fed #1 SWD  
API: 30-015-29605  
Legals: UL. H, Sec. 10, T26S, R31E, Eddy County  
GPS: 32.0592, -103.7590  
NM OCD: 2RP 2342

## Proposal

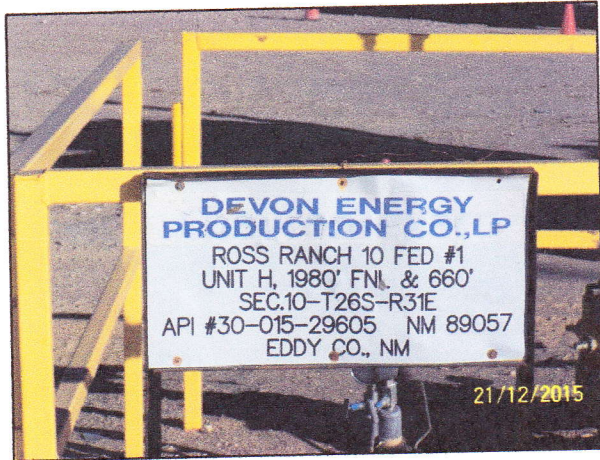
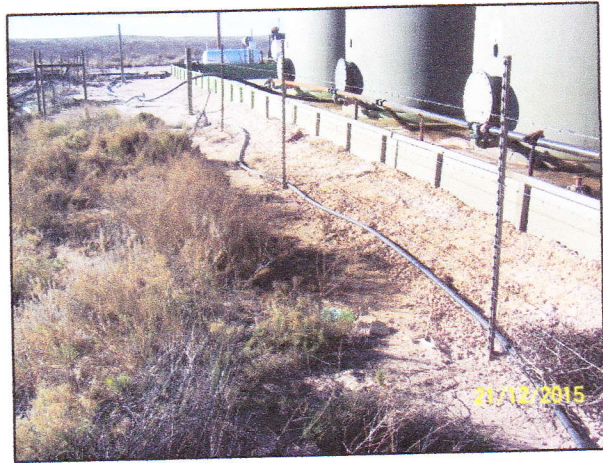
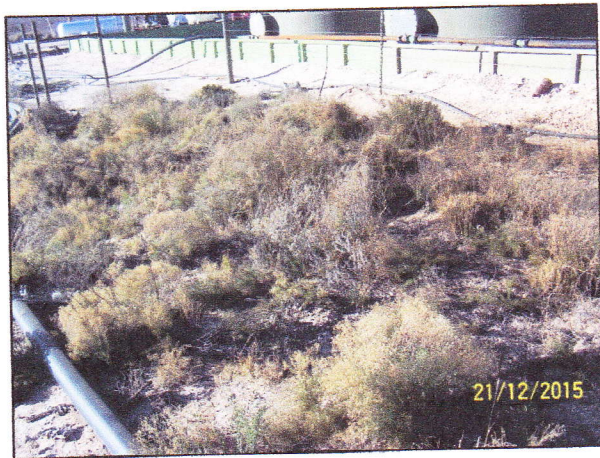
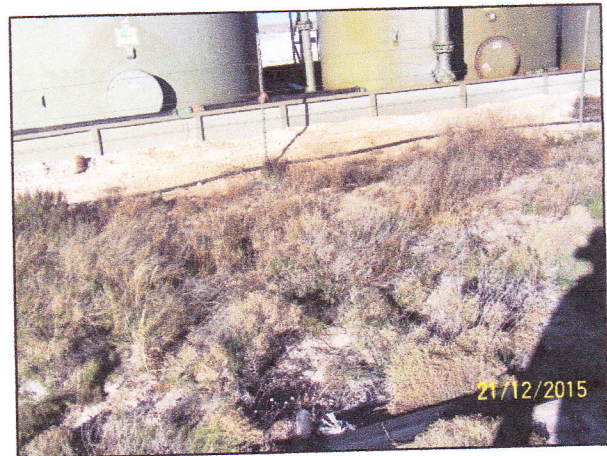
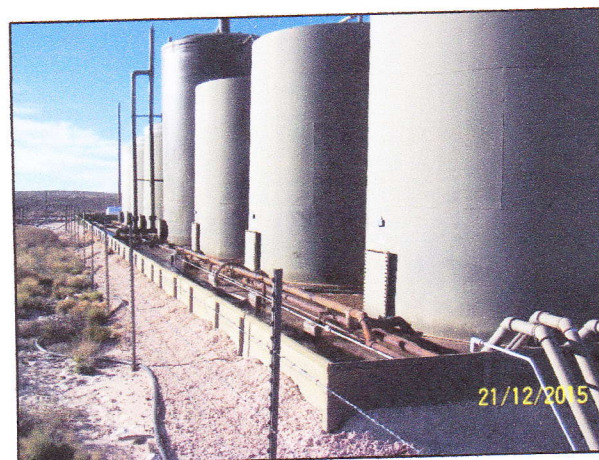
Devon Energy Production Company-Ross Ranch 10 Fed #1

The impacted area is on the south side of the battery at the edge of the pad and is approximately 15' x 20'. The release is the result of a failed fitting.

I propose to excavate the impacted area, approximately 15' x20', to a depth of 3' BGS and install a synthetic liner in order to prevent the downward migration of the Chlorides. Due to the low chloride level between the surface and 3' BGS, I propose to use the excavated material for backfill.

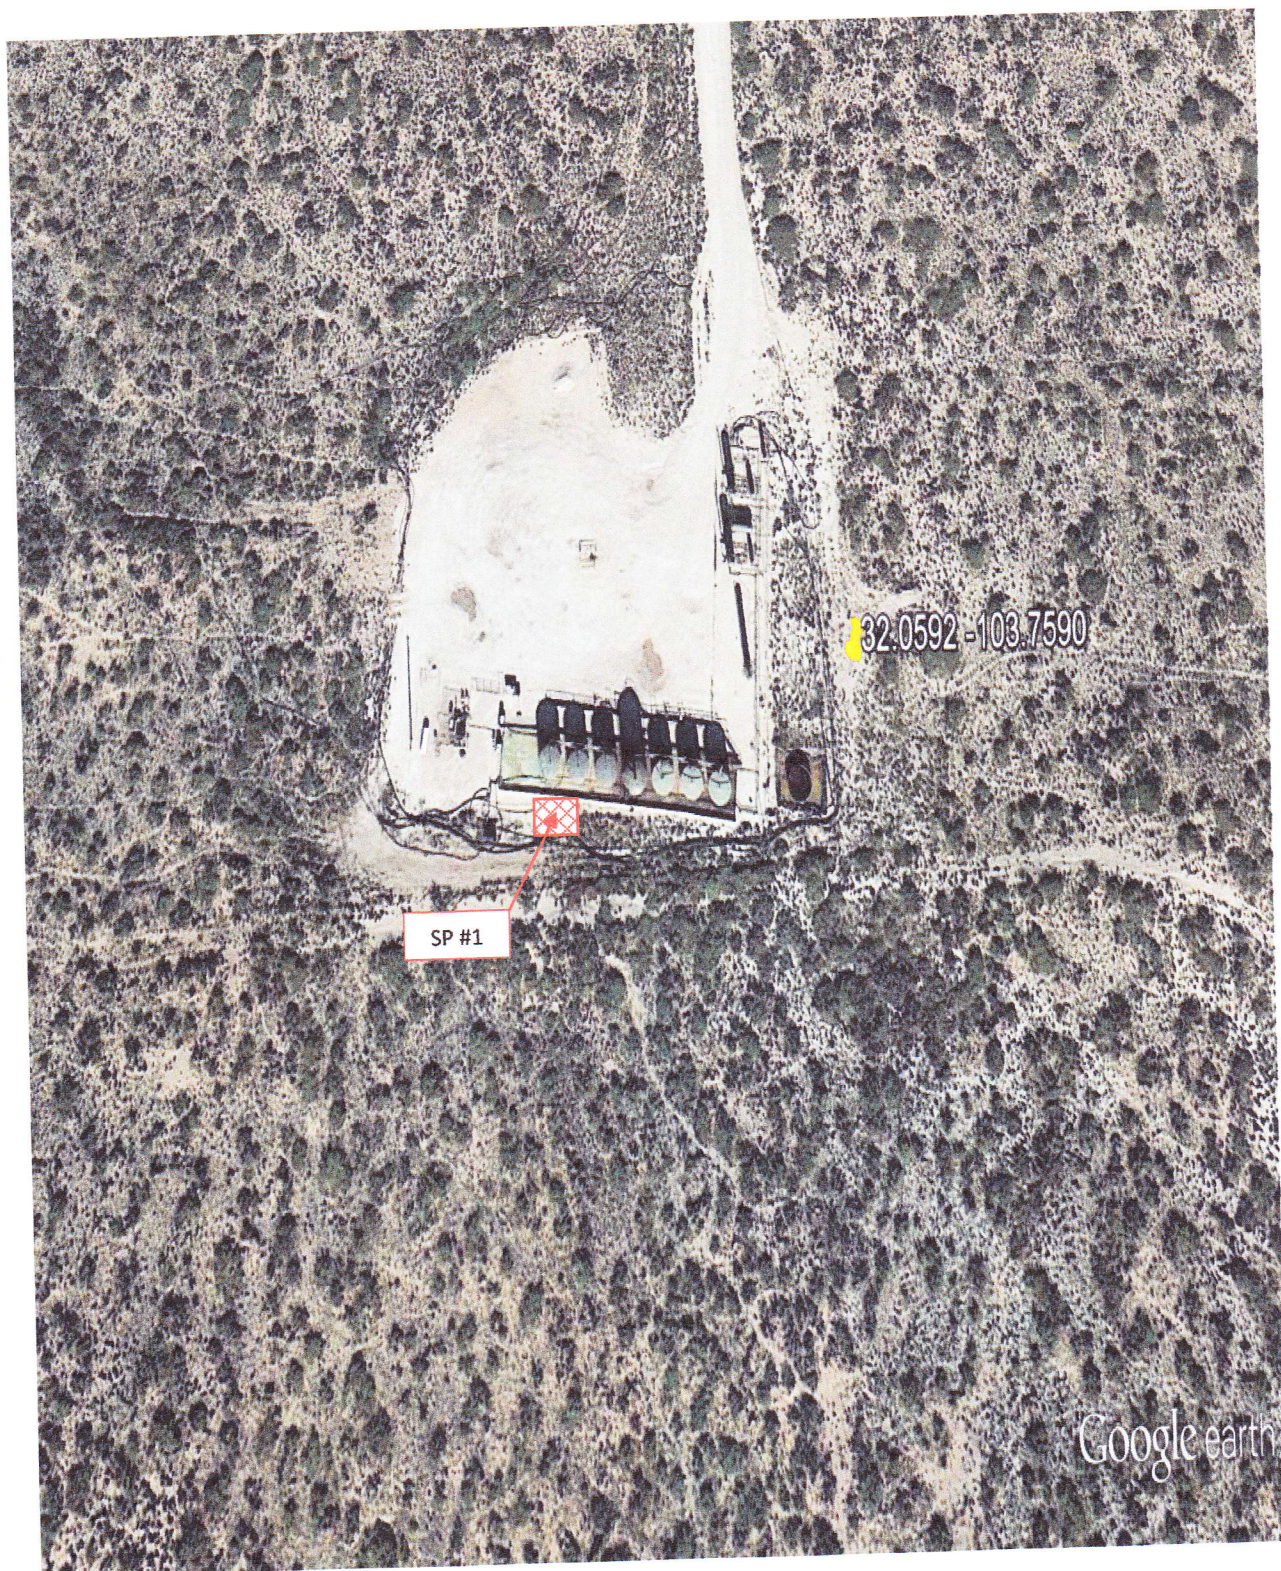
Devon Energy Production Company-Ross Ranch 10 Fed #1

Impacted area is approximately 15' x 20' .
