Linn Energy JL Keel B #84

REMEDIATION WORK PLAN

RP# 2RP-1683

RE: Linn Energy JL Keel B #084 – Remediation Work Plan
UL/H, Section 05, T17S, R31E
API No. 30-015-28551

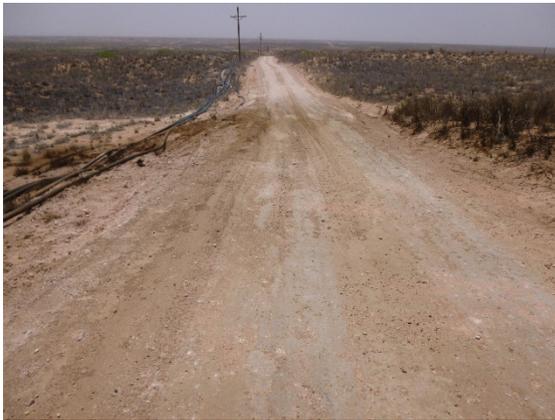
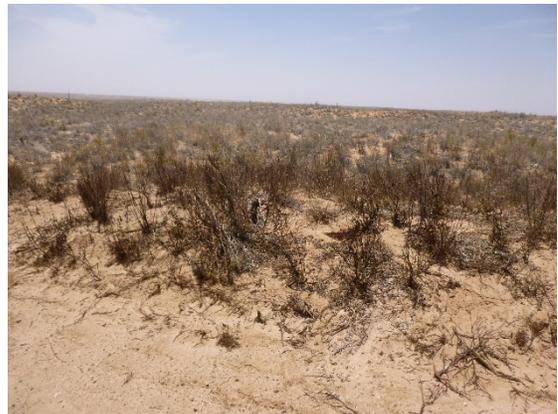
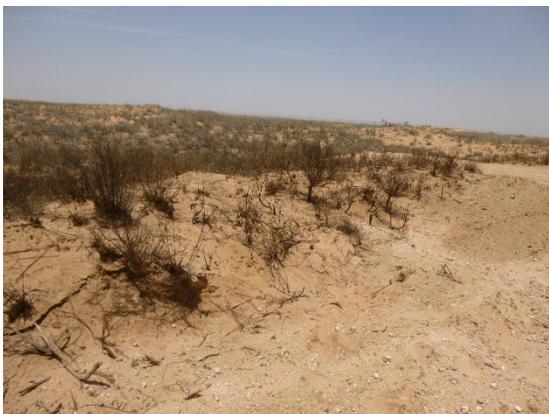
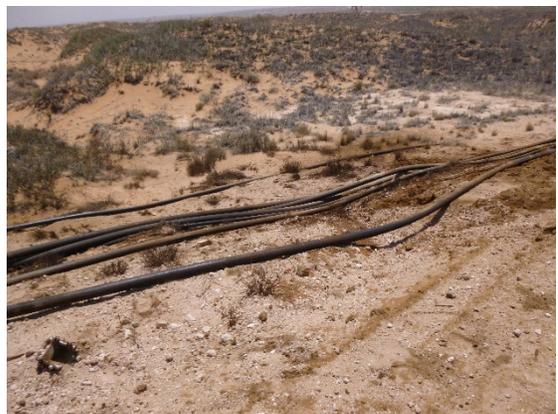
PHOTO PAGE

The site is located northeast of Loco Hills NM, in Eddy County. The leak site resulted from a pin hole in the poly flow line. The source of the leak was never determined. Approx. 20 bbls of produced water and 1 bbl of oil was released. Nothing was recovered. A C-141 was submitted to the NMOCD on June 6th, 2013 (2RP-2209).

Till and blend the affected area. Re contour the pasture and fix any erosion issues.
Seed with an approved BLM seed mixture.
