RE: Final Closure Report  
Vanguard – Water Disposal Line  
UL-P, Section 12, Township 20 South, Range 29 East  
Eddy County, New Mexico  
NMOCD Reference # 2RP 3098

The following *Final Closure Report* serves as a condensed update on closure activities for the above referenced Site.

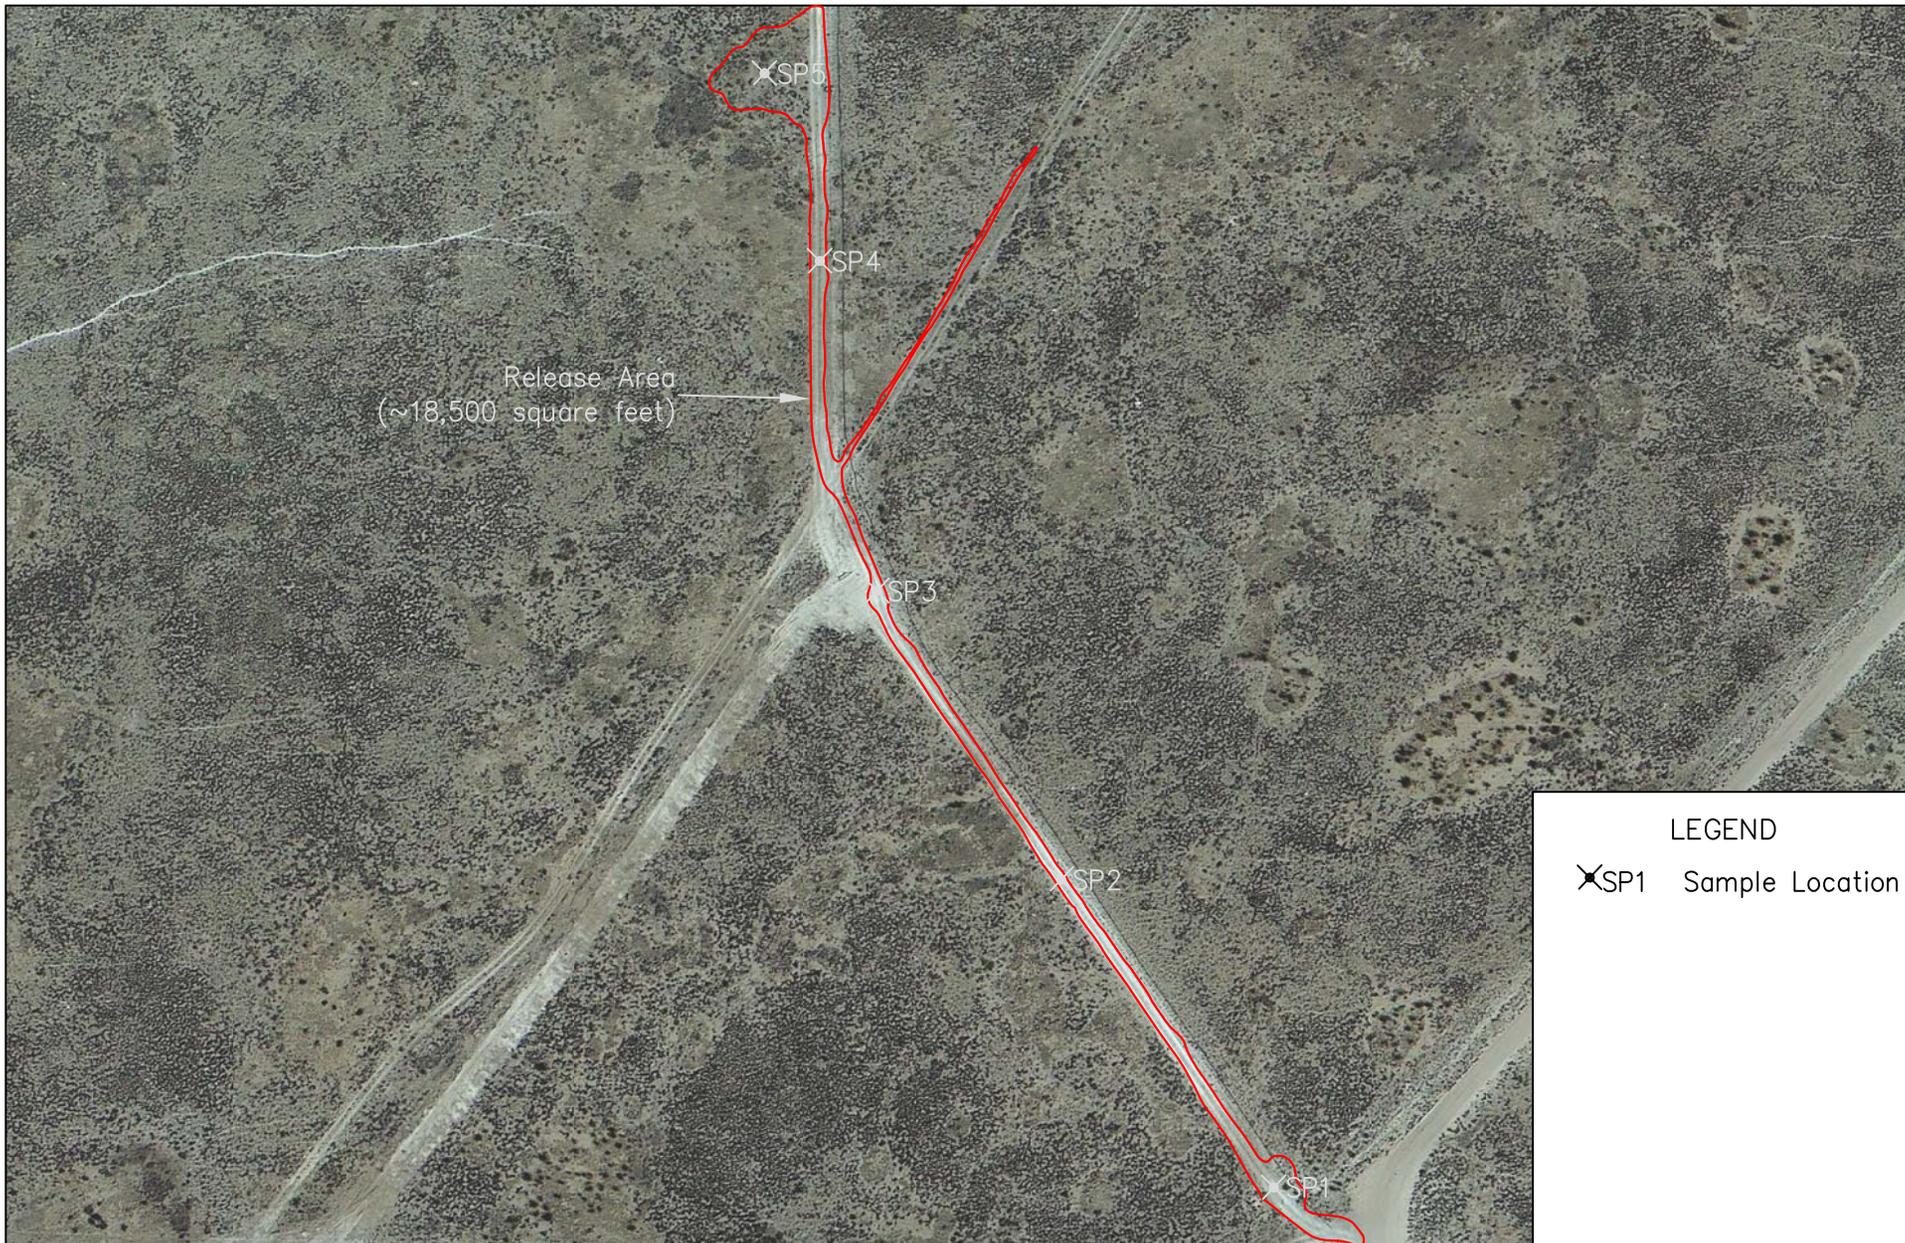
Figure 3  
 Site/Sample Map  
 Vanguard  
 Water Disposal Line

EPI personnel mobilized on the site on May 27, 2015 to collect soil samples via hand auger to determine the vertical extent of contamination. A total of fifteen (15) soil samples were collected from five (5) sample locations; SP1 – SP5. All samples were field tested for organic vapors and chloride concentrations. Soil samples were placed in self-sealing polyethylene bags and allowed to equilibrate to ~70° F. Soil samples were tested for organic vapors utilizing a Mini-Rae™ Photoionization Detector (PID) equipped with a 10.6 electron-volt (eV) lamp calibrated for benzene response. Chloride concentrations were determined via use of a LaMotte Chloride Kit (Titration Method). All samples were placed on ice and transported to Cardinal Labs in Hobbs, New Mexico and tested for Chloride concentrations. Laboratory results indicated the release area to be void of Chloride concentrations in excess of NMOCD Recommended Remedial Action Levels (RRALs) of 250 mg/Kg in all samples except SP1 at one (1) foot bgs (reference *Figure 3* and *Table 2*).

From May 27 – 28, 2015, the lease road was scraped to a depth of approximately six (6) inches bgs; the area of SP1 was excavated to a depth of approximately two (2) feet bgs. Approximately 303 tons of contaminated soil was excavated and hauled to a state approved facility for disposal.

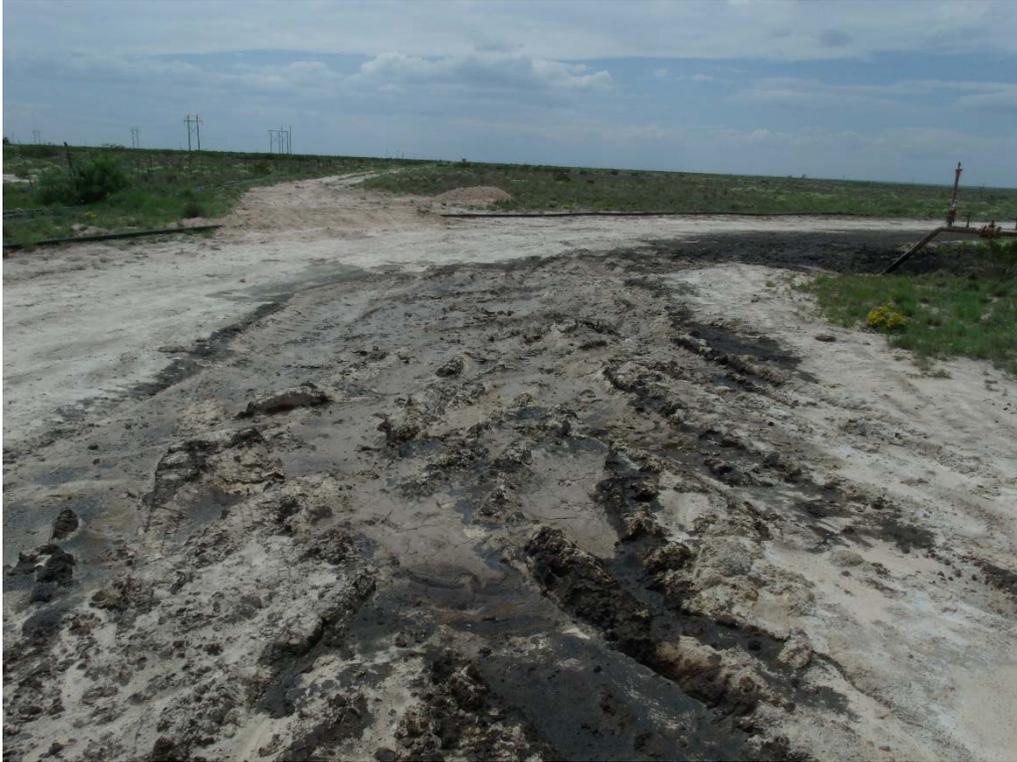
The poly disposal line failed due to vehicle traffic. The line was repaired and moved. The spill impacted approximately 18,500 sq. ft. of lease road. A vacuum truck was brought in and picked up approximately 5 bbls of water.

Photograph #1 – Northwest view over release area

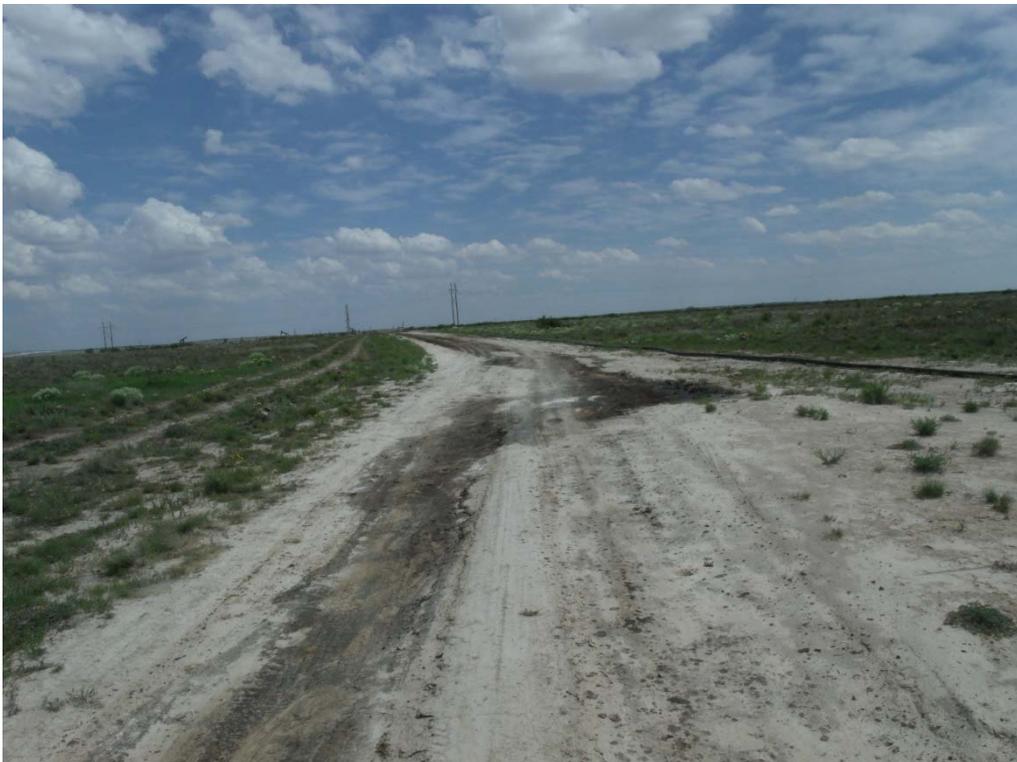
Photograph #2 – Northerly view across release area

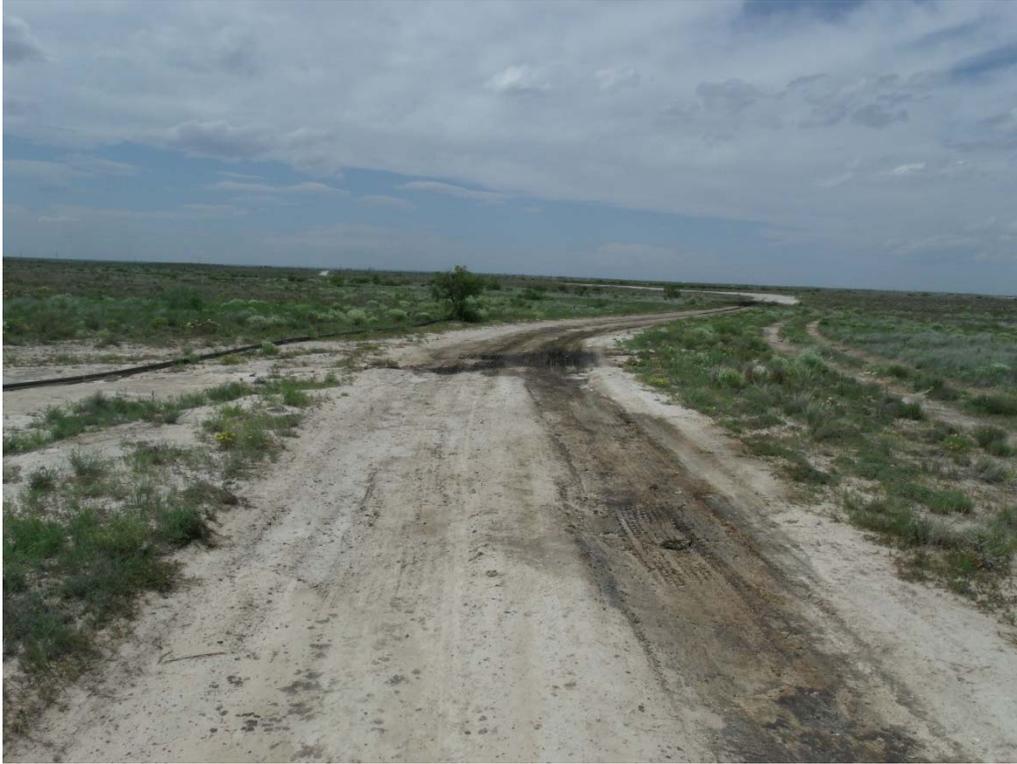
Photograph #3 – Looking north across release area

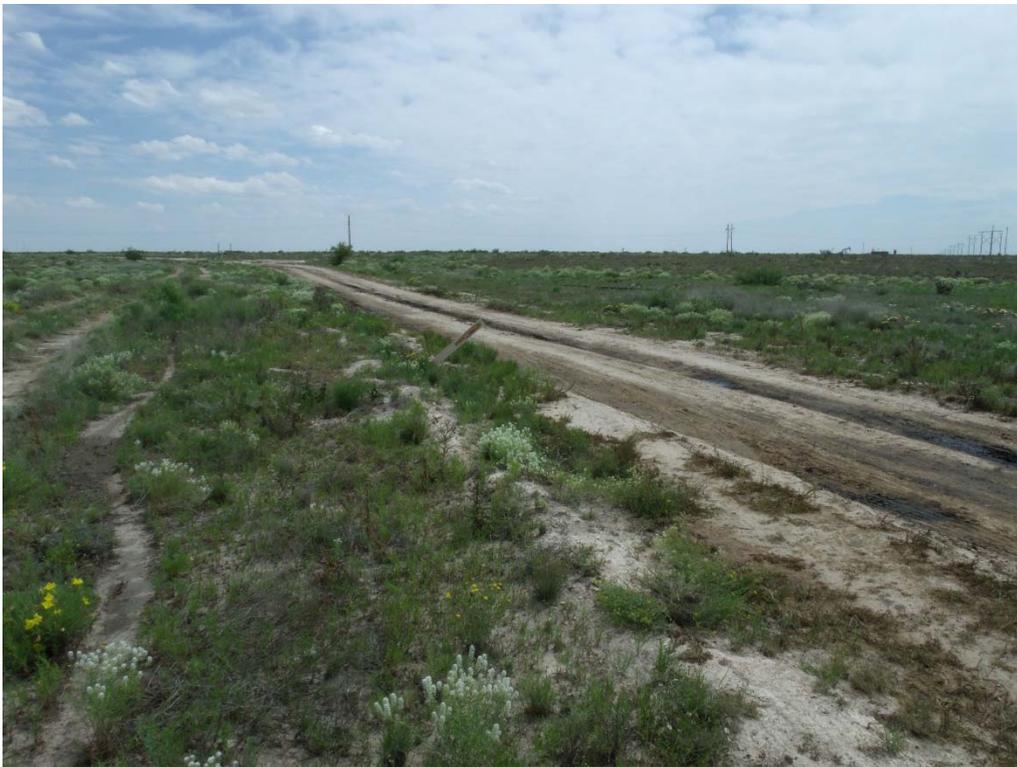
Photograph #4 – Looking north across release area

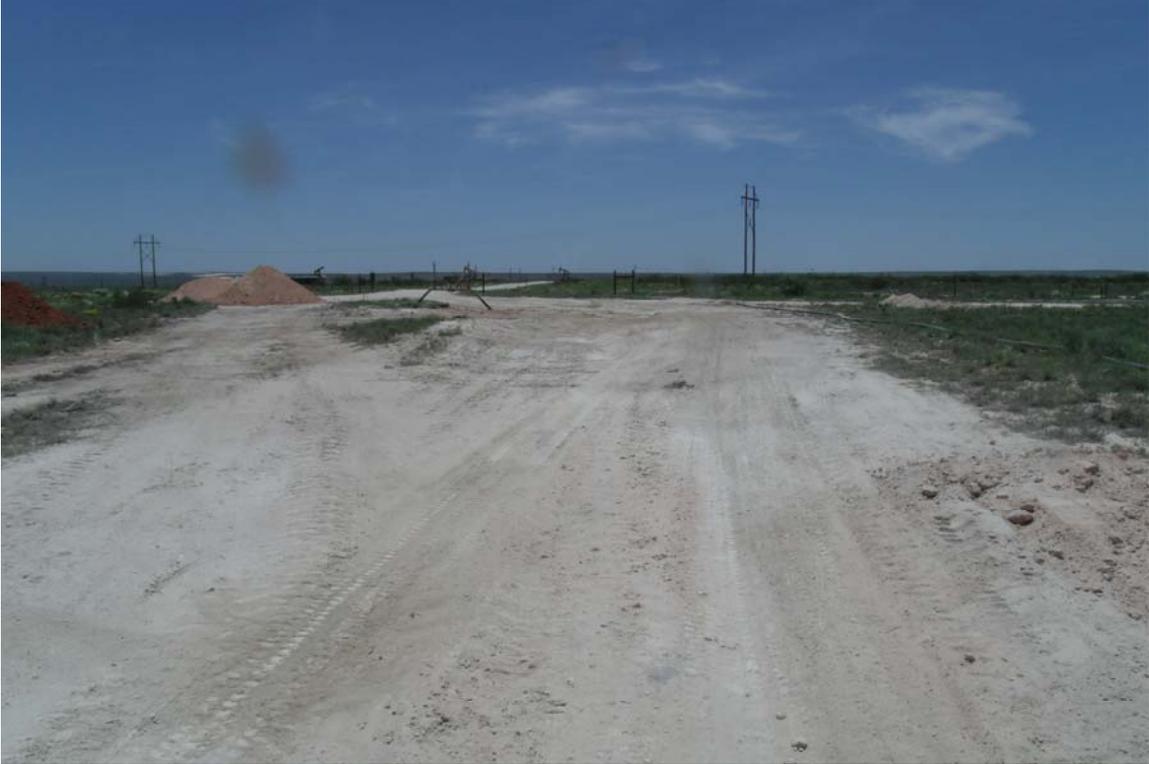
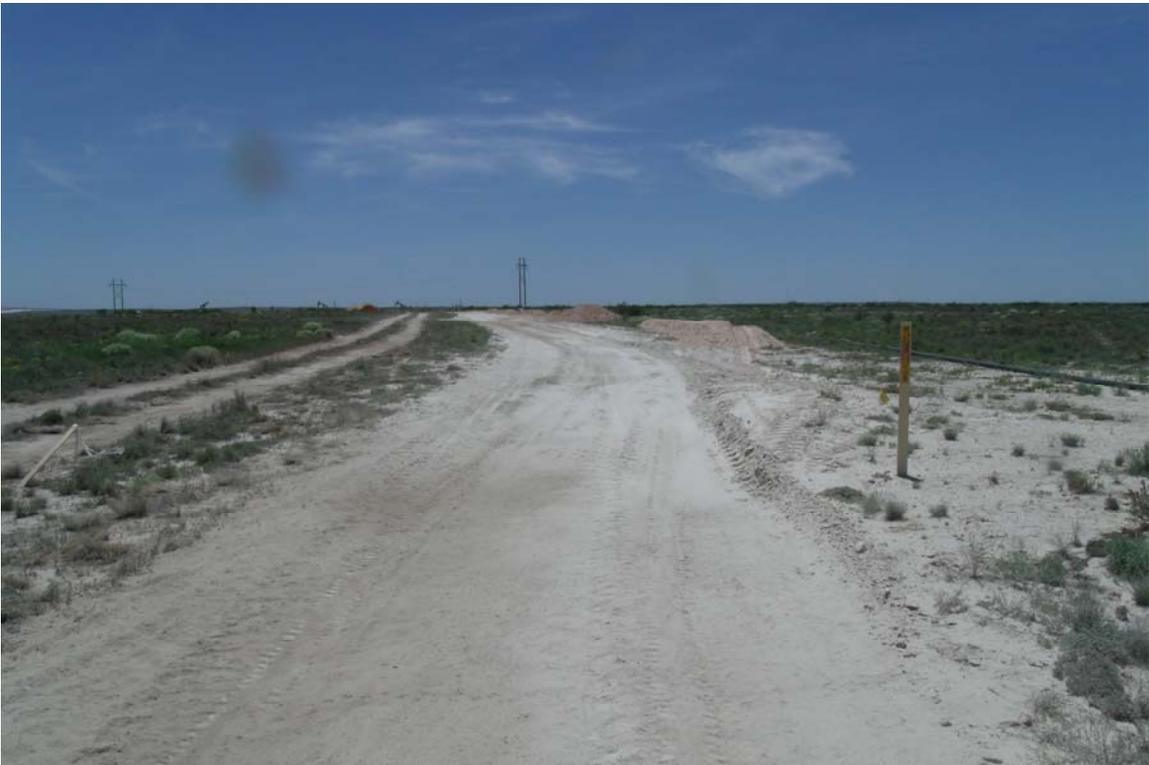
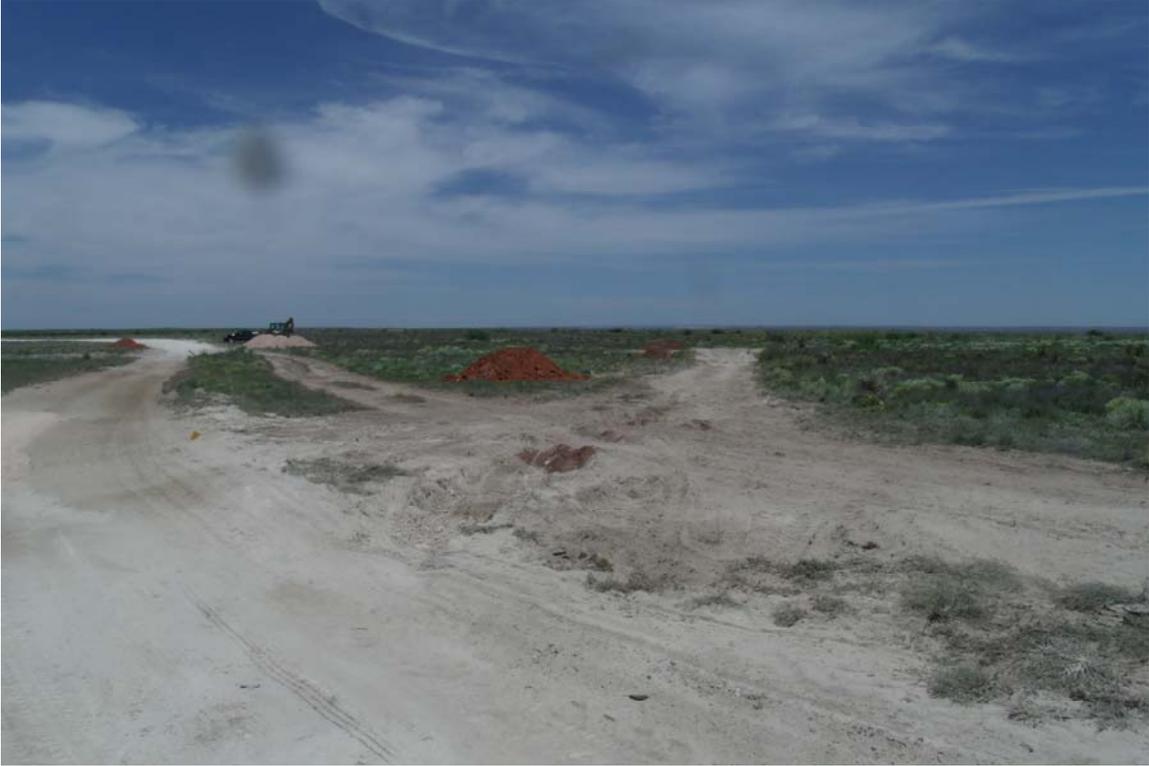
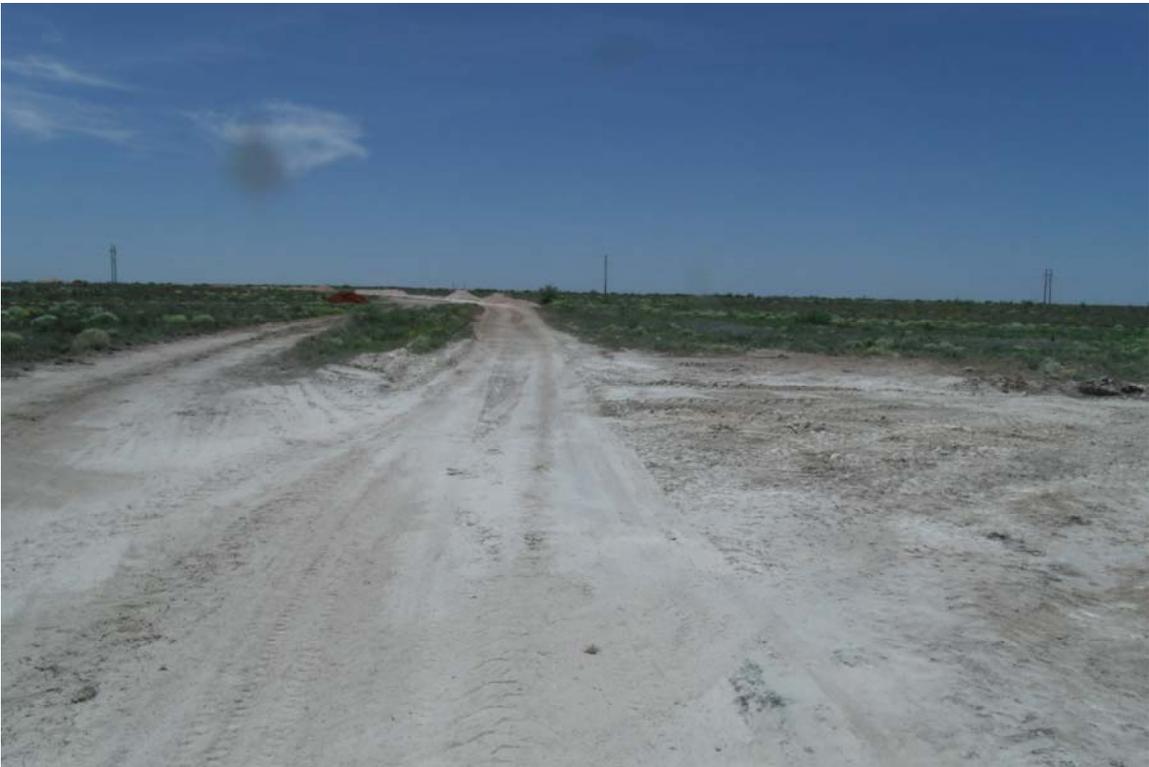
Photograph #5 – Lease road after surface scraping

Photograph #6 – Lease road after surface scraping

Photograph #7 – Lease road after surface scraping

Photograph #8 – Lease road after surface scraping

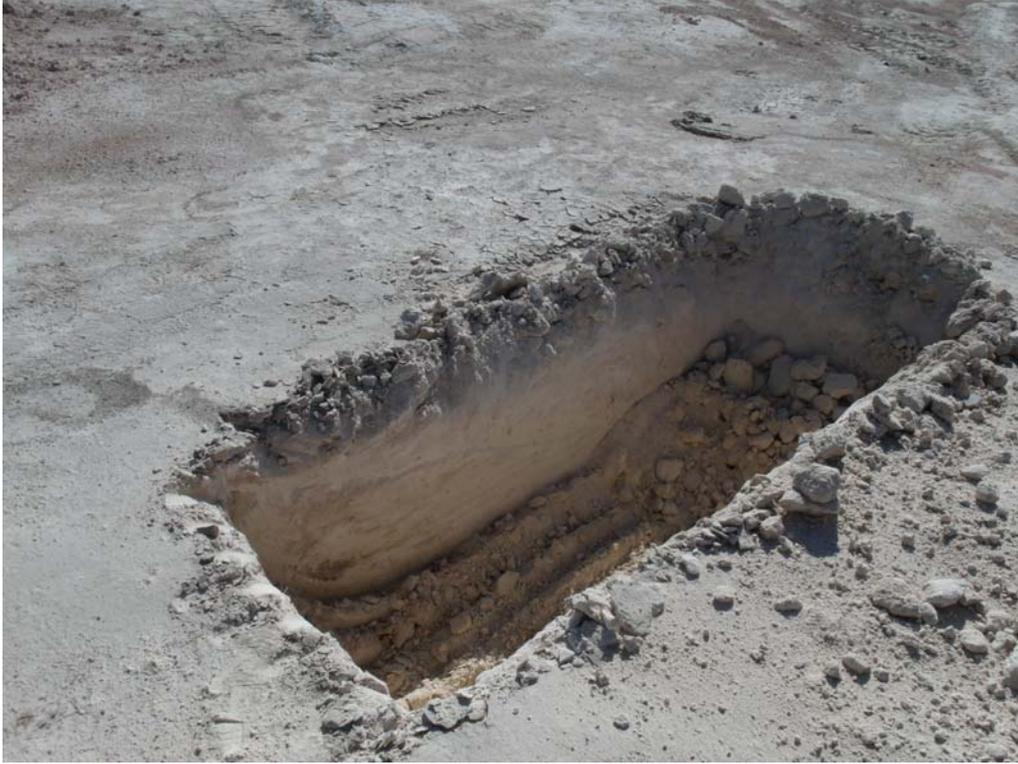
Photograph #9 – Excavated area

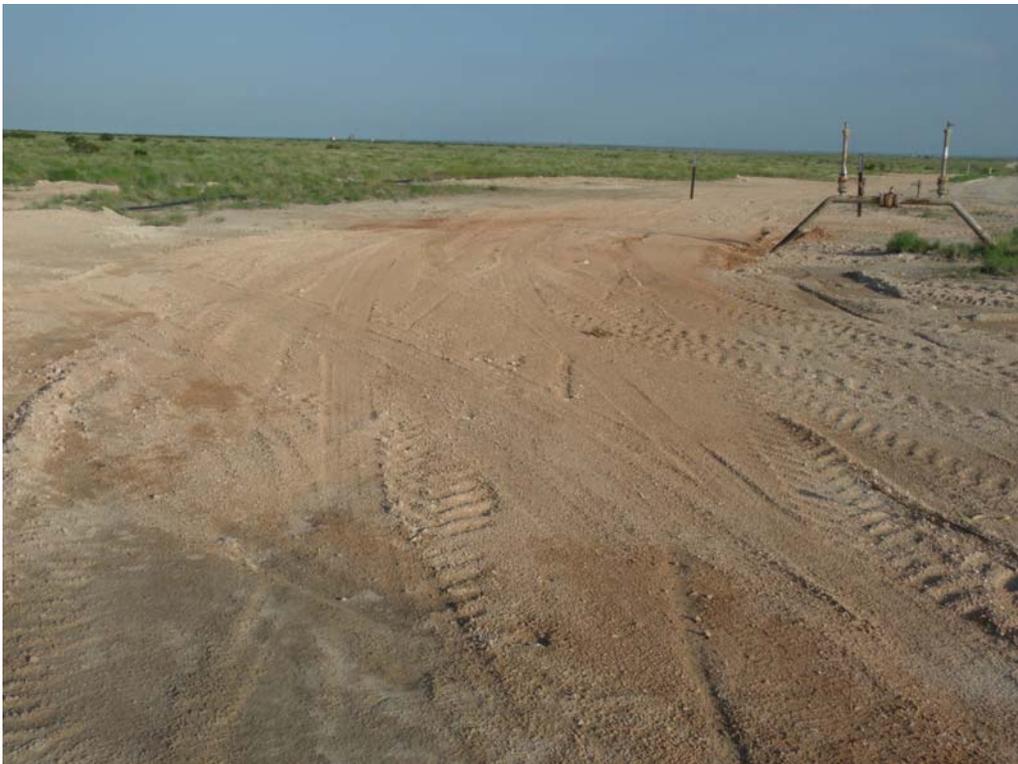
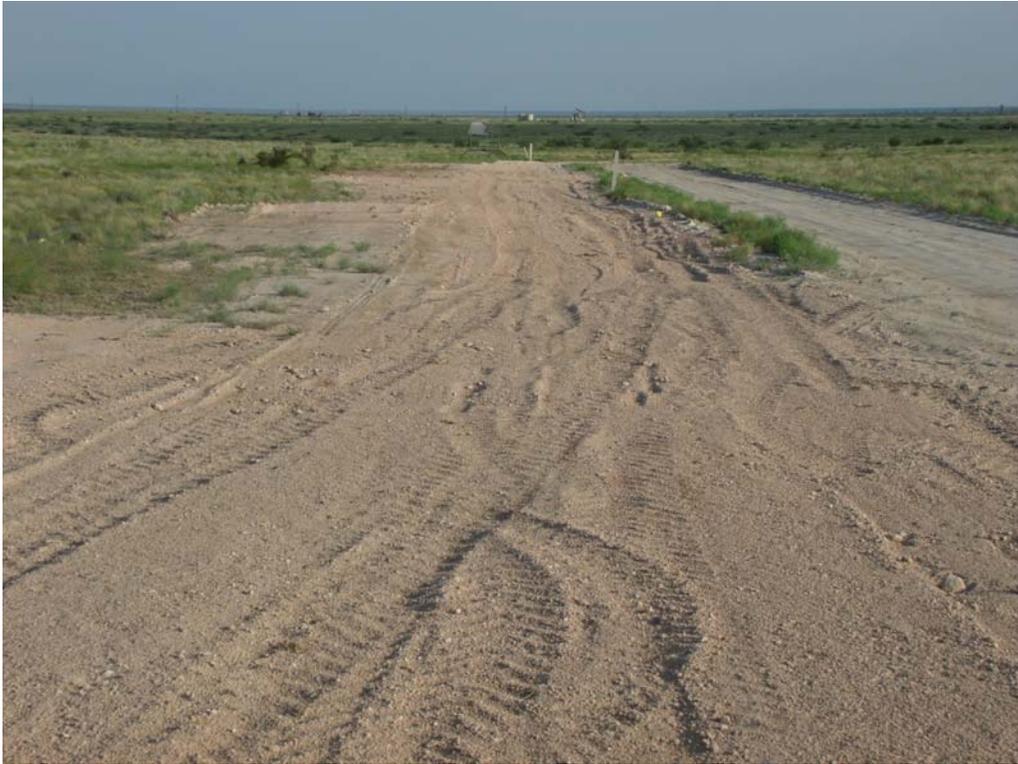
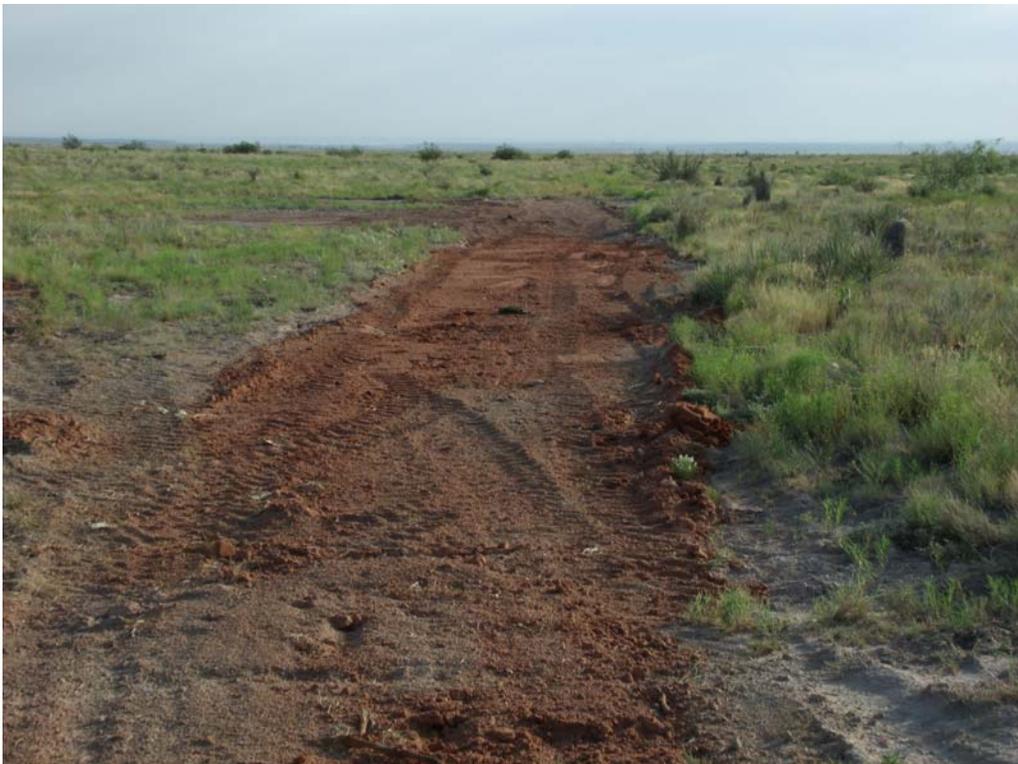
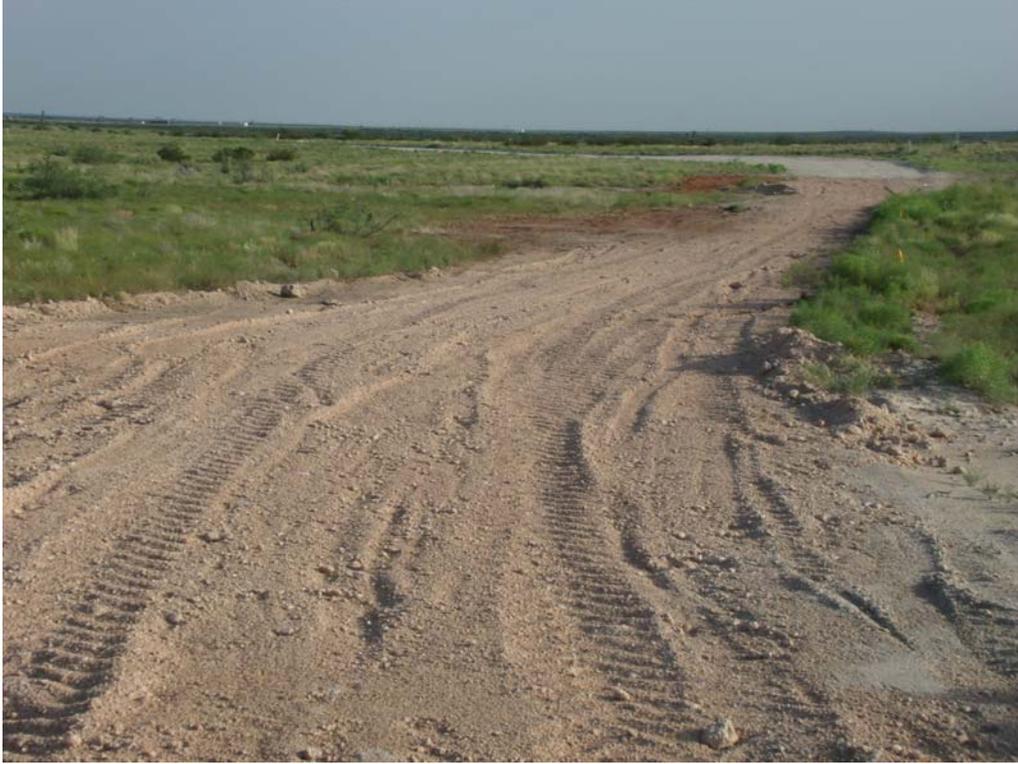
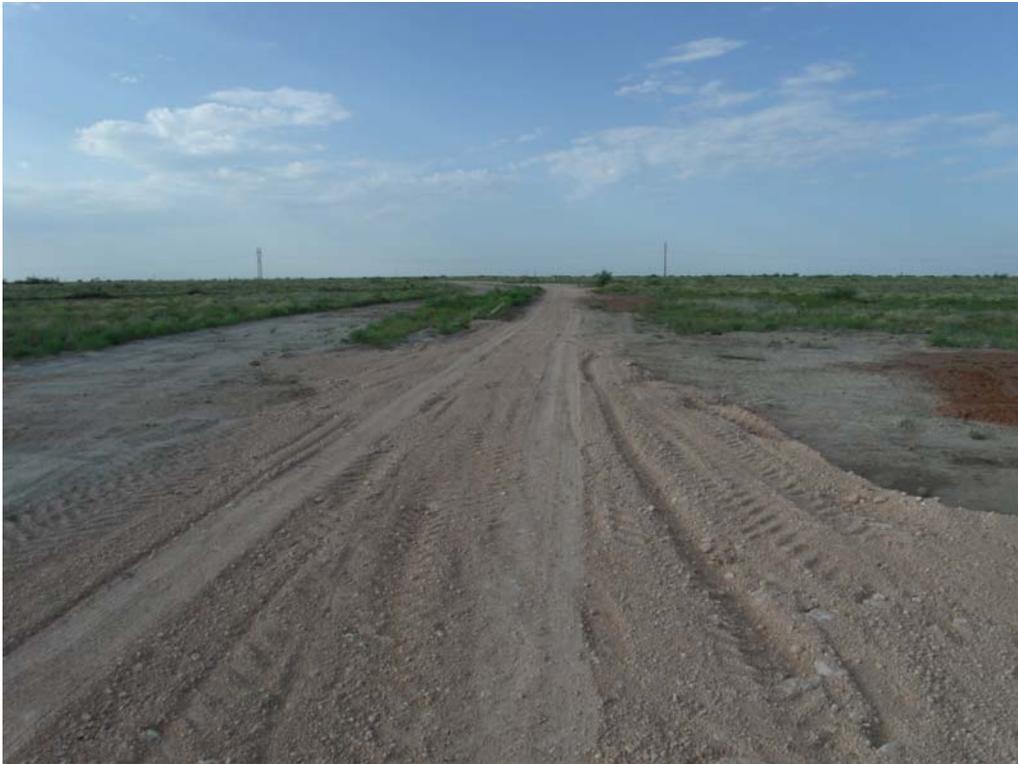
Photograph #10 – Backfilled area

Photograph #11 – Backfilled area

Photograph #12 – Backfilled area

Photograph #13 – Backfilled area

Photograph #14 – Backfilled area

As the release area is located on an active lease road, the area scraped up and the excavation at SP1, were backfilled with approximately 303 tons of clean soil. All soil was free of rocks, clumps or deleterious material. The entire disturbed area was then contoured to blend with existing lease road and protected against wind/water erosion.
