## **CLOSURE REPORT**

**BOPCO, L.P.**  
**PLU #232**  
**Eddy County, New Mexico**  
**Unit Letter "D", Section 31, Township 24 South, Range 30 East**  
**Latitude 32.178226 North, Longitude 103.925705 West**  
**NMOCD Reference #2RP-3463**

RE: Final Closure Report  
Bopco, L.P. – PLU #232  
UL-D, Section 31, Township 24 South, Range 30 East  
Eddy County, New Mexico  
NMOCD Reference #'s 2RP 3463

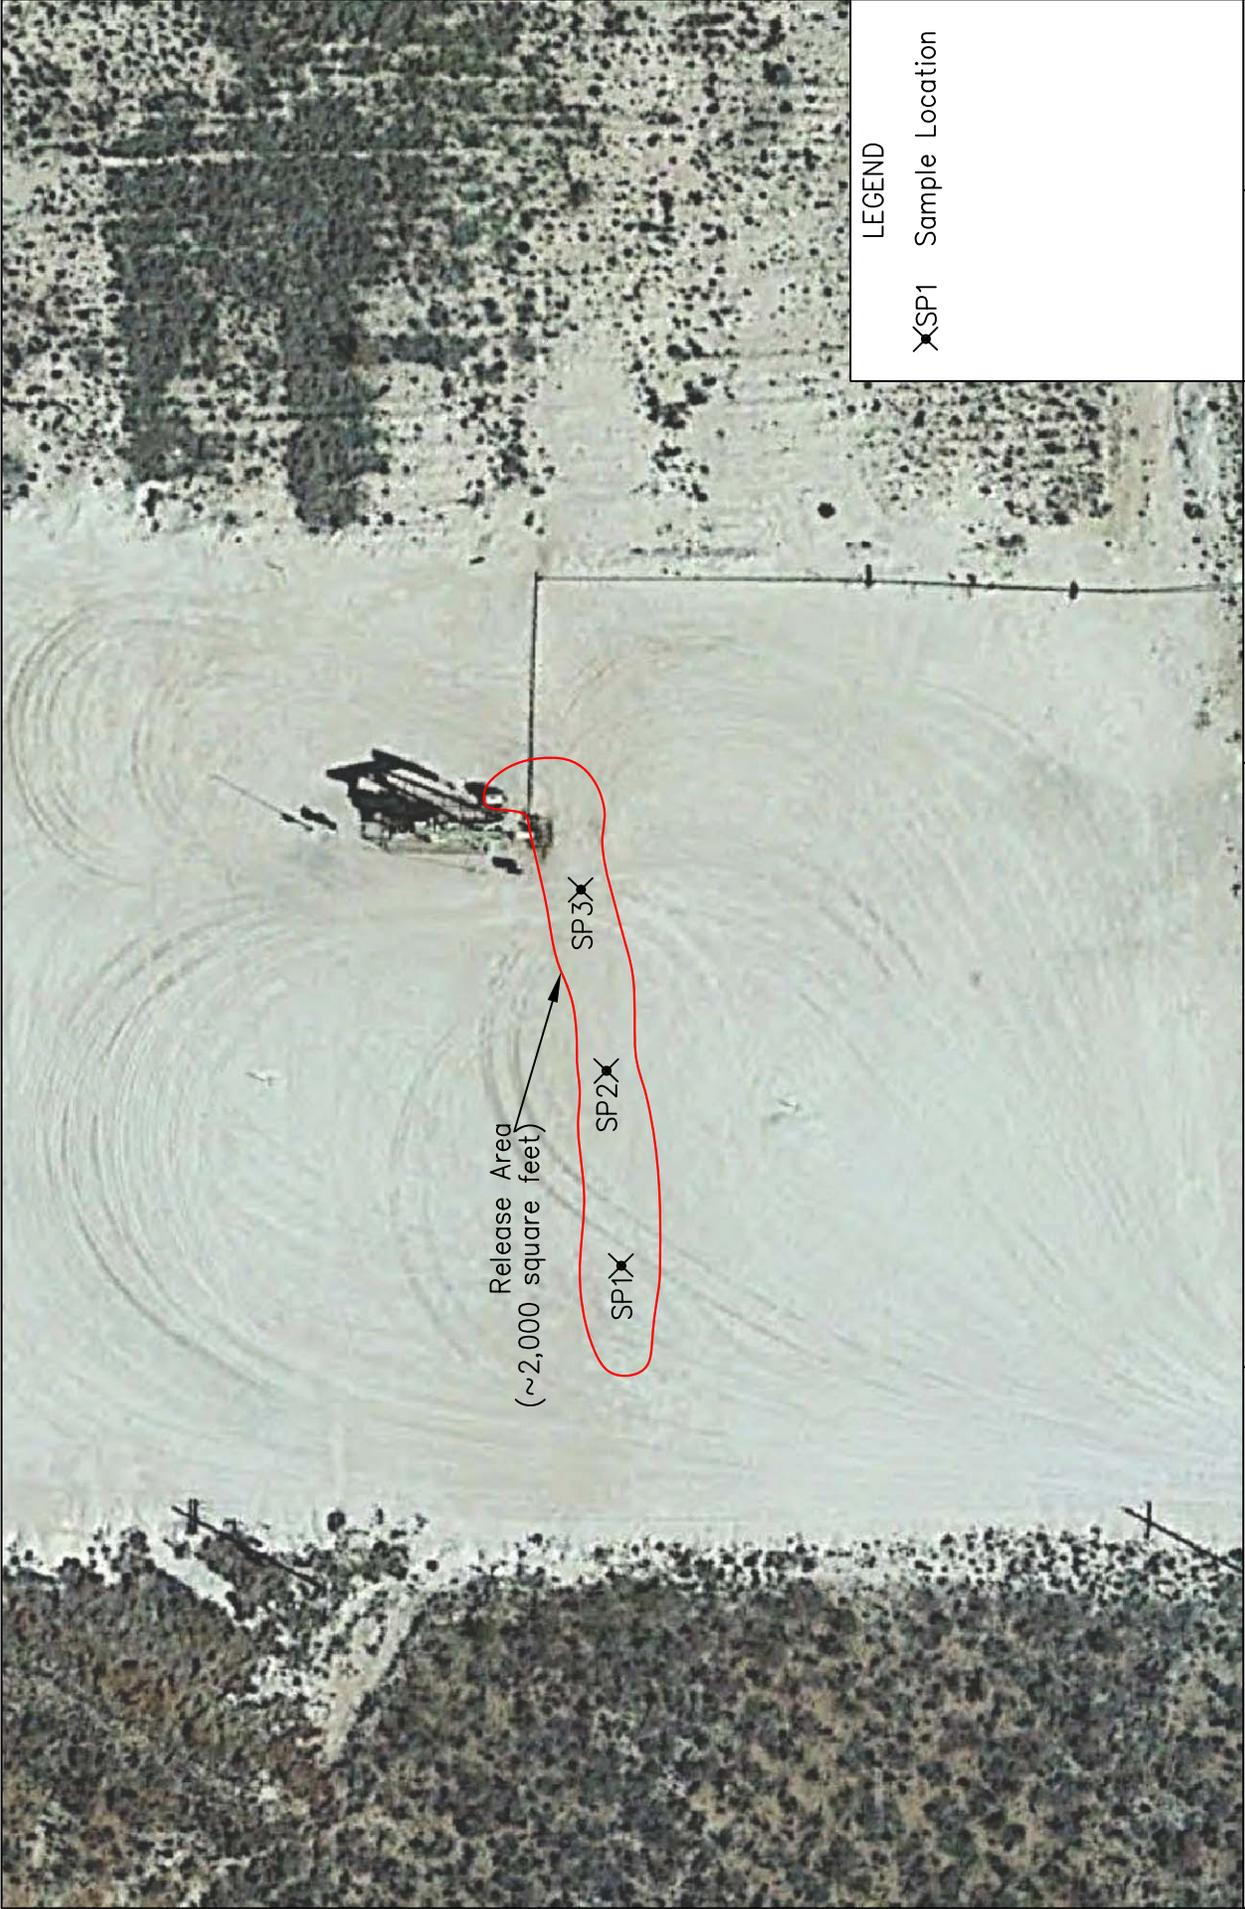
Figure 3  
Site/Sample Map  
Bopco, L.P.  
PLU #232

Release Area  
(~2,000 square feet)

SP1X

SP2X

SP3X

EPI personnel mobilized on the site on April 18, 2016 to collect soil samples to determine the vertical extent of contamination. A total of five (5) soil samples were collected from three (3) sample locations; SP1 – SP3. Three (3) representative samples were sent to Cardinal Labs in Hobbs, New Mexico, for testing. Laboratory analytical results indicate the release area to be void of Benzene, BTEX, TPH, and Chloride concentrations in excess of NMOCD Recommended Remedial Action Levels (RRALs) of 10 mg/Kg, 50 mg/Kg, 5,000 mg/Kg, and 1,000 mg/Kg, respectively (reference *Figure 3* and *Table 2*).

After an initial surface scrape of the release area, the NMOCD approved no further action at the areas around SP1 and SP2 while the area around SP3 was further excavated to a depth of approximately twelve (12) inches bgs. Approximately 36 tons of contaminated soil was excavated and hauled to a state approved facility for disposal.

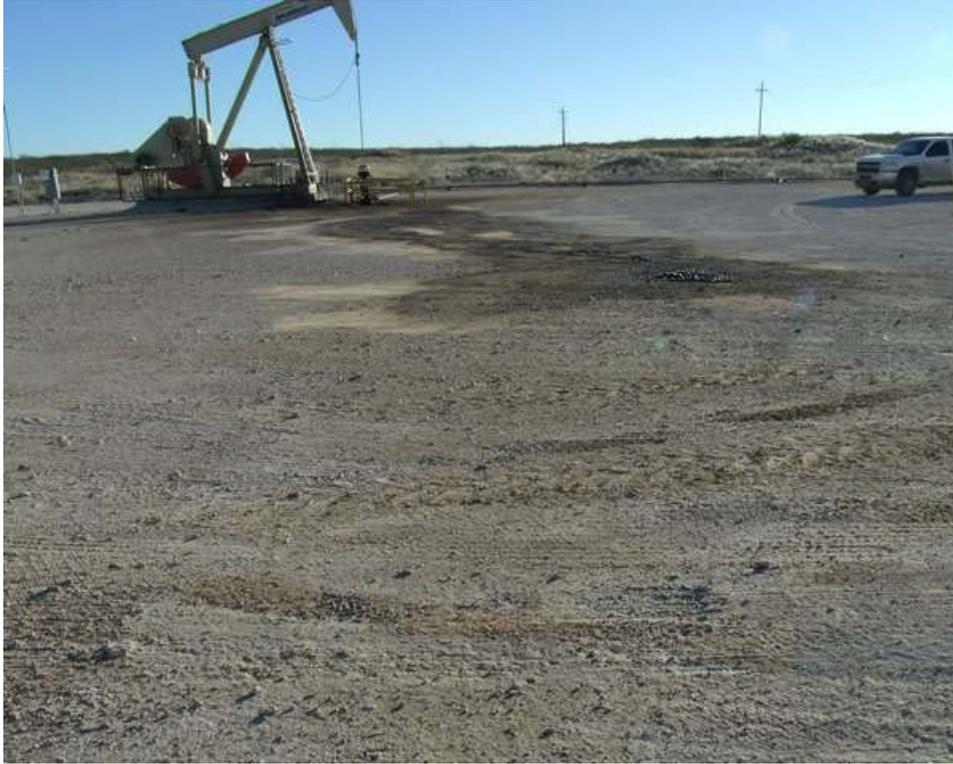
Photograph #1 – Northeast view across release area

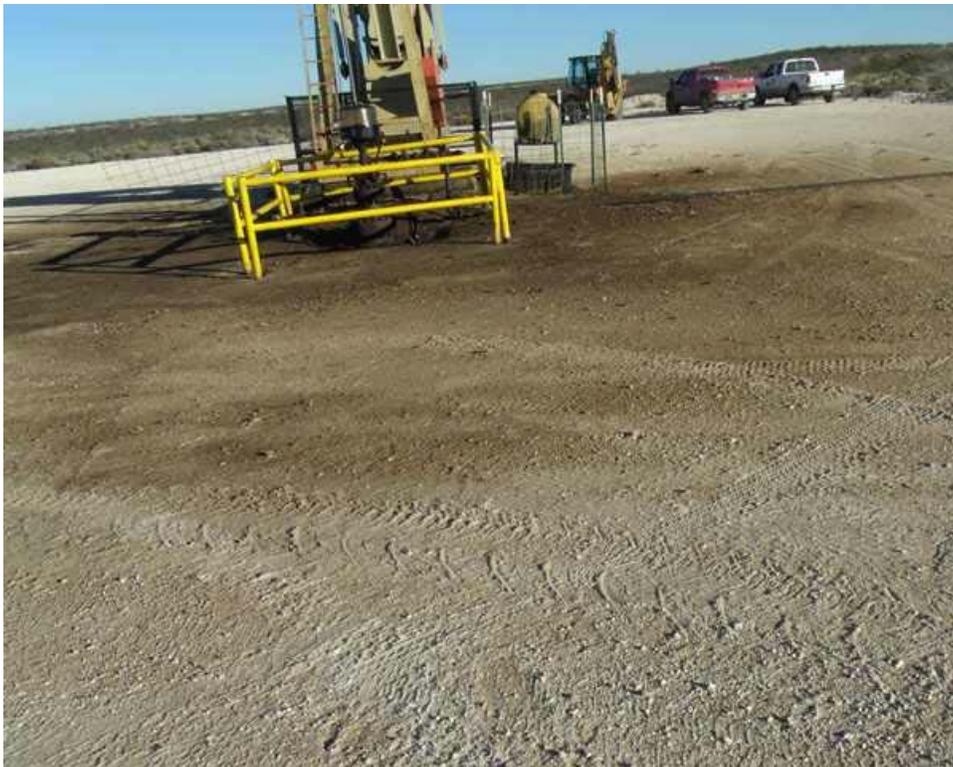
Photograph #2 – Northern view across release area

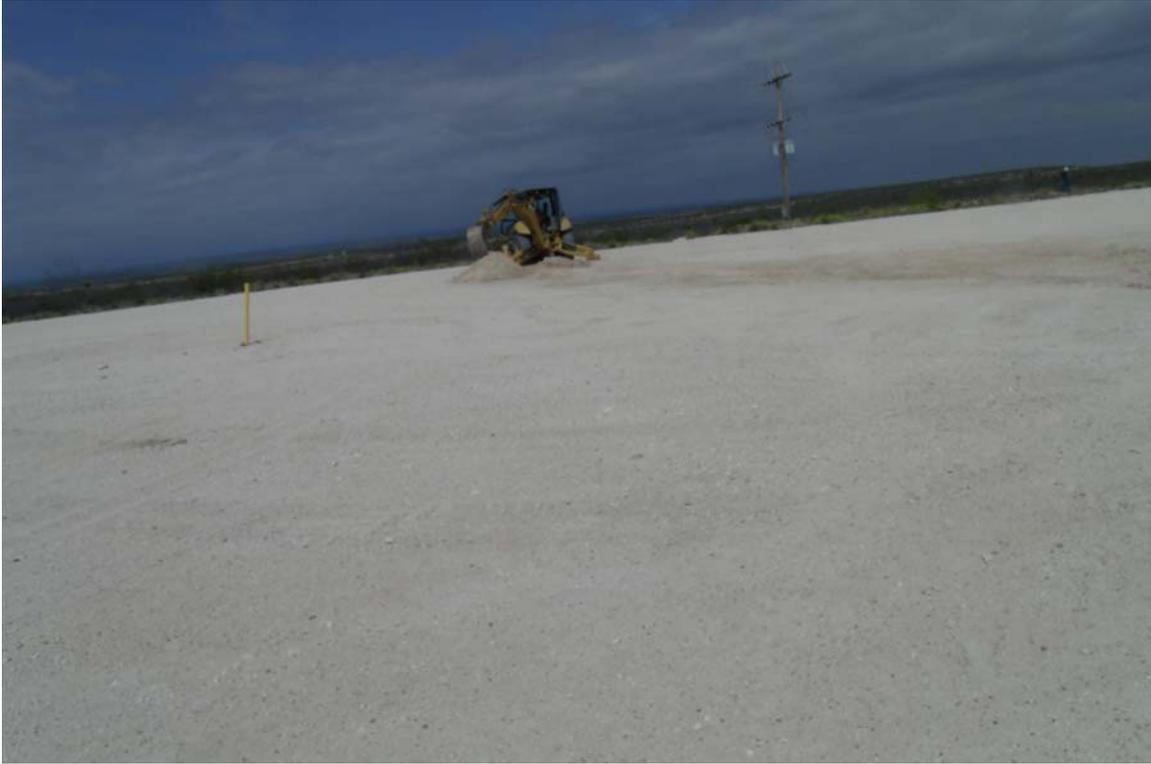
Photograph #3 – Excavating and collecting samples

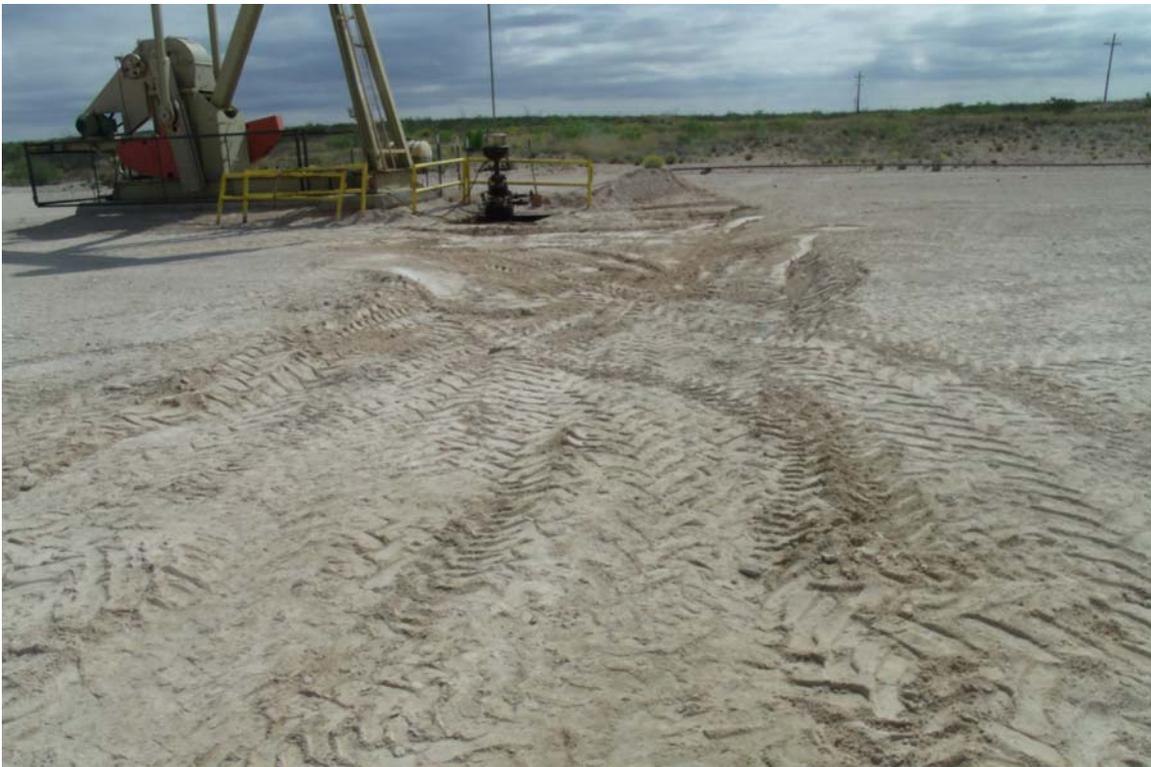
Photograph #4 – Excavated area

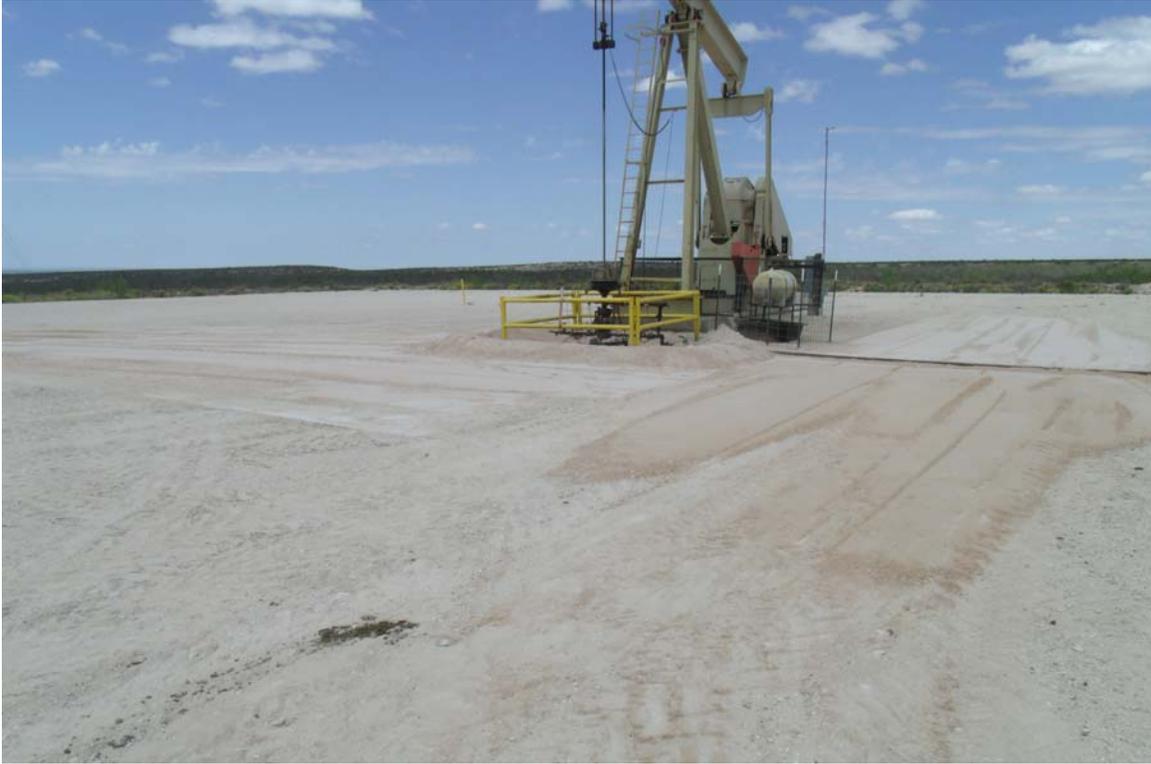
Photograph #5 – Backfilled

Based on laboratory analytical data and NMOCD approval, the excavation was backfilled with approximately 36 tons of clean soil. The entire disturbed area was then contoured to blend with existing pad area and protected against wind/water erosion.

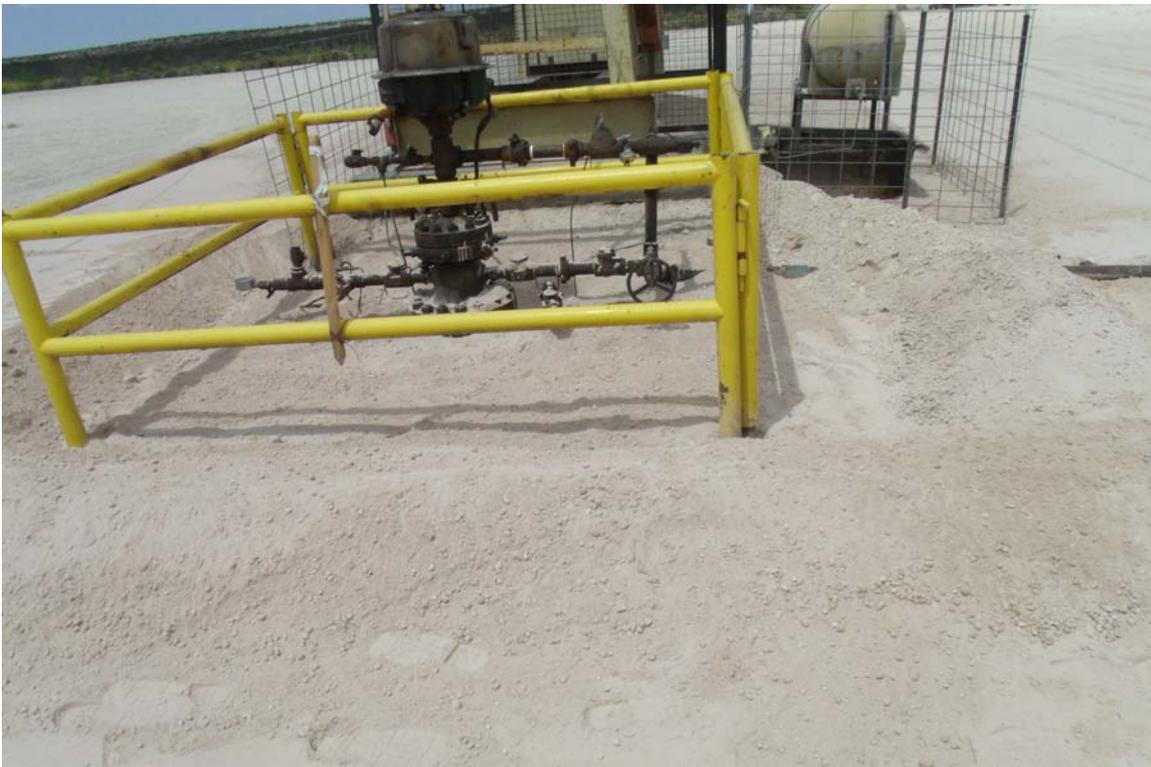
Photograph #6 – Backfilled
