# Lea D #23

## CLOSURE REPORT

Unit Letter F, Section 26, Township 17 South, Range 31 East

API No. 30-015-29703

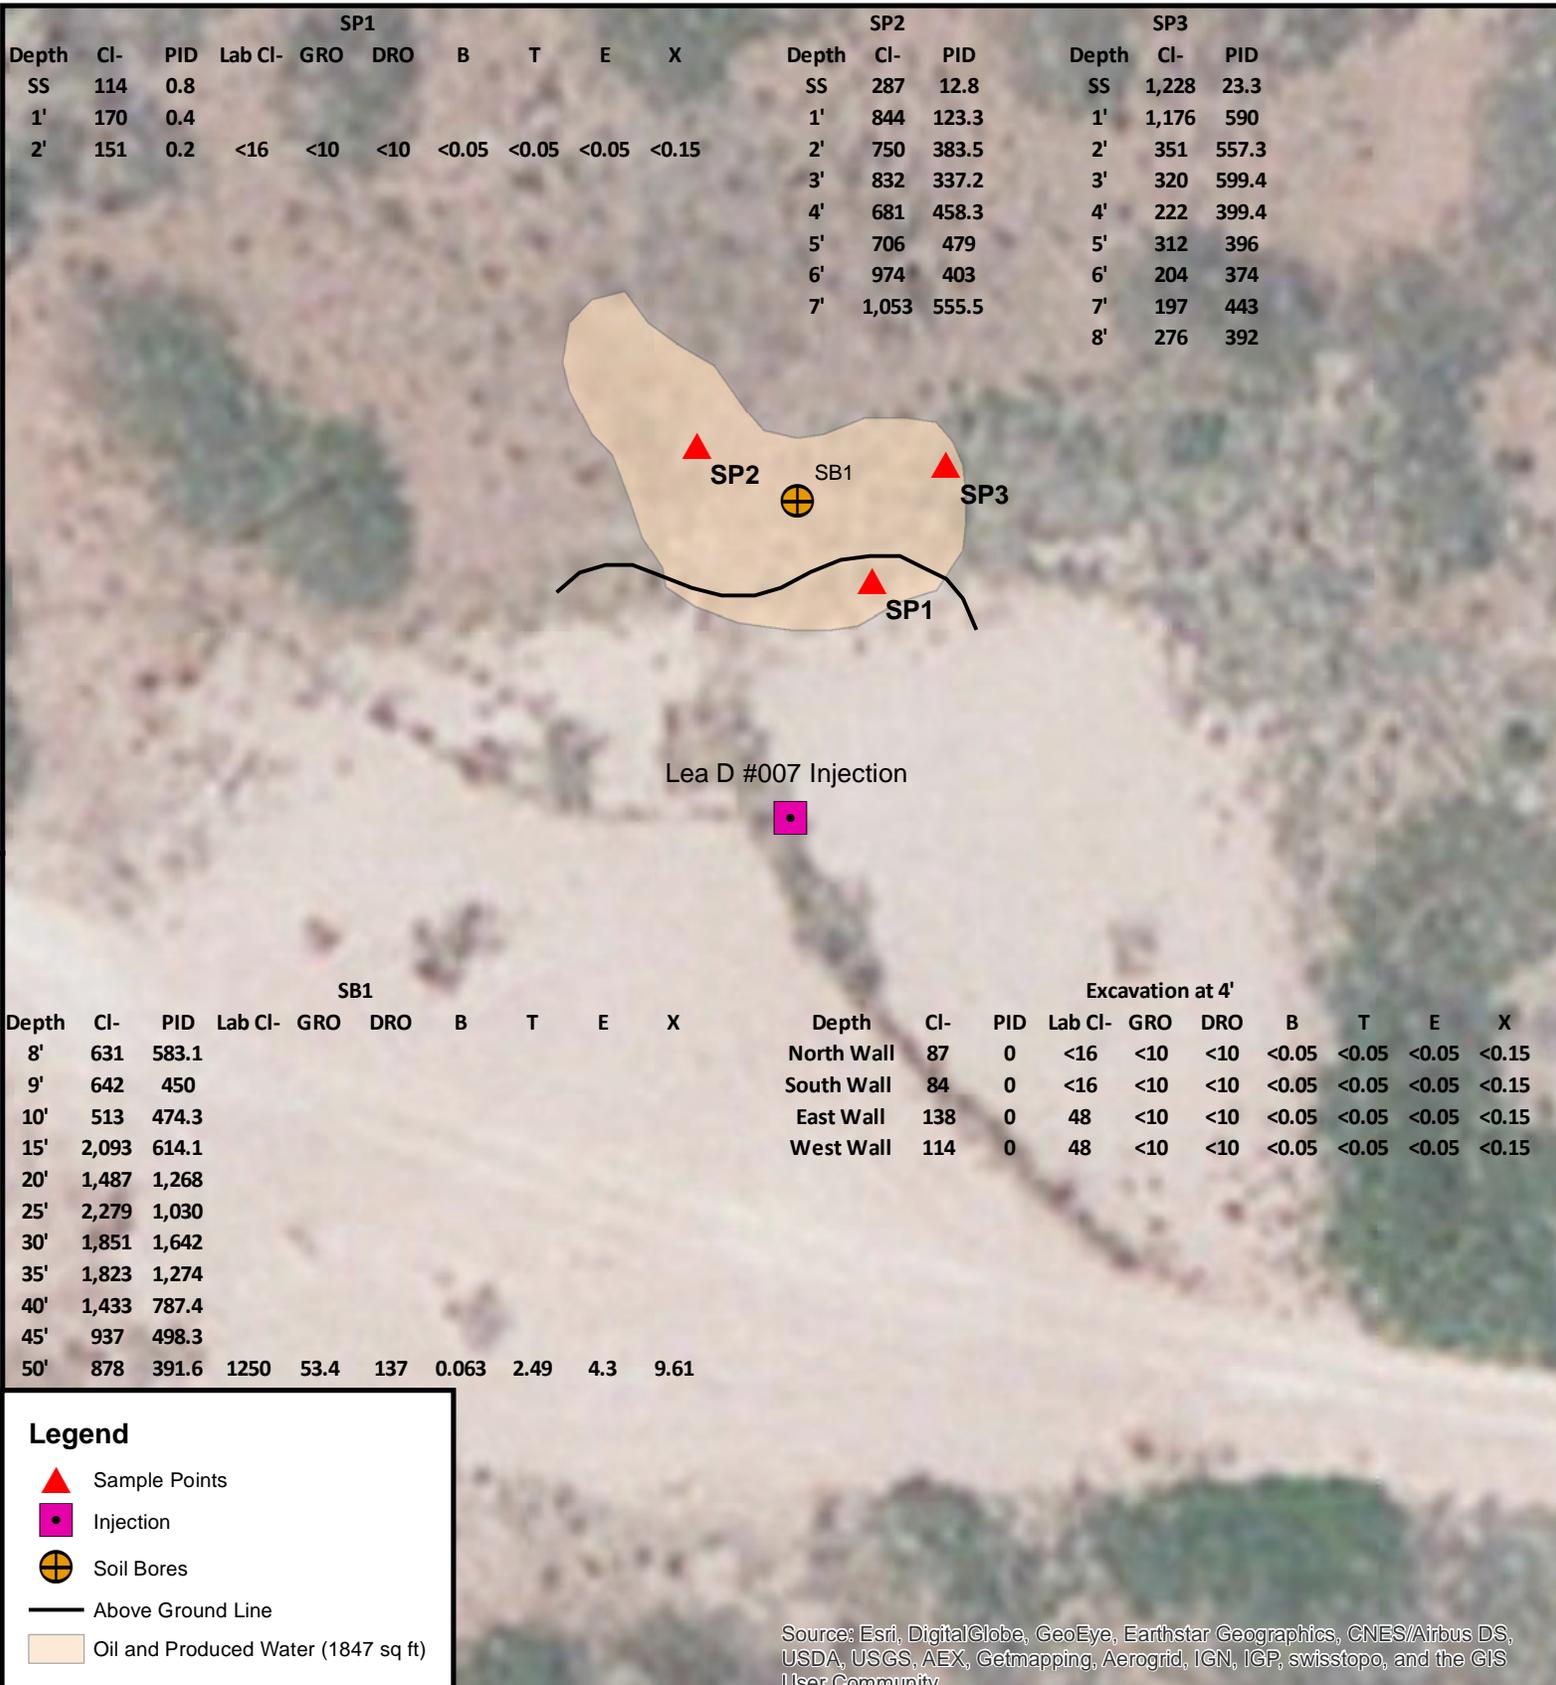
# Site Diagram

- Sample Points
- Injection
- Soil Bores
- Above Ground Line
- Oil and Produced Water (1847 sq ft)

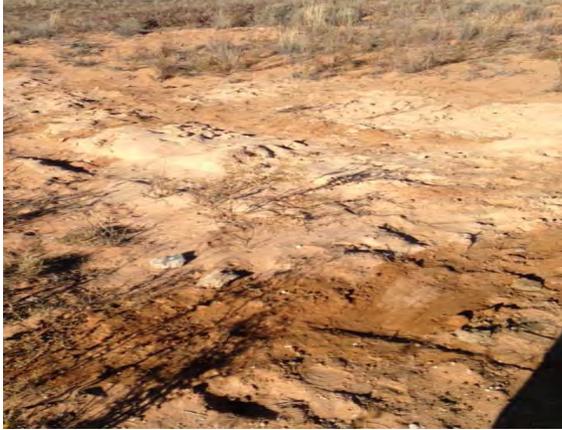
Site prior

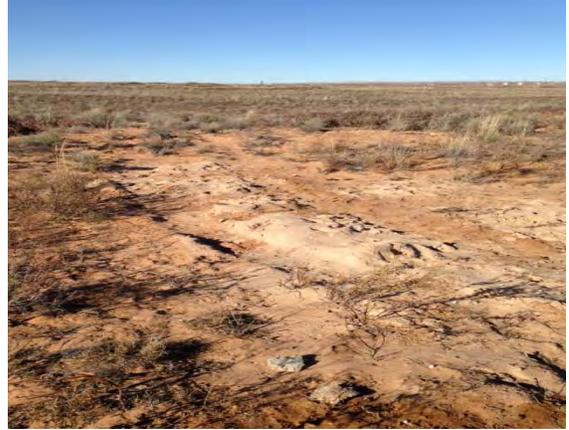
Site prior

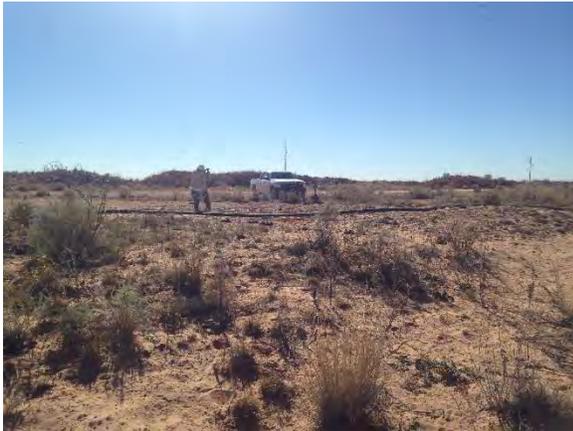
Collecting samples by auger, facing southwest

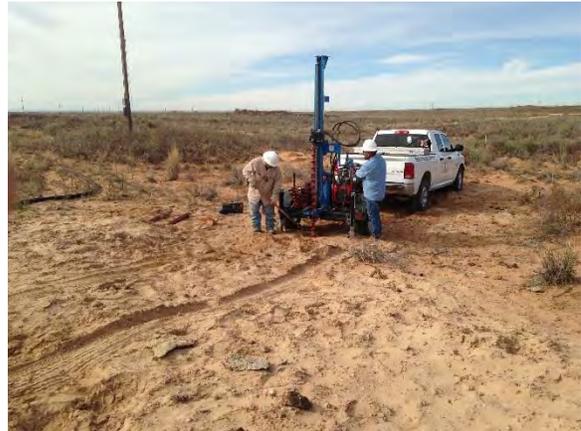
Collecting soil samples by soil bore installation, facing northwest

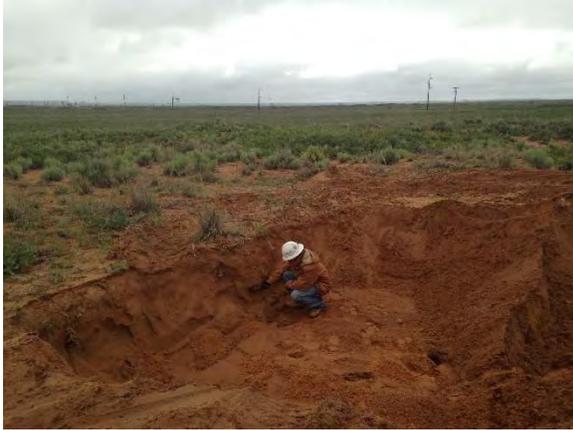
Collecting excavation wall samples, facing northeast 5/19/2016

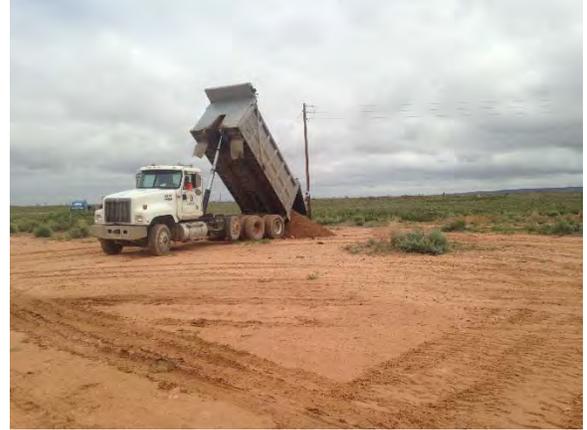
Importing topsoil, facing northwest 5/19/2016

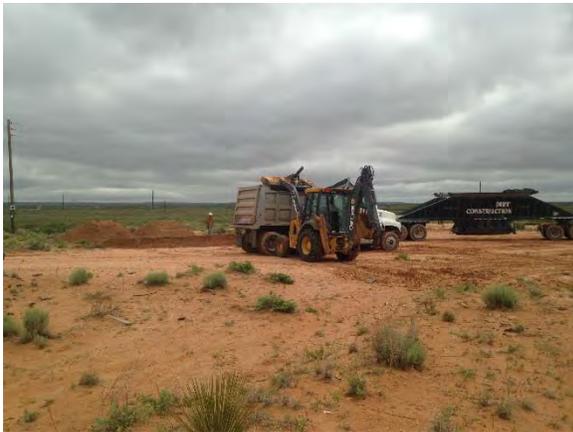
Exporting soil, facing northeast 5/19/2016

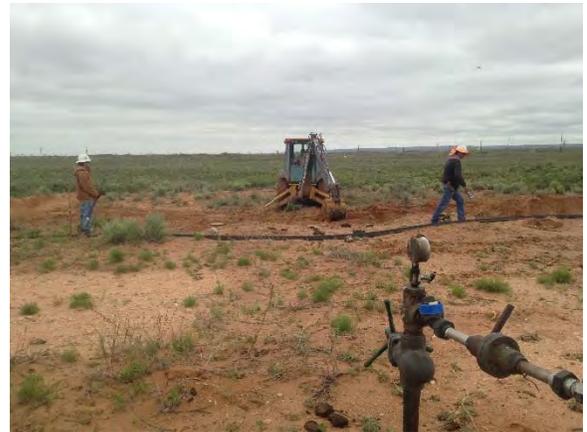
Excavating site down to 4', facing north 5/19/2016

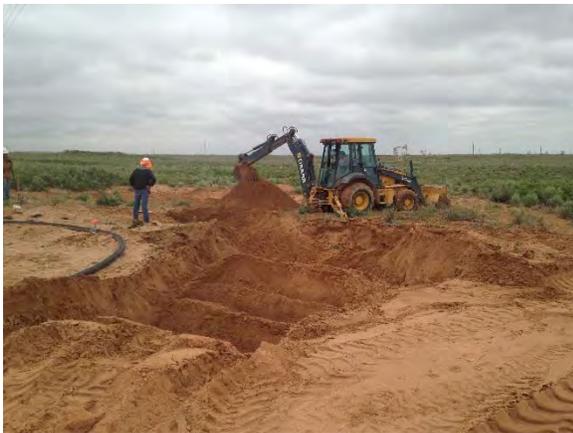
Excavating site, facing northwest 5/19/2016

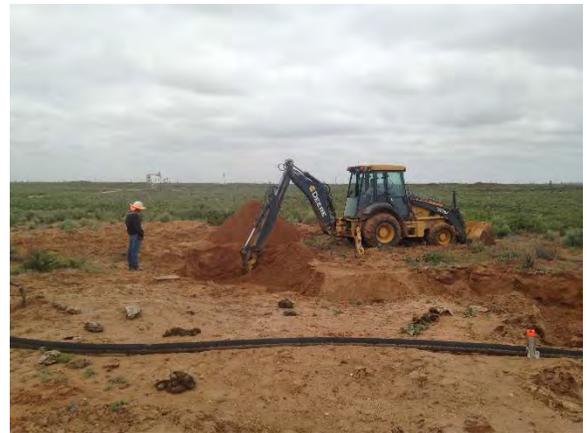
Excavating site, facing southwest 5/19/2016
