CORRECTIVE ACTION REPORT

Chinaberry #2 Leak
32.328537 N, 104.310943
NE ¼ SE ¼, S5 T23S R26E
Eddy County, New Mexico
2RP-3446

August 2016

Apex Project No. 725010112095

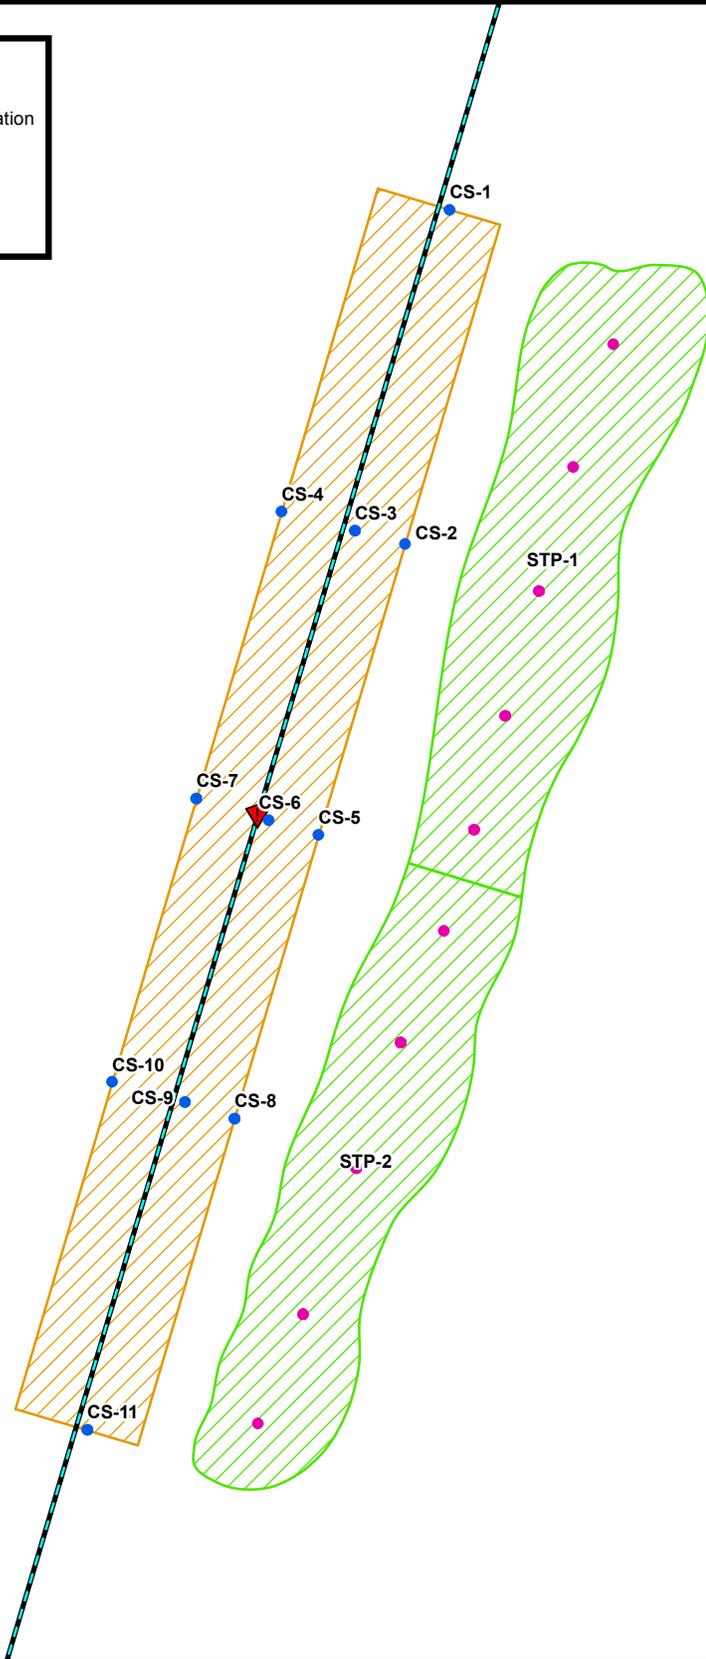
FIGURE 3
Site Map

Figure 3 is a Site Map that indicates the approximate location of the confirmation soil samples in relation to pertinent land features and general Site boundaries (Appendix A).

- Confirmation Sample Location
- Stockpile Composite Sample Location
- ▼ Release Point
- Enterprise Chinaberry Pipeline
- ▨ Extent of Excavation
- ▨ Soil Stockpile Location

The excavation was carried out on January 14, 2015. Impacted soil was removed from below and surrounding the release point on the Chinaberry line. The excavation dimensions measured approximately 100 feet long by ten (10) feet wide, with a total depth of approximately five (5) feet below ground surface (bgs). Impacted soil was removed and collected into one (1) stockpile on Site.

On January 14, 2016, Apex collected 11 confirmation soil samples (CS-1, CS-2, CS-3, CS-4, CS-5, CS-6, CS-7, CS-8, CS-9, CS-10 and CS-11), from the resulting excavation. In addition, two (2) composite soil samples (STP-1 and STP-2) were collected from the stockpiled material for disposal purposes.

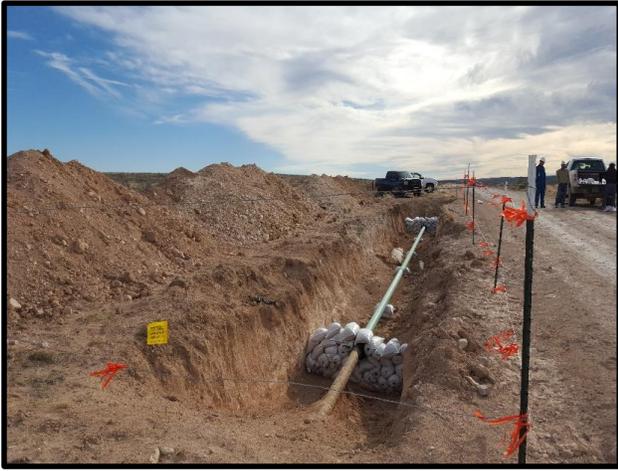
View of excavation facing south.

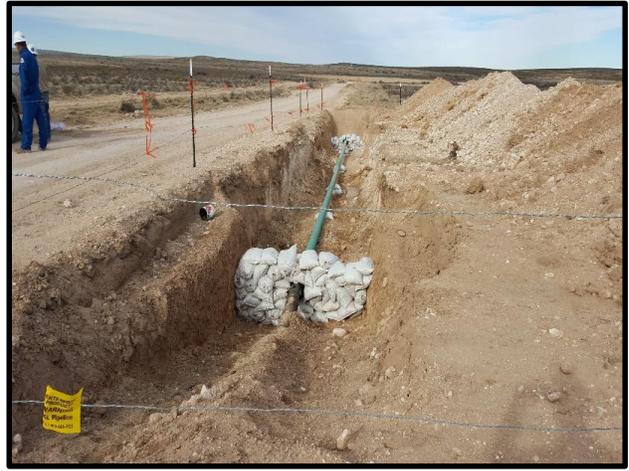
View of excavation facing north.

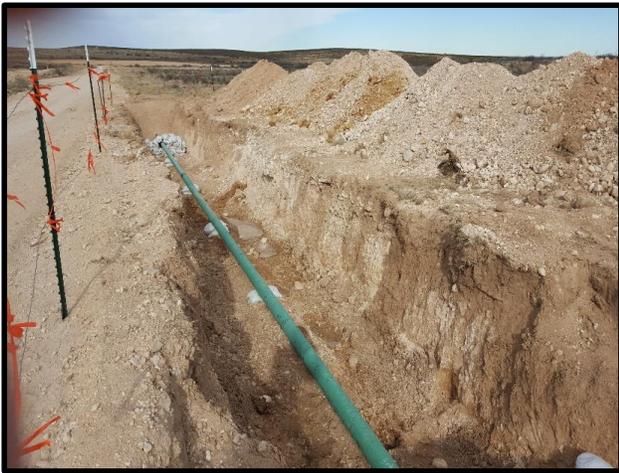
View of excavation, facing northeast, in the vicinity of the release point

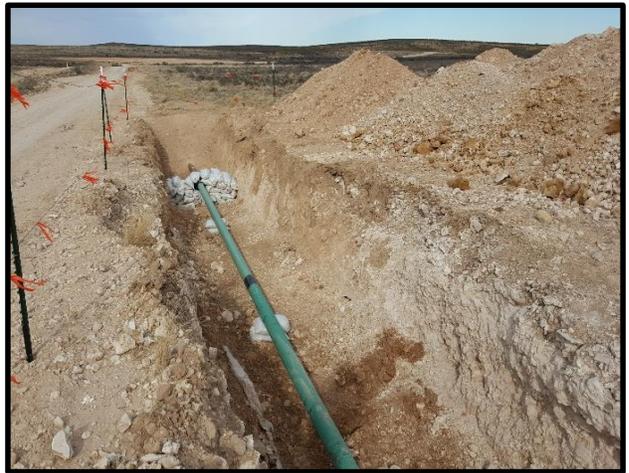
View of excavation facing northeast.

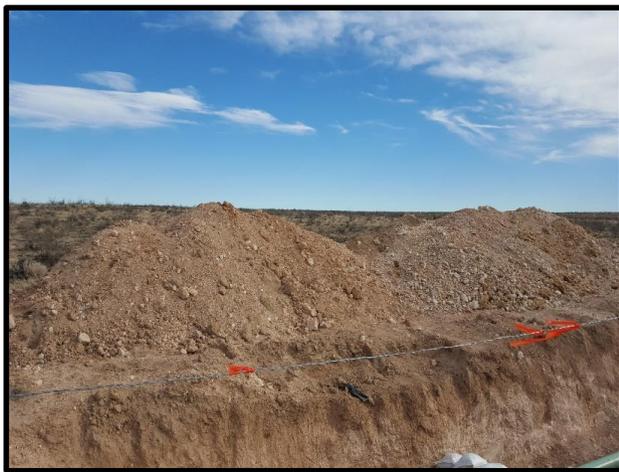
View of stockpiles facing west.

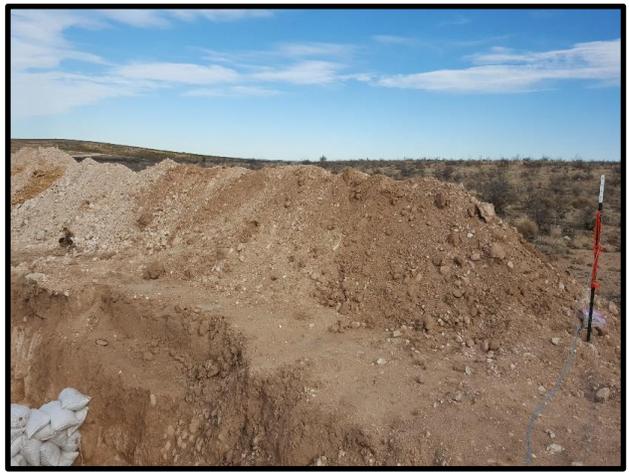
View of stockpiled material, facing west, near vicinity of the release point
