## **Soil Assessment and Remediation Work Plan**

Myrtle Myra No. 8 \* 30-015-43372 \* 1572

Talon Project No. 701771.002.01

Subject: **Soil Assessment and Remediation Work Plan**  
Myrtle Myra No. 8  
API #: 30-015-43372 \* 2RP-1572

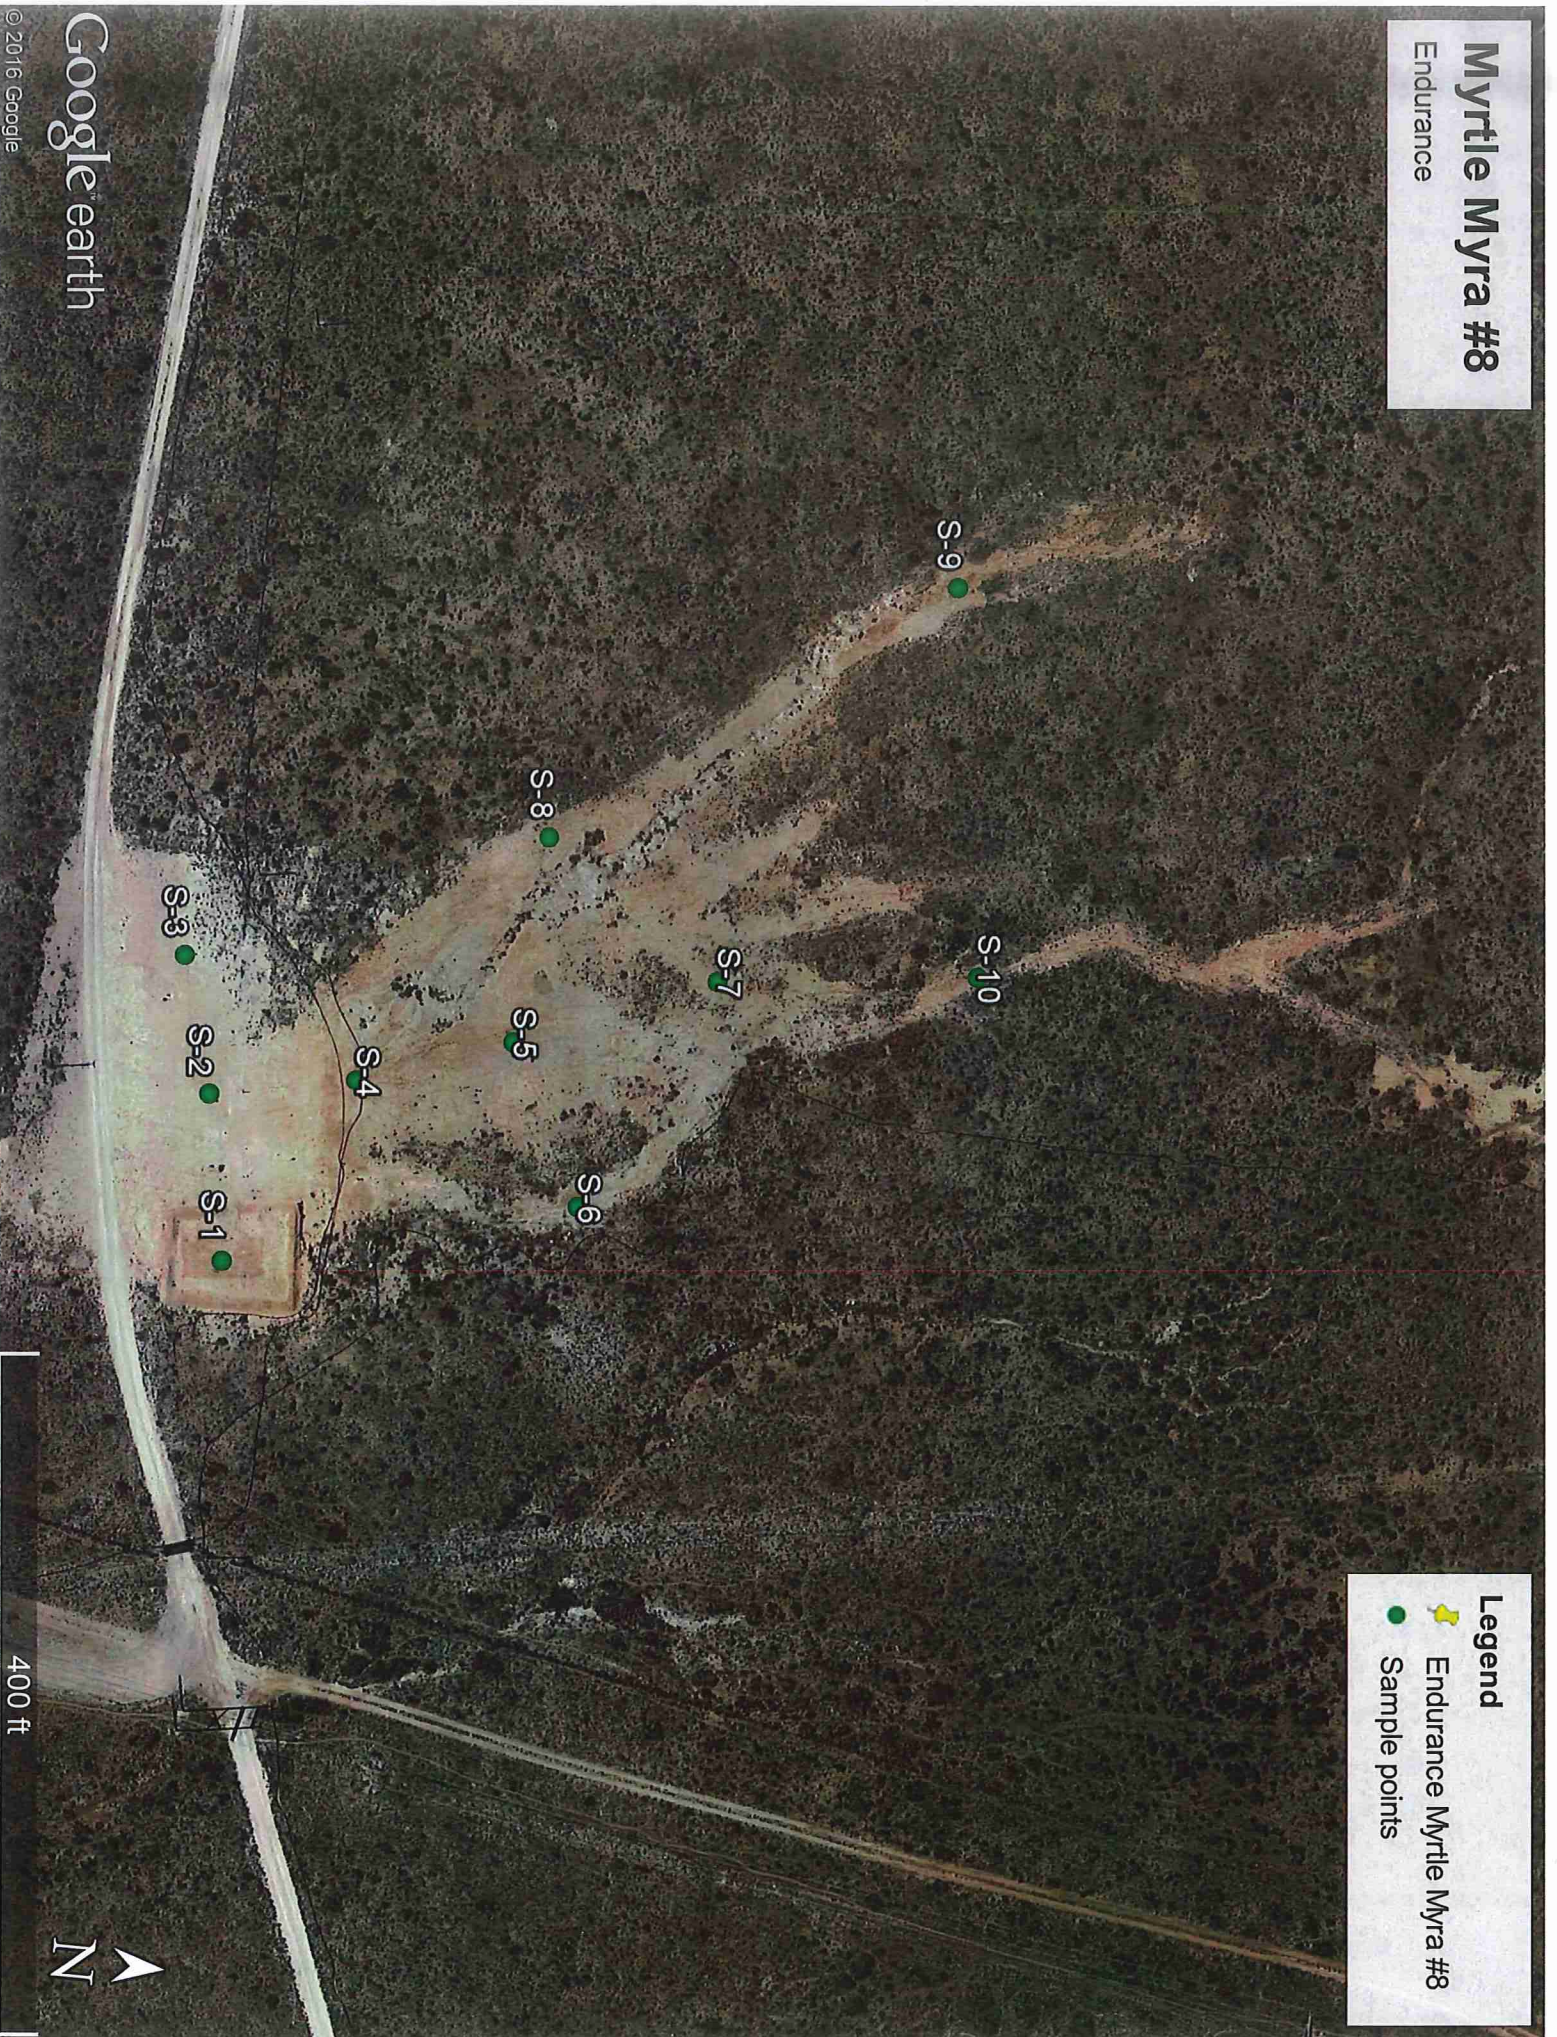
### SITE MAP

# Myrtle Myra #8

Sample points

- The impacted areas in the vicinity of sample locations S-1, S-2, S-4, S-5 and S-6 will be excavated to a depth of 4-feet deep or to the extent possible where refusal with an excavator is encountered at top of rock. A 20 mil liner will be laid within the excavated area at this location. Pictures will be taken at depths and areas will be documented where 4-foot depths cannot be achieved due to top of rock.

- The area around sample location S-3 will be scraped to a depth of 0.5-foot deep. The impacted area in the vicinity of sample location S-7 will be excavated to 1-foot deep and the area around S-9 will be excavated to the depth 1.5-foot deep where refusal was encountered.
