Report Type: Work Plan 2RP-4083

Site:	Burch Keely Unit #933H				
Company:	COG Operating LLC				
Section, Township and Range	Unit E	Sec. 13	T 17S	R 29E	
Lease Number:	API No. 30-015-40970				
County:	Eddy County				
GPS:	32.835019° N			104.035119° W	
Surface Owner:	Federal				
Mineral Owner:					
Directions:	From the intersection of Hwy 82 (Lovington Hwy) and Kewanee Rd in rural Eddy County, travel north on Kewanee Rd for approximately 1.0 mi, turn east onto the lease road for approximately 330 feet to the location on the south side of the lease road.

Re: Work Plan for the COG Operating LLC., Burch Keely Unit #933H, Unit E, Section 13, Township 17 South, Range 29 East, Eddy County, New Mexico. 2RP-4083

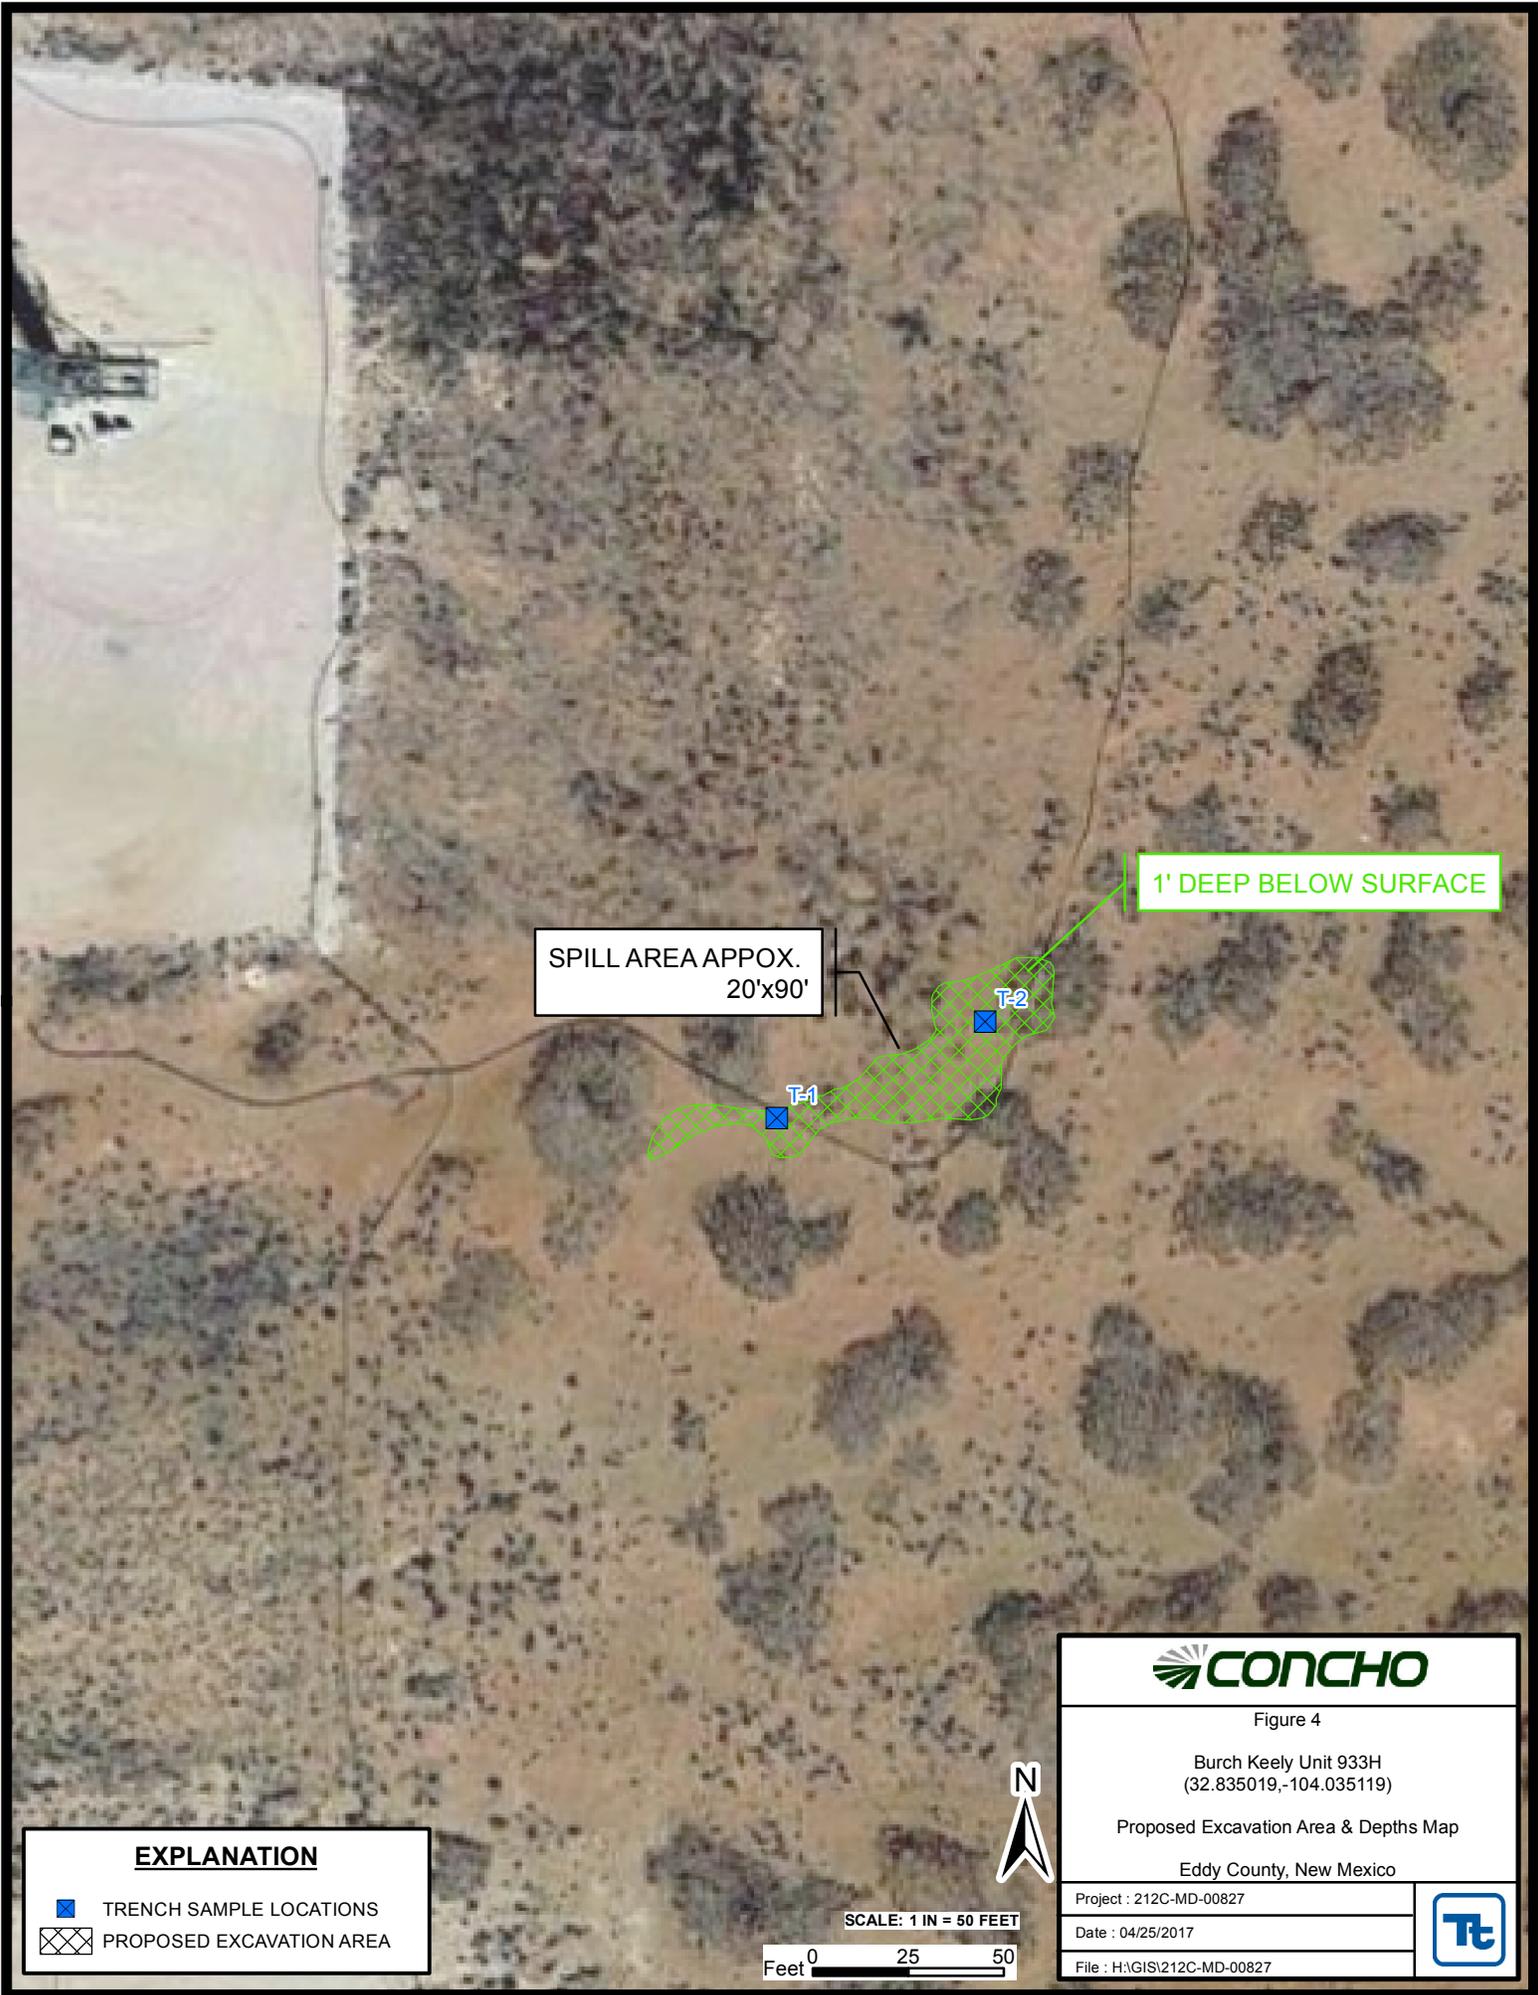
Figure 4	
Burch Keely Unit 933H (32.835019,-104.035119)	
Proposed Excavation Area & Depths Map	
Eddy County, New Mexico	
Project : 212C-MD-00827

1' DEEP BELOW SURFACE

SPILL AREA APPROX.
20'x90'

Based on the laboratory results, COG proposes to remove the impacted material as highlighted (green) in Table 1 and shown on Figure 4. The areas of trenches (T-1 and T-2) will be excavated to a depth of approximately 1.0' below surface to remove the elevated BTEX concentrations in the shallow soils. Once excavated to the appropriate depth, the excavated area will be backfilled with clean material to surface grade. All of the excavated material will be transported offsite for proper disposal.

The proposed excavation depths may not be reached due to wall cave ins and safety concerns for onsite personnel. In addition, impacted soil around oil and gas equipment, structures or lines may not be feasible or practicable to be removed due to safety concerns for onsite personnel. As such, COG will excavate the impacted soils to the maximum extent practicable.
