**BARNSDALL
FEDERAL BATTERY
Remediation Plan
2RP-4202**

Eddy County, New Mexico

BARNSDALL
FEDERAL BATTERY
REMEDIATION PLAN
2RP-4202

Date:
August 6, 2017

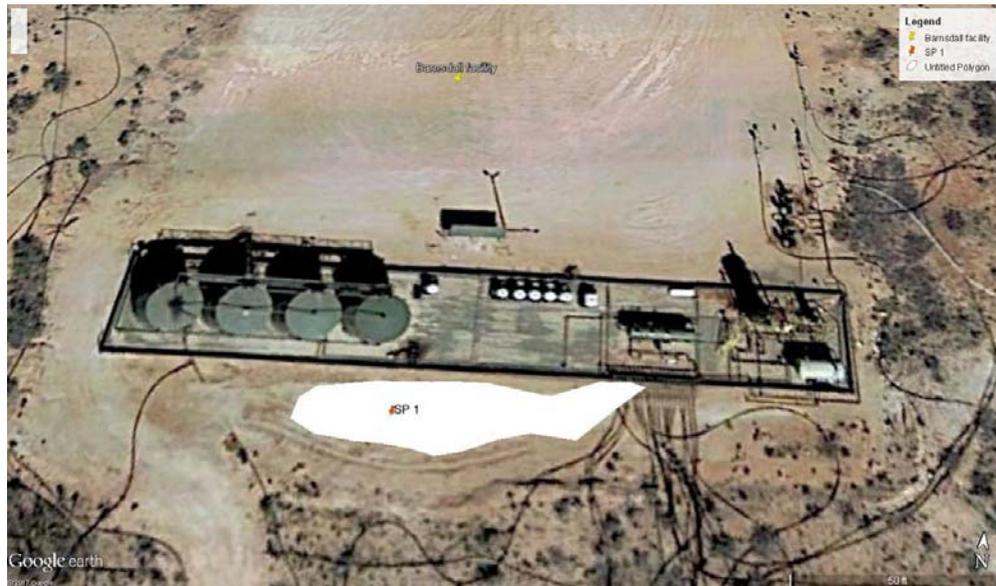
Figure 1: Sample Point Locations and Release Area

The release was reported to have had the header riser pipe failed resulting in the release of fluids. The line was isolated and a vacuum truck was dispatched to pick up any fluid. The riser was repaired. There was an area of 1,440 sq. ft. impacted by the release.

At SP 1, clay was reached at a shallow depth with a small percentage of sand. SP 1 became a tight clay at 7 ft. bgs. An EC meter was used to delineate the site. One bottom sample was taken at SP 1 and sent to a laboratory. The horizontal extent of impacted samples was mapped using a GPS. Side wall samples will be grabbed at time of remediation.

The lab sample was analyzed to be below OCD guidelines for chlorides with groundwater less than 100 ft. but greater than 50 ft. Apache will remove 4 ft. bgs. and lay 20 mil reinforced liner. The area will then be backfilled with caliche in order for maintenance to be completed on header as needed.

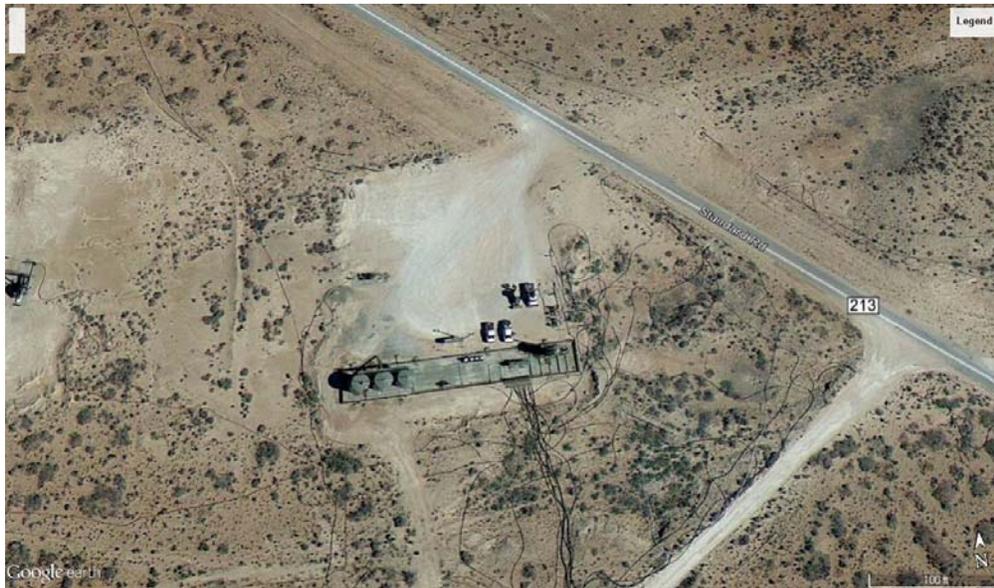
Figure 2: Historical Image of area in 2013

The 2013 and 2011 images show the area has not changed appearances up to 2016 as seen in Figures 2 & 3.
