Work Plan

Cimarex Energy Company: Glycerin 10 Federal Com #001

|30-015-36359|2RP-3407|

Subject: **Soil Assessment and Remediation Work Plan**
Cimarex Energy Co.
Glycerin 10 Federal Com #001 |30-015-36359|2RP-3407|

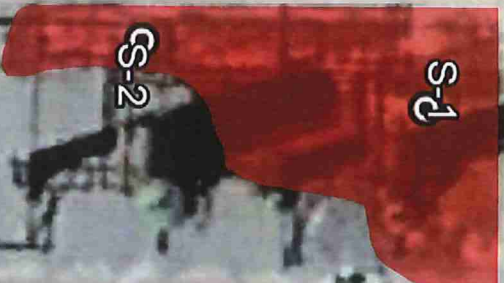
SITE PLAN

- Legend**
- Feature 1
 - Impacted Area

- The area in the vicinity of sample location S-1 will be hand excavated to a depth of 3-feet BGS.
- The impacted area in the vicinity of sample location S-2 will be hand excavated to a depth of 1-foot BGS.
- A soil shredder will be used to aerate and treat the soil with a 33% hydrogen peroxide solution to oxidize the hydrocarbons. A soil sample will be taken from approximately every 100-yards of treated soil. The soil samples will be analyzed for TPH and BTEX.
- Once the laboratory results indicate that TPH, BTEX concentrations from the two respective excavation areas are below NMOCD RRAL's the results will be forwarded to NMOCD and BLM for review and permission to backfill the excavation with the treated soil.
- The backfilled area will be backfilled and contoured to match the surrounding location.
