## **Remediation and Closure Report**

Cedar Canyon 22 CTB

2RP-4274

Talon Project No. 702231.002.01

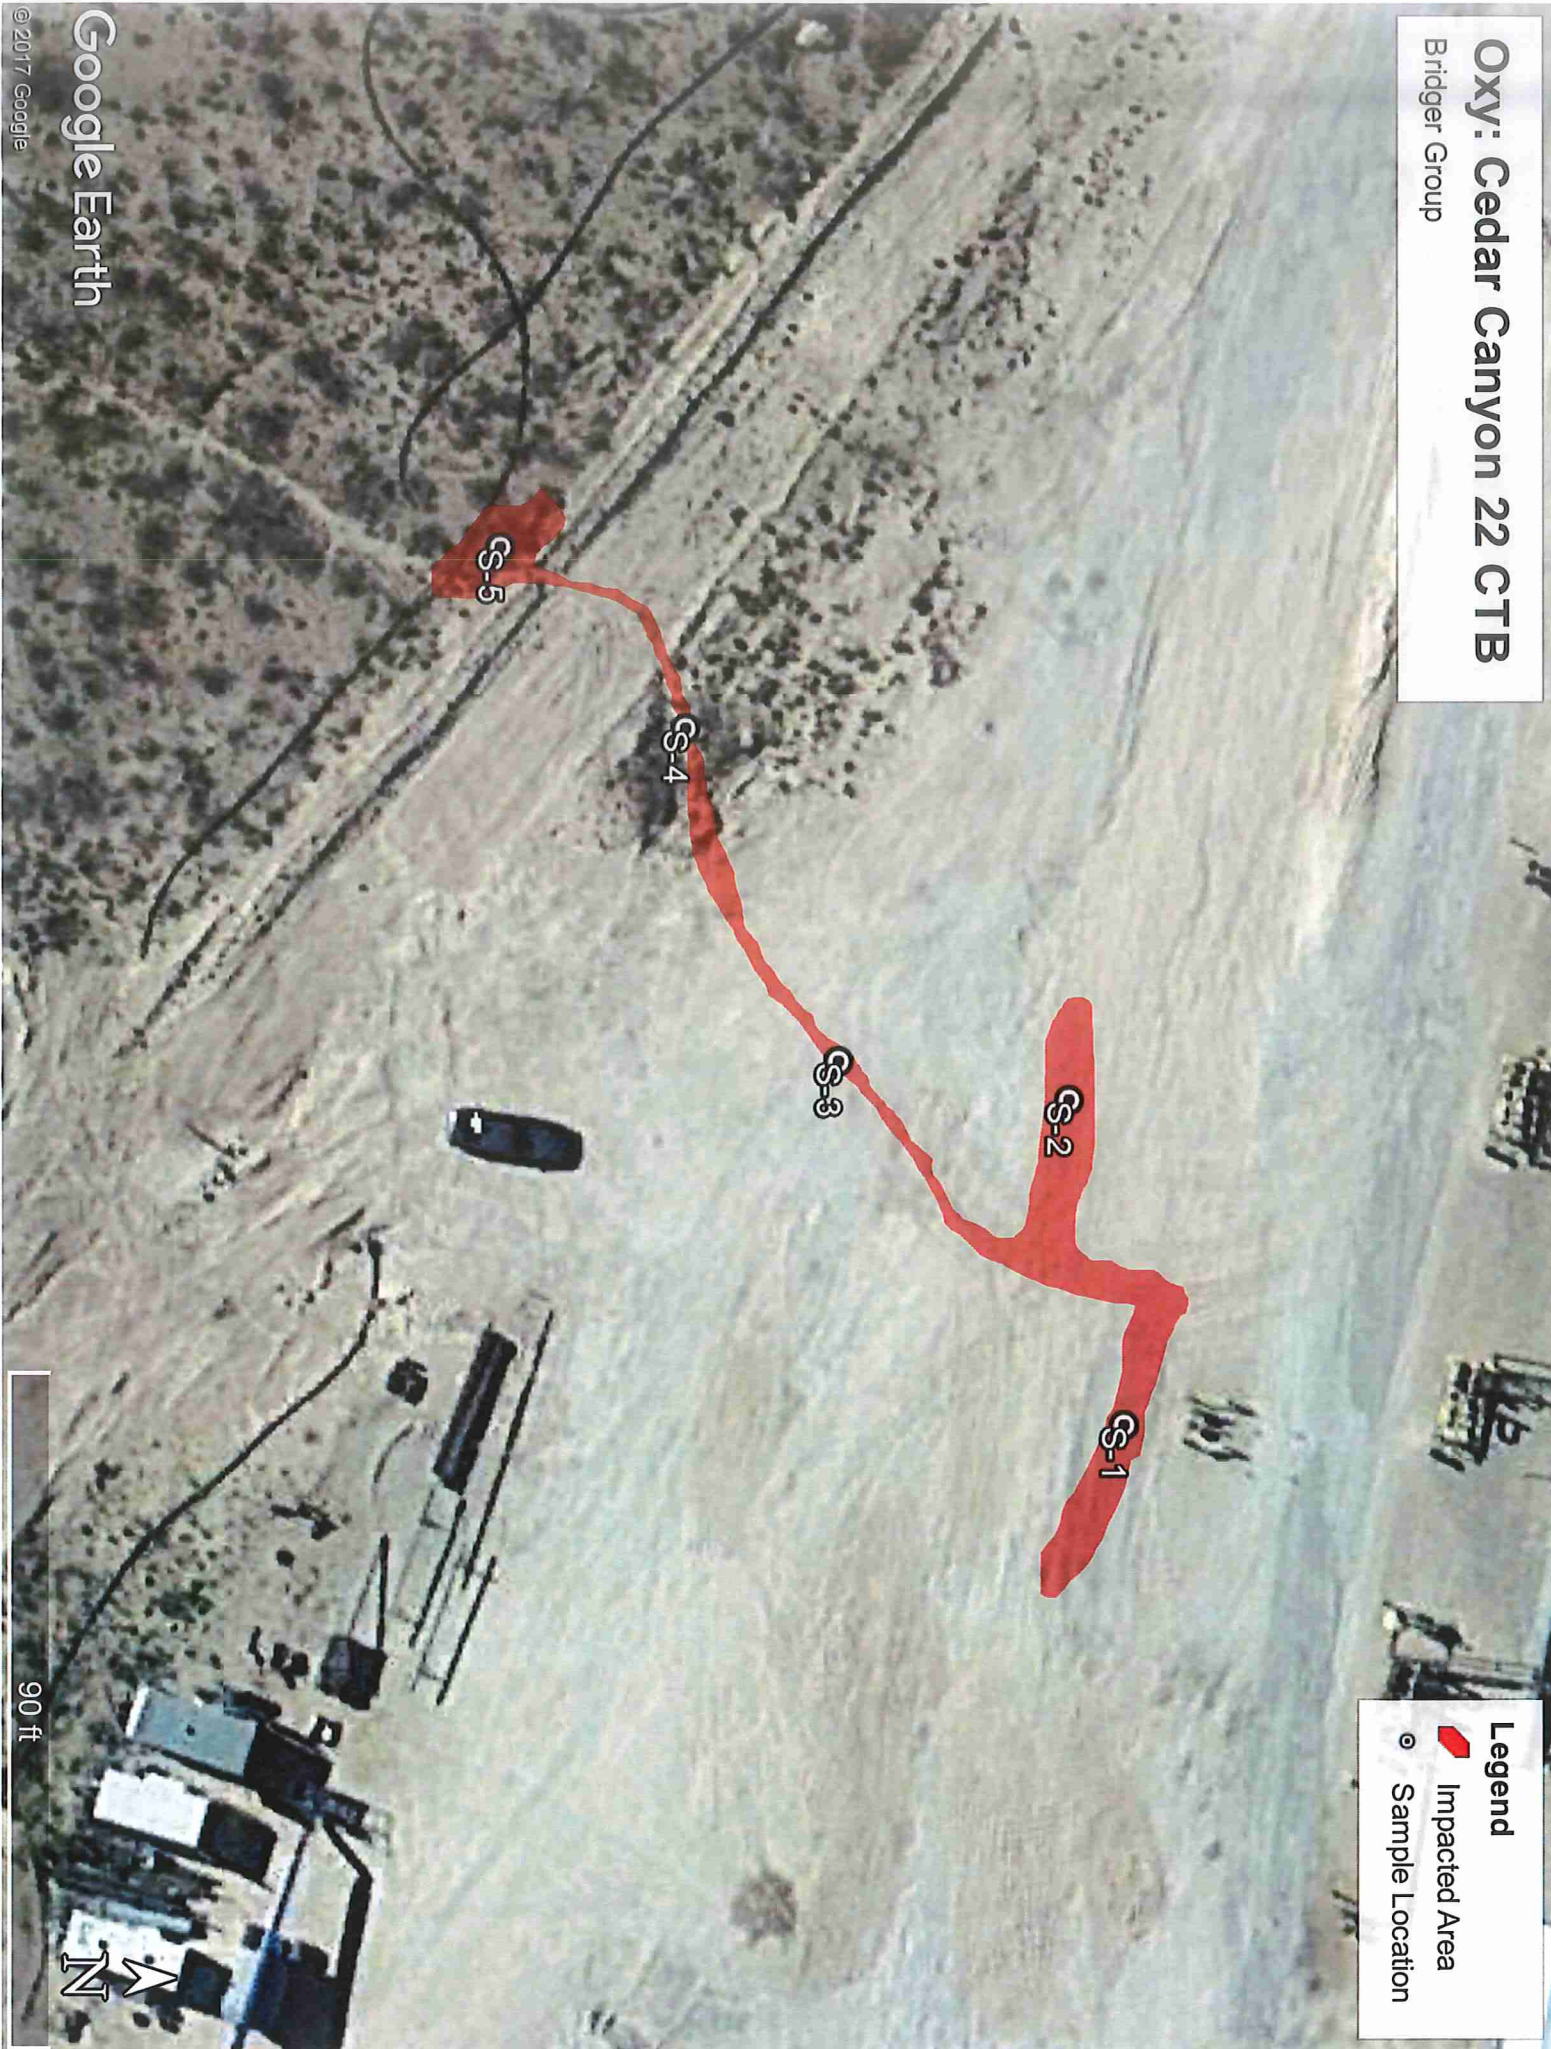
## SITE PLAN

# Oxy: Cedar Canyon 22 CTB

**Legend**

Impacted Area
-

Sample Location

A driver error during truck load/unload resulted in the release of approximately 12bbls of crude oil with no recovery. The release originated at the truck load outs and flowed south across the location for approximately 120-feet and into the pasture just off the side of the location. The spill was reported to the OCD. The extent of the impact is shown on the attached site plan presented in [Appendix I](#).

Talon/LPE was contracted by Bridger Logistics for the correction of this release. The remediation activities were completed per the NMOCD Rules and Regulations. The contaminated soil within the impacted area was excavated to depths ranging from 0.5-feet to 5-feet below ground surface (BGS). Confirmation soil samples were obtained from the bottom of the excavation. The impacted area in the vicinity of sample location S-1 was excavated to a depth of 1-foot BGS. The impacted area in the vicinity of sample location S-2 was excavated to a depth of 2.5-feet BGS. The impacted area in the vicinity of sample location S-3 was excavated to a depth of 0.5-feet BGS. The impacted area in the vicinity of sample location S-4 was excavated to a depth of 2-feet BGS. The impacted area in the vicinity of sample location S-5 was excavated to a depth of 5-feet deep.
