Soil Assessment and Remediation Work Plan:

West Red Lake Unit #25

API # 30-015-00819 – **2RP-4315-0**

Talon Project No. 701307.100.01

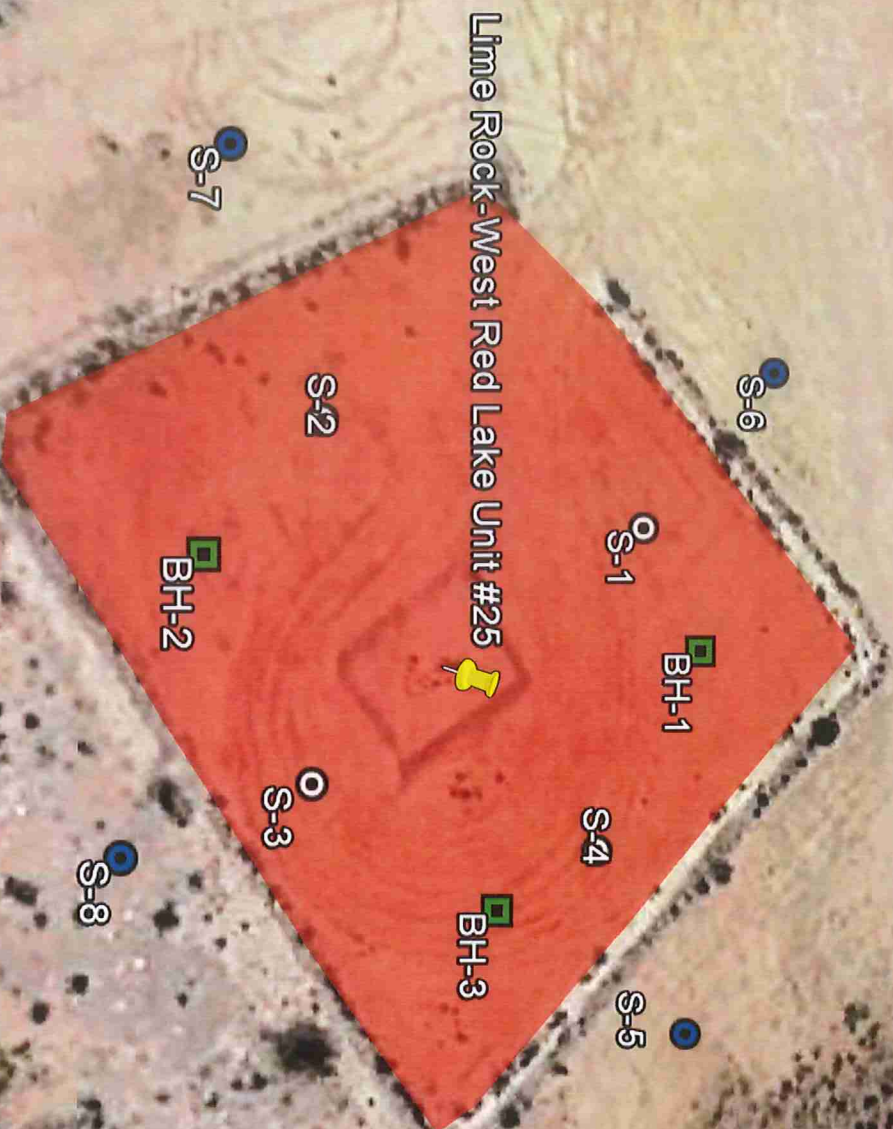
West Red Lake #25

On June 28, 2017, a nipple on the filter pot failed due to corrosion resulting in the loss of approximately 330 barrels of produced water onto the location. All fluids were contained on the pad. A vac truck was called to the location and recovered 300 barrels of fluid. Talon mobilized personnel to perform an initial site assessment and collect soil samples from the impacted area. A site plan is presented in [Appendix I](#) which illustrates the impacted area.

- Please note that the impacted area is vertically and horizontally delineated.
- The impacted soil at S-1, S-2, S-3, and S-4 will be excavated to a depth of 2.0-feet deep. This represents the entire location within the berms.
- A 20 millimeter liner will be installed in the bottom of the excavation.
- All contaminated soil will be transported to Lea Land, LLC, a NMOCD approved disposal facility.

- The excavated area will be backfilled with new caliche. Once the backfilling activities are complete the work area will be contoured to match the surrounding location.
- A final closure report documenting all remedial actions will be provided to the NMOCD Artesia Office along with a Final C-141 Form.
