**RE: Corrective Action Plan
XTO Energy
Big Eddy Unit #74
UL/B Sec25, T21S R28E
32.456770, -104.037534
NMOCD Reference # 2RP – 2664, 2RP - 3213**

XTO Energy (XTO) has retained Basin Environmental Service Technologies (Basin) to address potential environmental concerns at the above-referenced site.

Corrective Action Plan

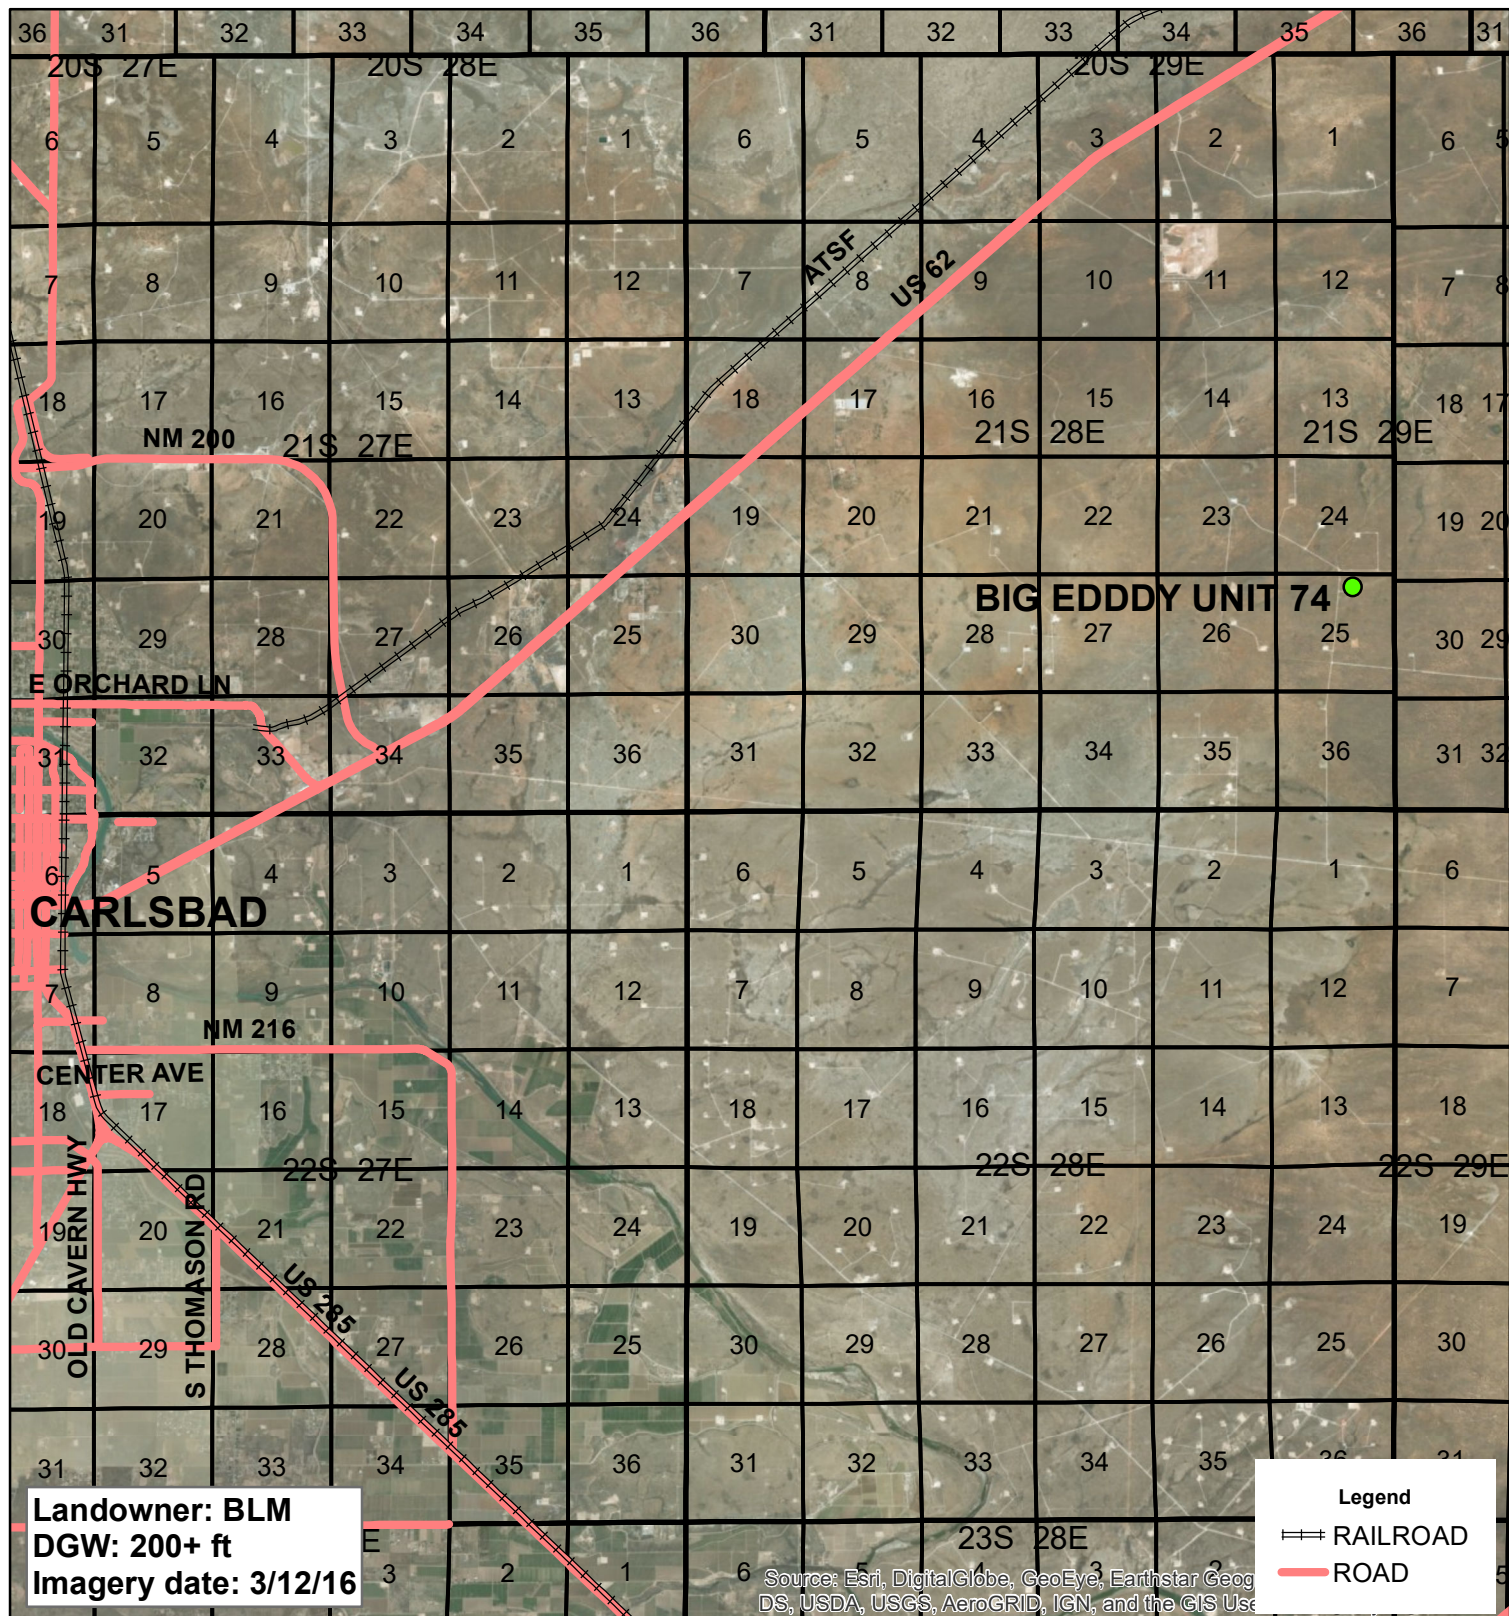
The site is located approximately eleven and one-half (11.5) miles northeast of Carlsbad, New Mexico at Unit Letter B of Section 25 in Township 21 South of Range 28 East. (See Figure 1) This site is located in an area where groundwater can be anticipated to be found at a depth of over two-hundred feet (200') below ground surface (bgs) (See Figure 2).

Figure 1 – Site Location Map

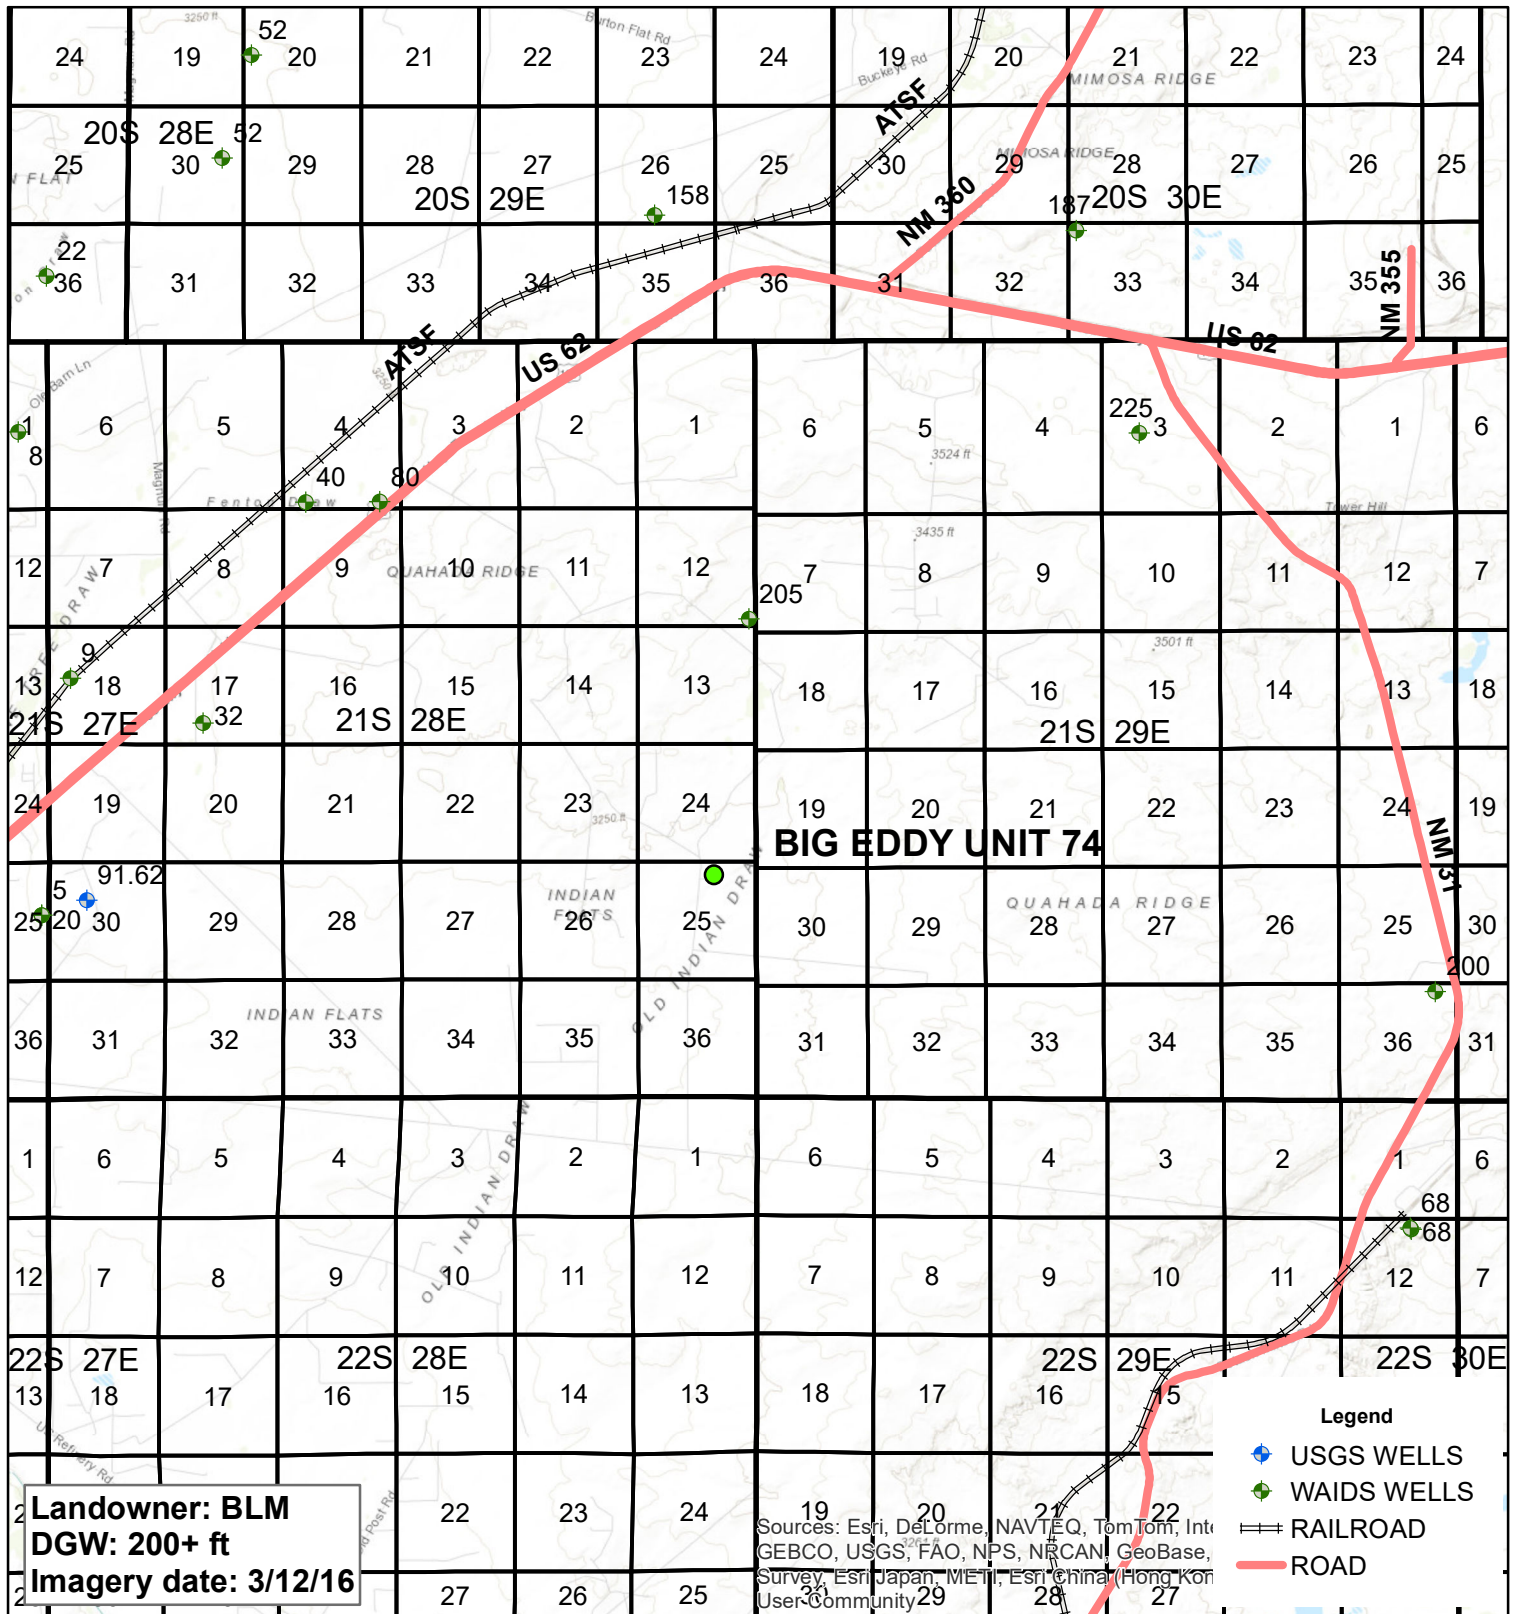
Figure 2 – Depth to Groundwater Map

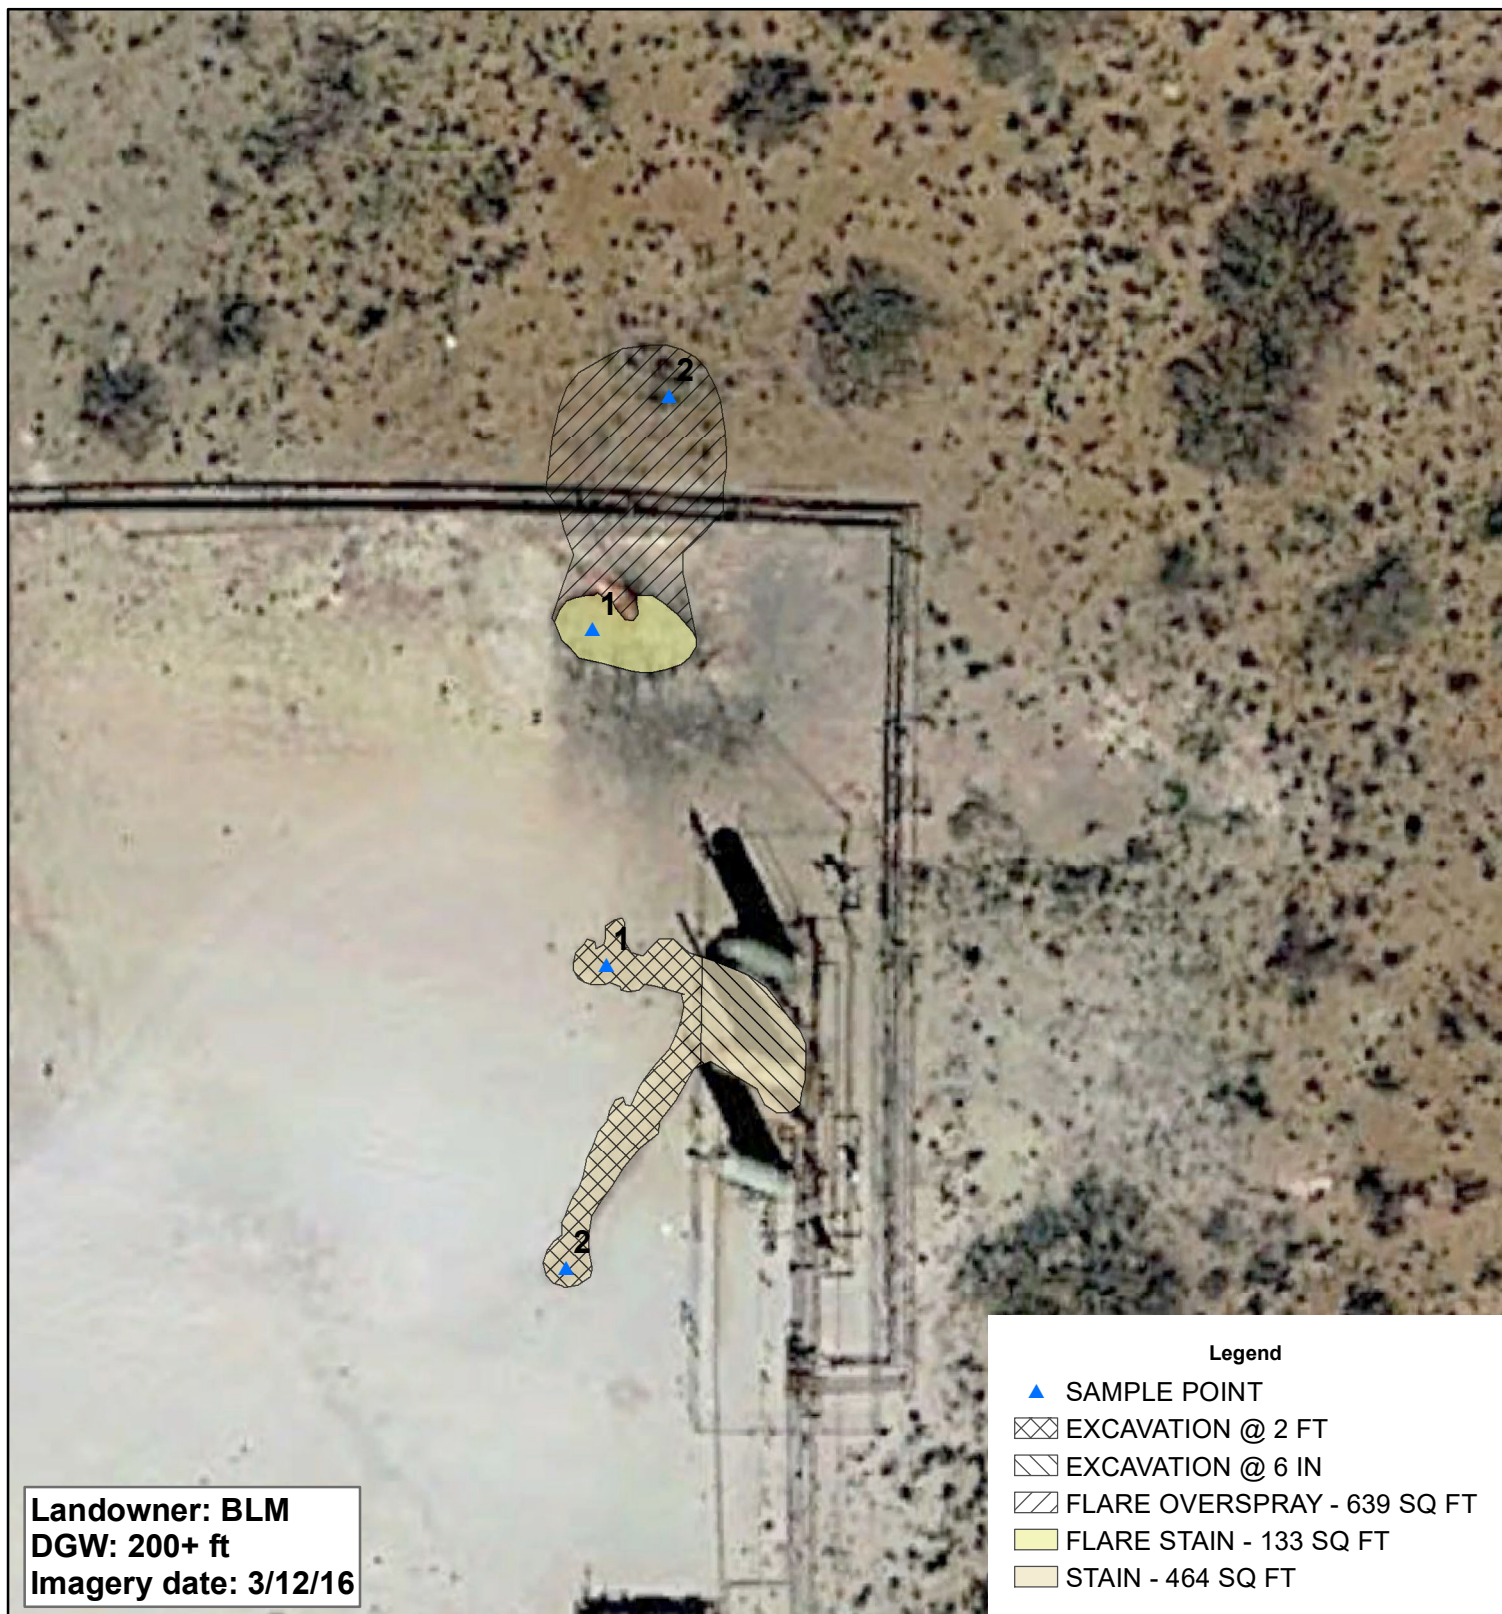
Basin personnel were on site beginning January 4th, 2017, to begin delineation activities and reapply Micro-Blaze® to the flare release area (2RP-2664). Two (2) soil sample points were established. The soil sample points, (SP 1, SP 2) were advanced to one-foot bgs. Discrete soil samples were retrieved at the surface and at one foot. The soil samples were delivered to an NMOCD approved laboratory for concentration analysis of Benzene, Toluene, Ethyl-benzene, Xylenes (BTEX), Gasoline Range Organics (GRO), Diesel Range Organics (DRO), Oil Range Organics (ORO) [Total Petroleum Hydrocarbons (TPH)] and chloride concentrations. (See Soil Chemistry Table).

In addition, two (2) soil sample points were established for the heater release (2RP-3213). The soil sample points, (SP 1, SP 2) were advanced in one-foot increments to 2' bgs. Discrete soil samples were collected at the surface and at 2' to be delivered to an NMOCD approved laboratory for concentration analysis of Benzene, Toluene, Ethyl-benzene, Xylenes (BTEX), Gasoline Range Organics (GRO), Diesel Range Organics (DRO), Oil Range Organics (ORO) [Total Petroleum Hydrocarbons (TPH)] and chloride concentrations.

Figure 3 - Area Sampling and Proposed Excavation Map

The impacted area for the heater release will be excavated to 2' bgs outside of the fence on the pad. The contaminated area within the fence line will be excavated to approximately six inches (6") or the depth practical. The contaminated soils will be removed and disposed of at an NMOCD approved facility. Floor soil samples will be retrieved at the completion of remediation to ensure the impacted soils have been removed from the release area outside the fence. Floor samples will be retrieved inside the fence for clarity of remaining contamination (if any) to be remediated at the time of abandonment. The excavated area will then be backfilled with clean, imported, non-impacted soils and contoured to the surrounding area.

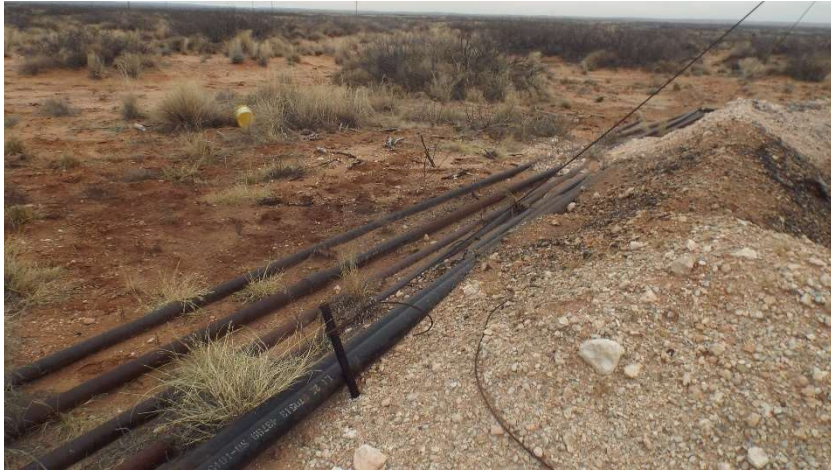
On December 4th, 2014, XTO discovered a release of approximately one barrel (bbl) of crude oil and four (4) bbls of produced water when a float valve failed causing fluid to escape the flare stack. The valve was repaired. An estimated one bbl of total fluid was recovered. An estimated five hundred square feet (500 ft²) of pasture was misted and approximately six-hundred forty-eight square feet (648 ft²) of earthen containment around the flare stack was impacted. Micro-Blaze® was applied to the pasture area. The New Mexico Oil Conservation Division (NMOCD) was notified of the release on December 16th, 2014. An initial Release Notification and Corrective Action form (C-141) was submitted to NMOCD on December 16th, 2014, for approval.

Flare release area, facing east

Analytical results indicate the concentrations of TPH, BTEX, and chlorides were below the recommended remediation action levels (RRALs) for the flare release area (2RP-2664).

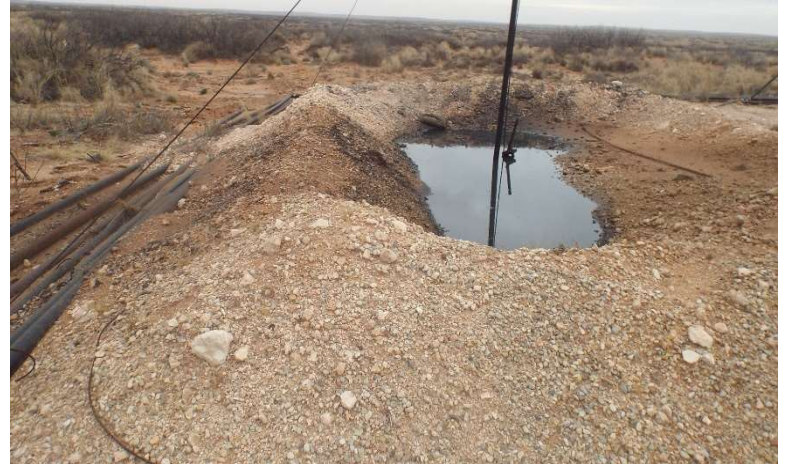
Flare release area, facing east

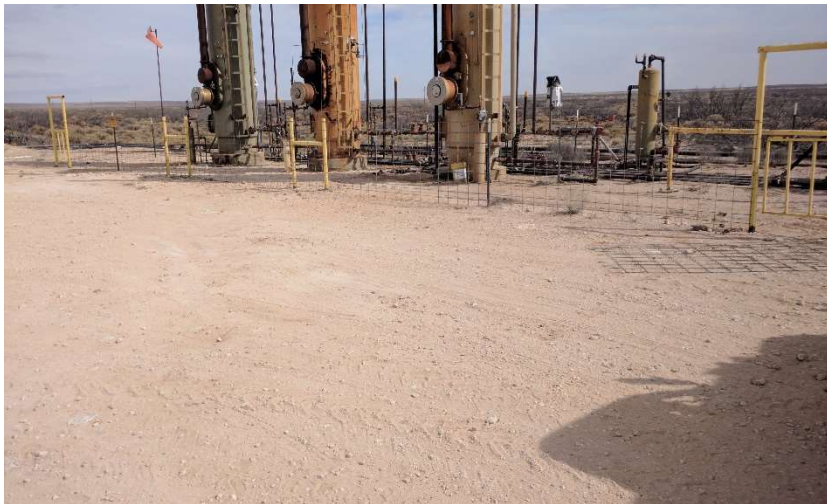
On August 13th, 2015, XTO discovered a release of approximately twelve (12) barrels (bbls) of crude oil when the heater began leaking. The heater was removed from production. An estimated ten (10) bbls of crude were recovered. Approximately five-hundred forty-five square feet (545 ft²) of the gypsum (caliche) pad area were impacted. The New Mexico Oil Conservation Division (NMOCD) was notified of the release on August 20th, 2015. An initial Release Notification and Corrective Action form (C-141) was submitted to NMOCD on August 20th, 2015, for approval.

Release area, facing northeast

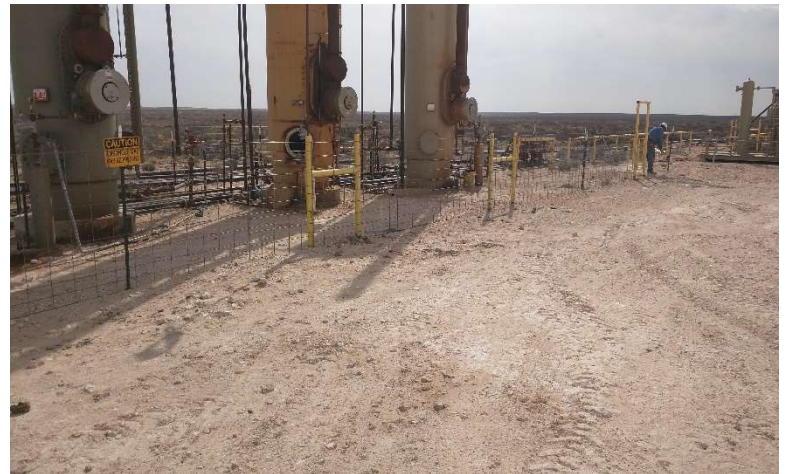
Release area, facing southeast
