R. T. HICKS CONSULTANTS, LTD.

RE: Corrective Action Modification #3 - 2RP-3333 Remnant Oil Company NSLU #3: Unit J, Sec 19, T16S R31E, Eddy County, NM

Data and Interpretation

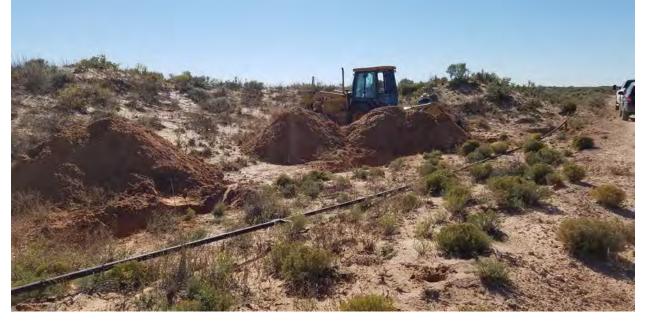
Image #2 – November 2017 sampling within the footprint of the October 2015 release. Sample locations approximate those obtained by eTech in 2015

November 2017 sample locations are

- S-1 32.90292, -103.89378
- S-2 32.90292, -103.89383
- S-3 32.90292, -103.89378

Therefore, we propose that Remnant reseed the site with a mix acceptable to the BLM. Upon the satisfactory inspection of re-vegetation by BLM, we propose closure of the regulatory file with both agencies.

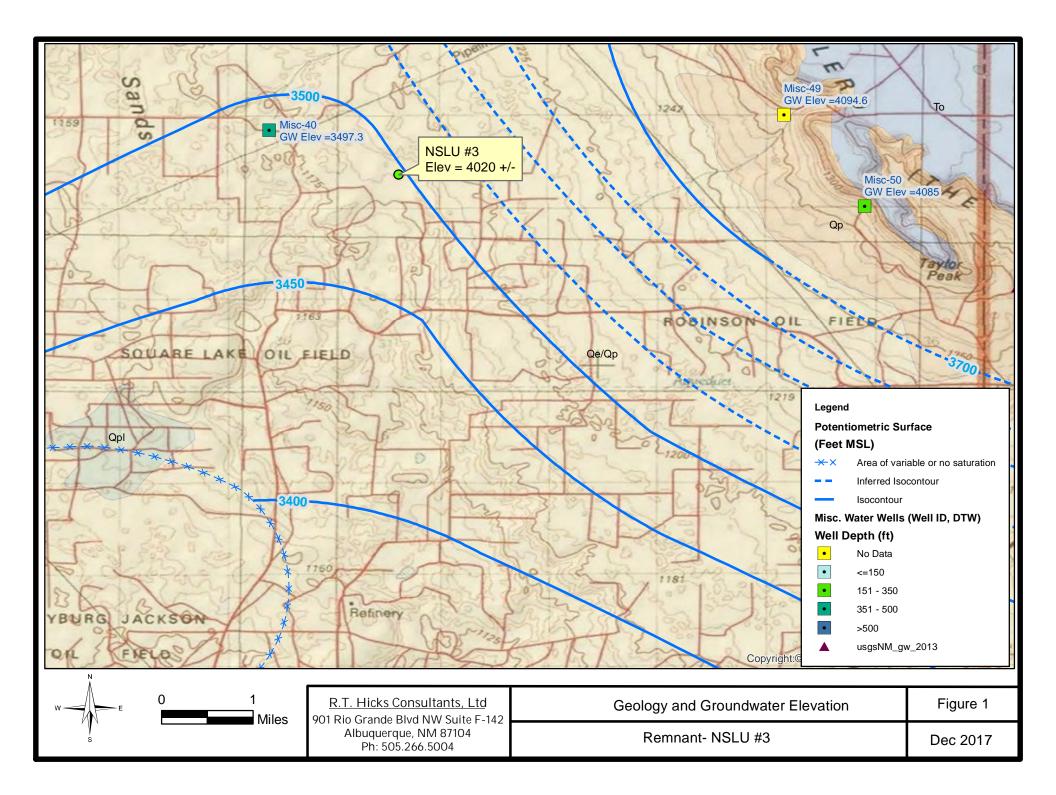
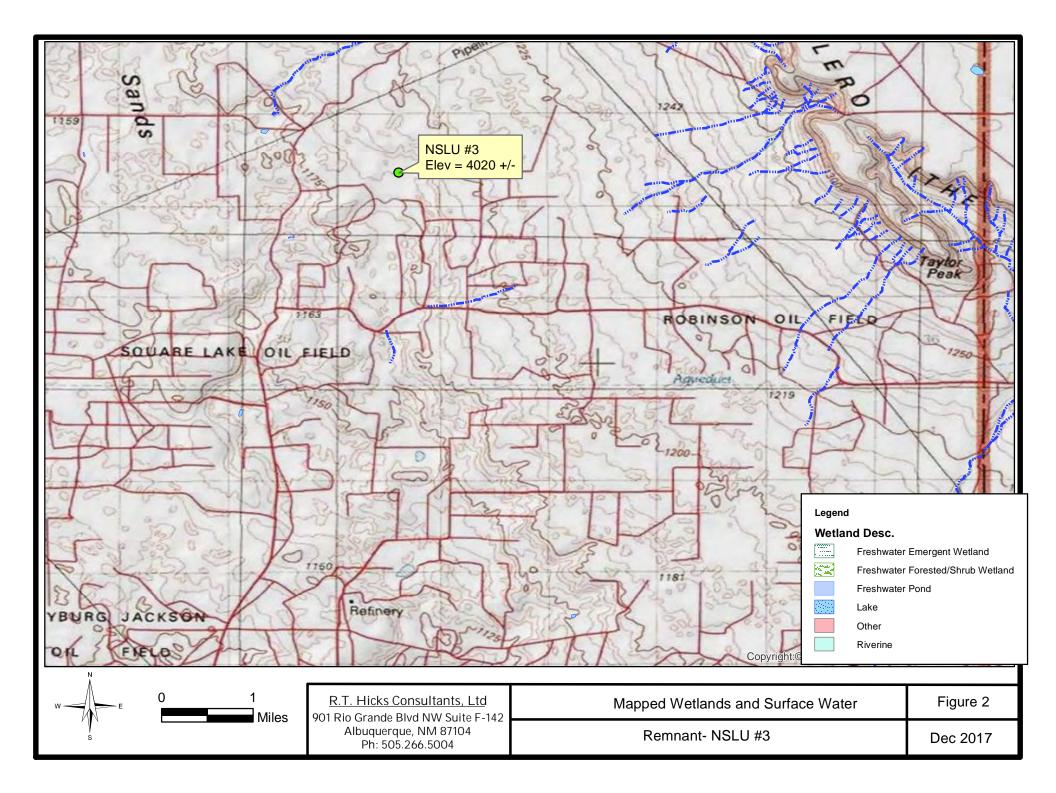
Figures 1 and 2 from the August 2016 submission, which summarize groundwater and surface water conditions in the area, are attached to this submission. The data support the following interpretations and calculations:
