REMEDIATION SUMMARY AND RISK-BASED SITE CLOSURE REQUEST

**COG Operating, LLC
SRO State Com #064H
Eddy County, New Mexico
Unit Letter "E", Section 10, Township 26 South, Range 28 East
Latitude 32.0576019° North, Longitude 104.0815811° West
NMOCD Reference No. 2RP-3974**

**TRC Environmental Corporation
10 Desta Drive, Suite 150E
Midland, Texas 79705**

February 19, 2018

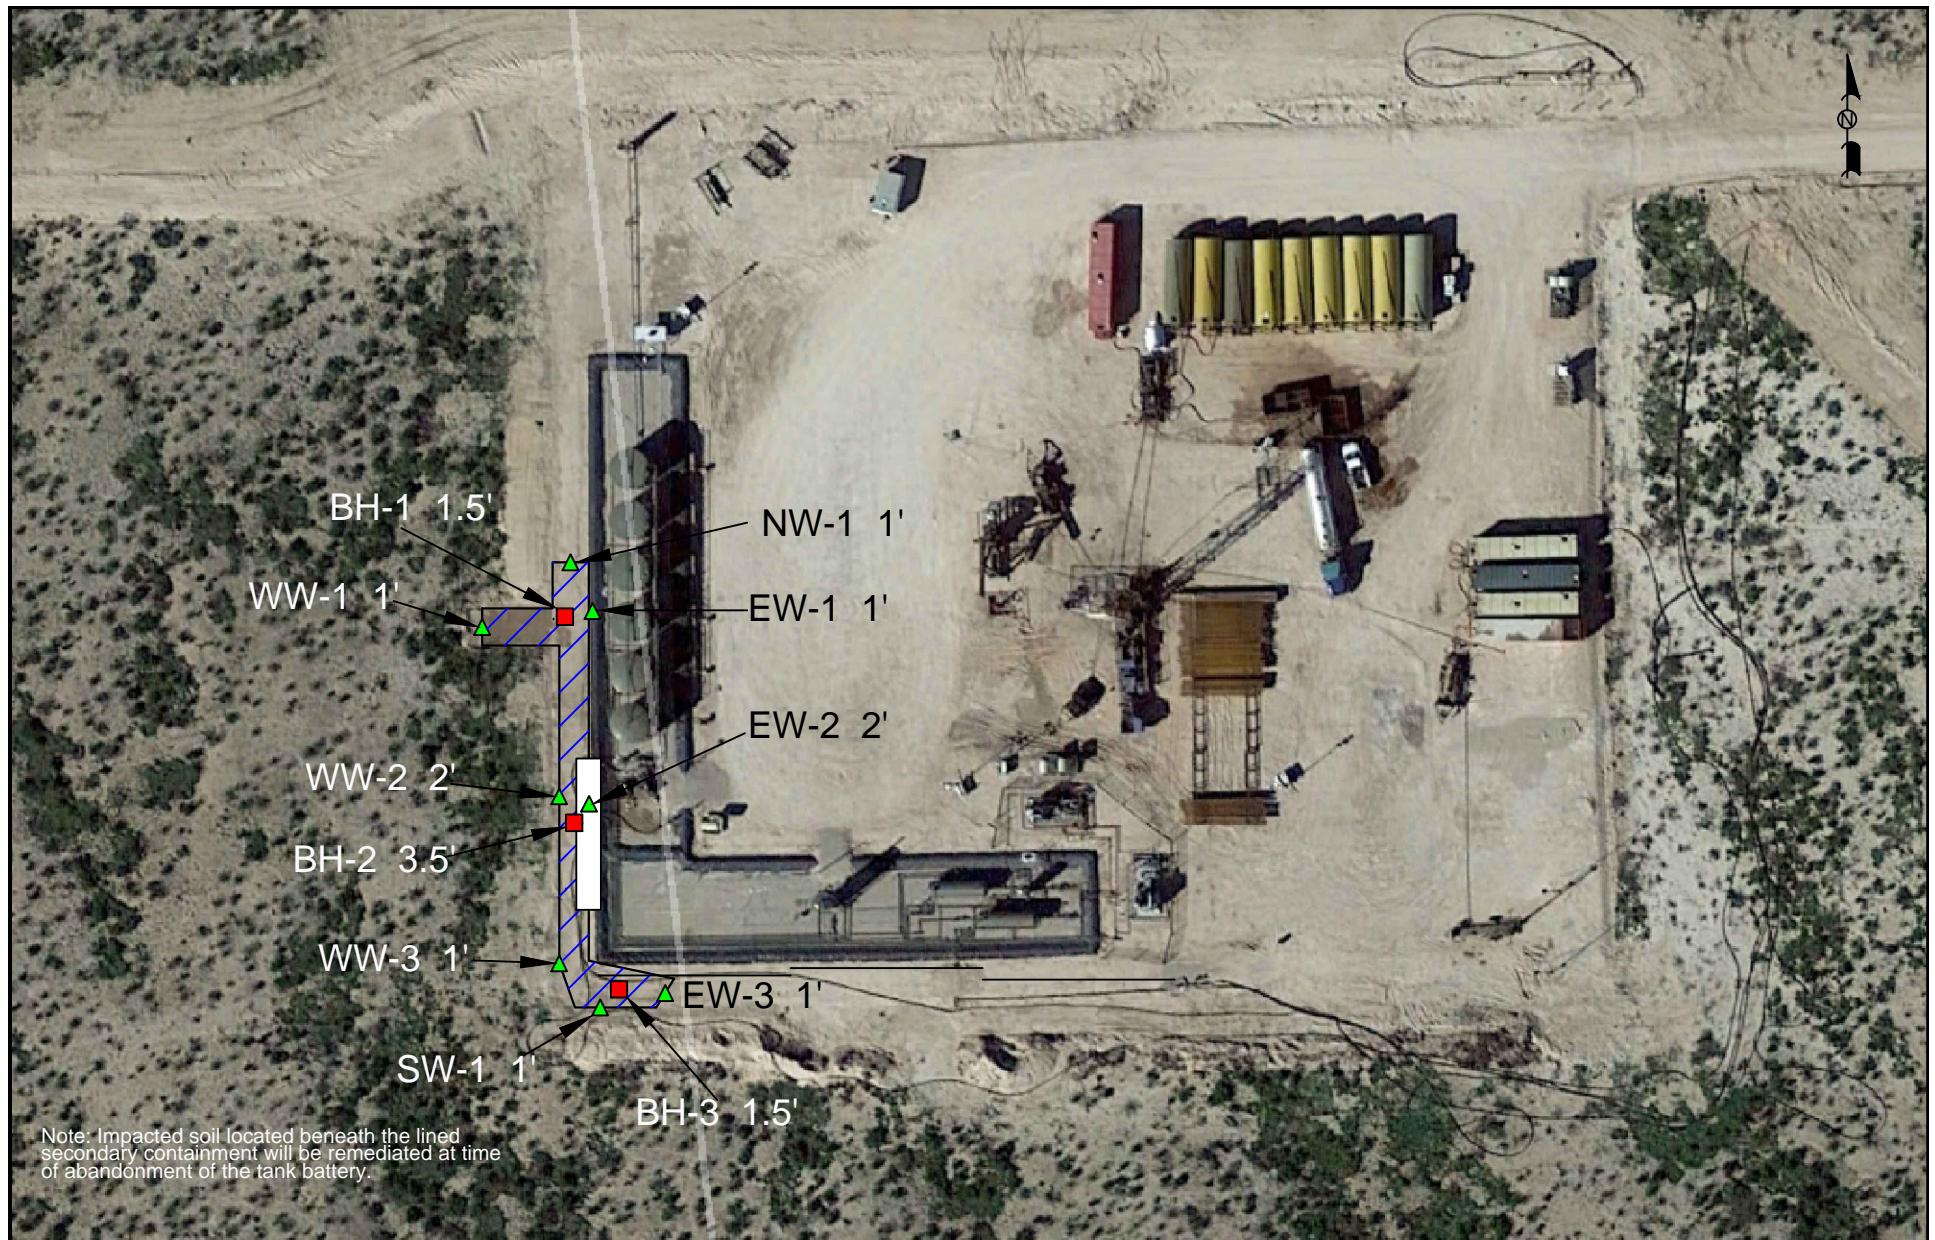
Figure 2
Site & Sample Location Map
SRO STATE COM #064H
COG Operating,LLC.
Eddy County,NM

- ▲ Sidewall Sample
- Impacted Soil
- Floor Sample

area. During the advancement of the test trenches, thirty-two (32) delineation soil samples were collected and submitted to Xenco Laboratories in Midland, Texas for analysis of chloride concentrations using Method 300/300.1. Chloride concentrations ranged from 14,000 mg/kg for soil sample T2-3' to 8.35 mg/kg for soil sample T3-2'. A review of laboratory analytical results indicated soil was not affected above the NMOCD Recommended Remediation Action Level beyond two (2) ft. bgs in the area characterized by test trench T1, four (4) ft. bgs in the area characterized by test trench T2, and two (2) ft. bgs in the area characterized by test trench T3. Soil sample locations are depicted in Figure 2 – Site and Sample Location Map. Laboratory analytical results are summarized in Table 1 - Concentrations of Benzene, BTEX, TPH and Chloride in Soil. Laboratory analytical reports are provided in Appendix A.

On October 23, 2017, remediation activities commenced at the release site. As per the approved Work Plan, impacted soil within the release margins was excavated and stockpile on-site, atop an impermeable liner pending final disposition. The floor of the excavation was advanced to a depth of approximately three and one half (3.5) ft. bgs in the area characterized by test trench T2 and approximately one and a half (1.5) ft. bgs in the area characterized by test trenches T1 and T3. Upon excavating impacted soil within the release margins, eleven (11) excavation confirmation soil samples (NW-1 1', EW-1 1', BH-1 1.5', WW-1 1', EW-2 2', BH-2 3.5', WW-2 2', EW-3 1', BH-3 3.5', WW-3 1' and SW-1 1') were collected from the floors and sidewalls of the excavated area and submitted to the laboratory for analysis of BTEX, TPH, and/or chloride. Laboratory

Beginning January 30, 2018, the excavated areas were backfilled with locally-sourced, non-impacted “like” material. Prior to backfilling, the final dimensions of the excavated area were approximately one hundred and sixty-five (165) ft. in length, ten (10) to thirty (30) ft. in width, and one and one half (1.5) to three and one half (3.5) ft. in depth.

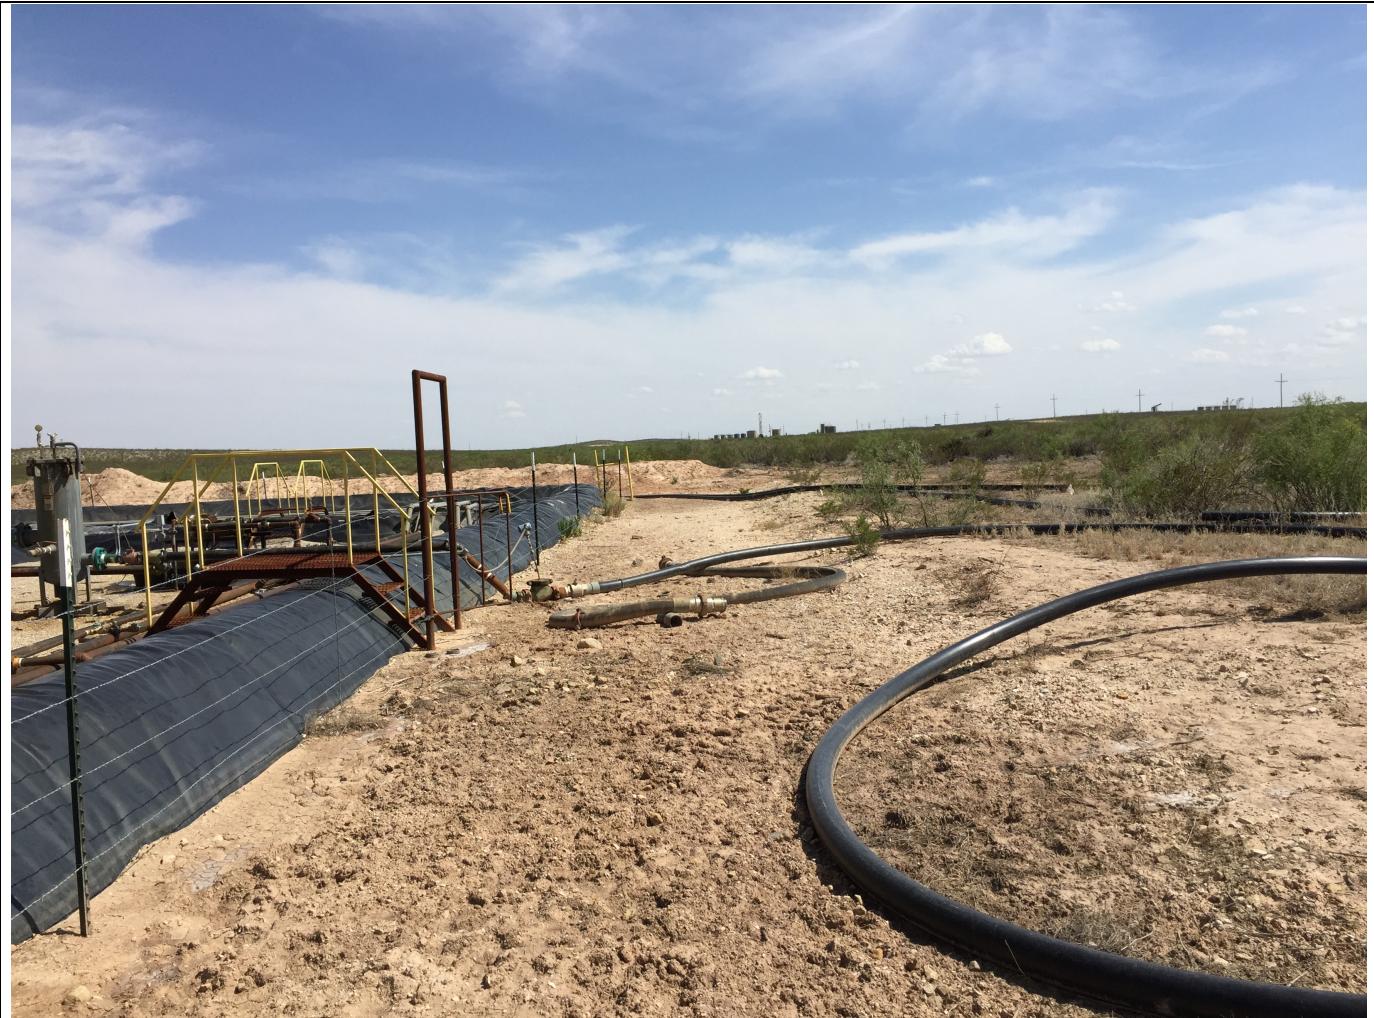
Figure 1 – View of the affected area before remediation activities, facing South.

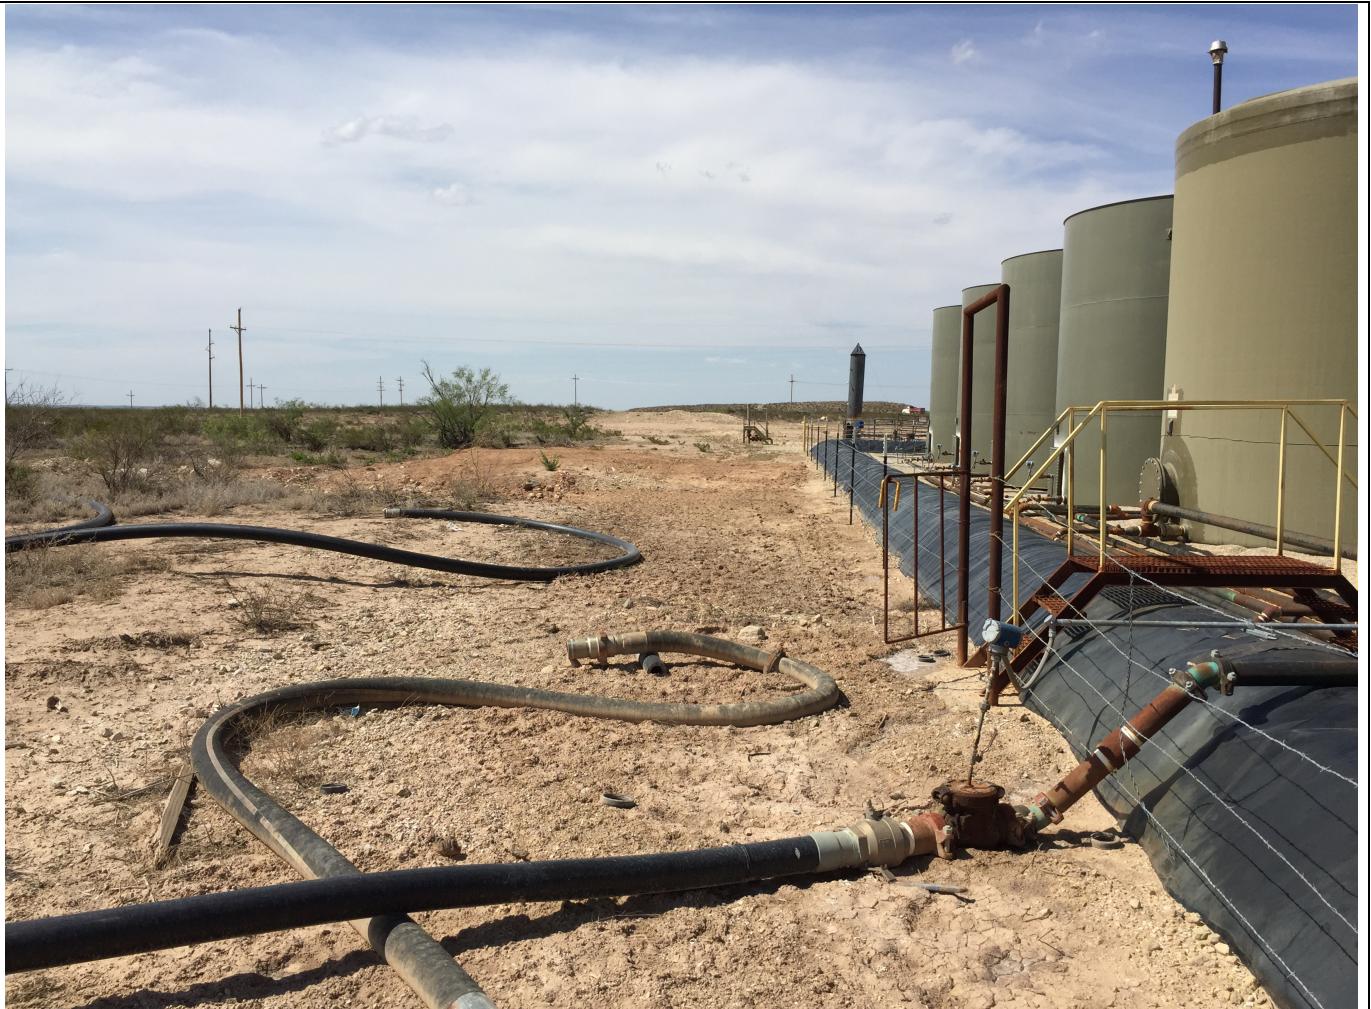
Figure 2 – View of the affected area before remediation activities, facing North.

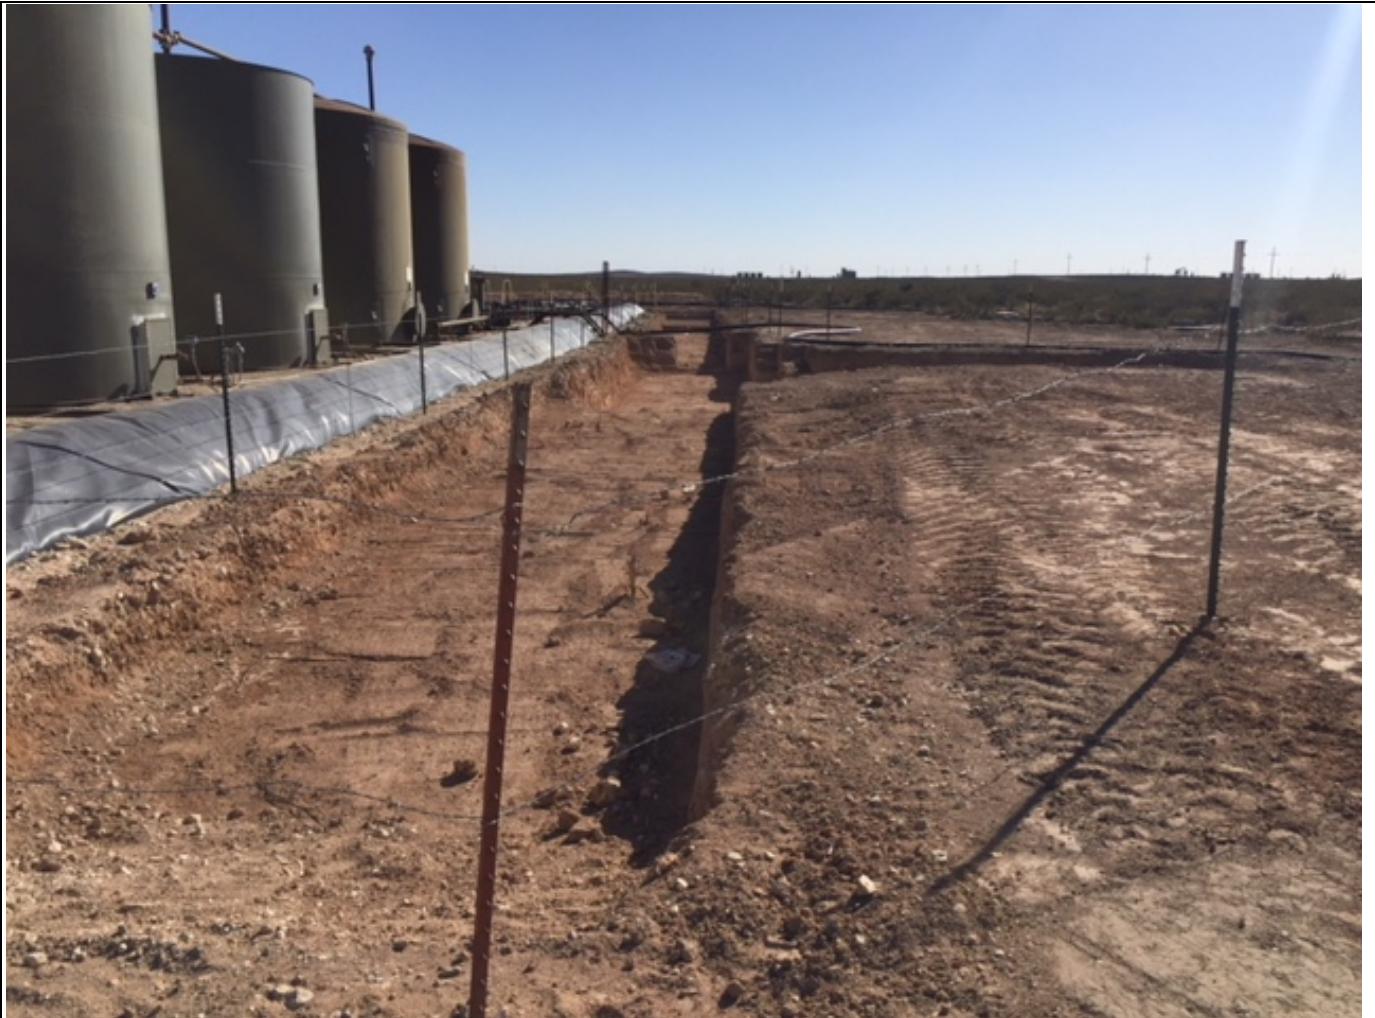
Figure 3 – View of portion of the excavated area, facing South.

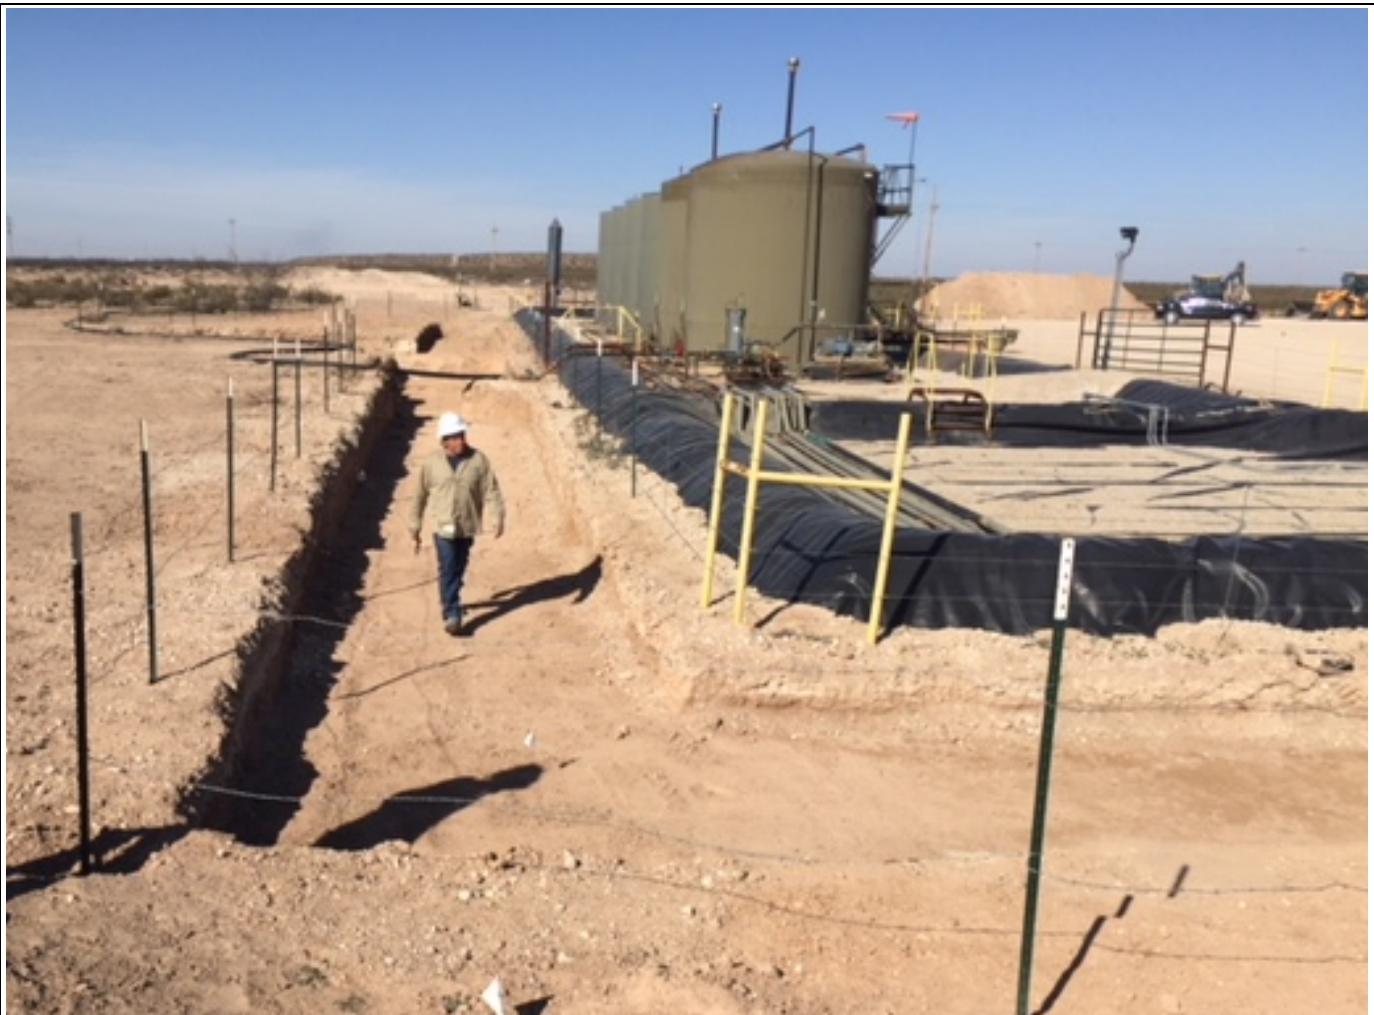
Figure 4 – View of portion of the excavated area, facing North.

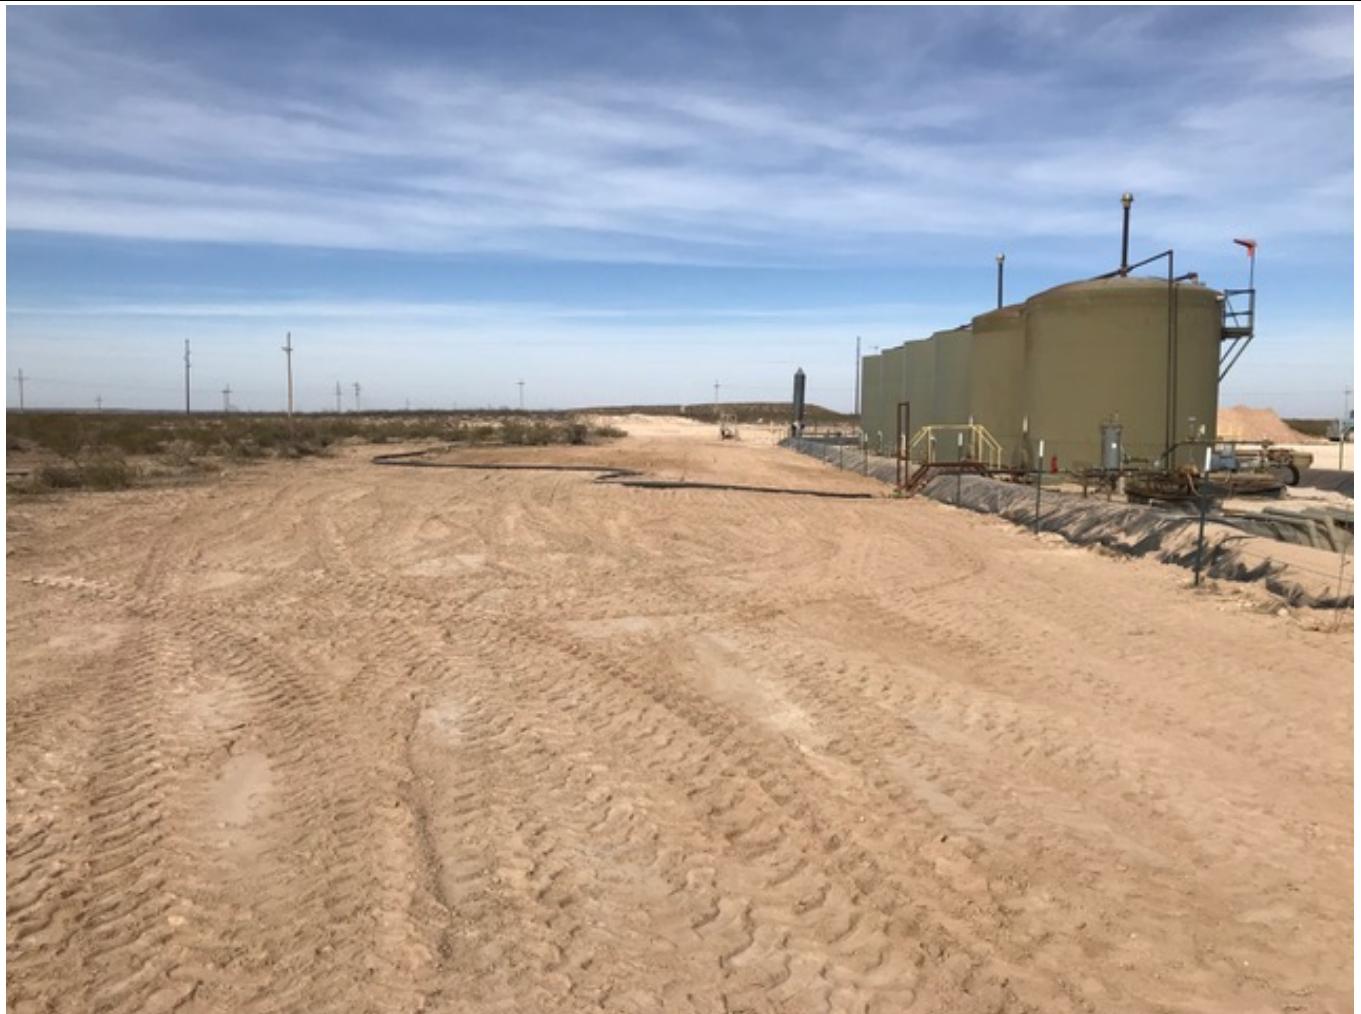
Figure 5 – View of the affected area after remediation activities, facing North.

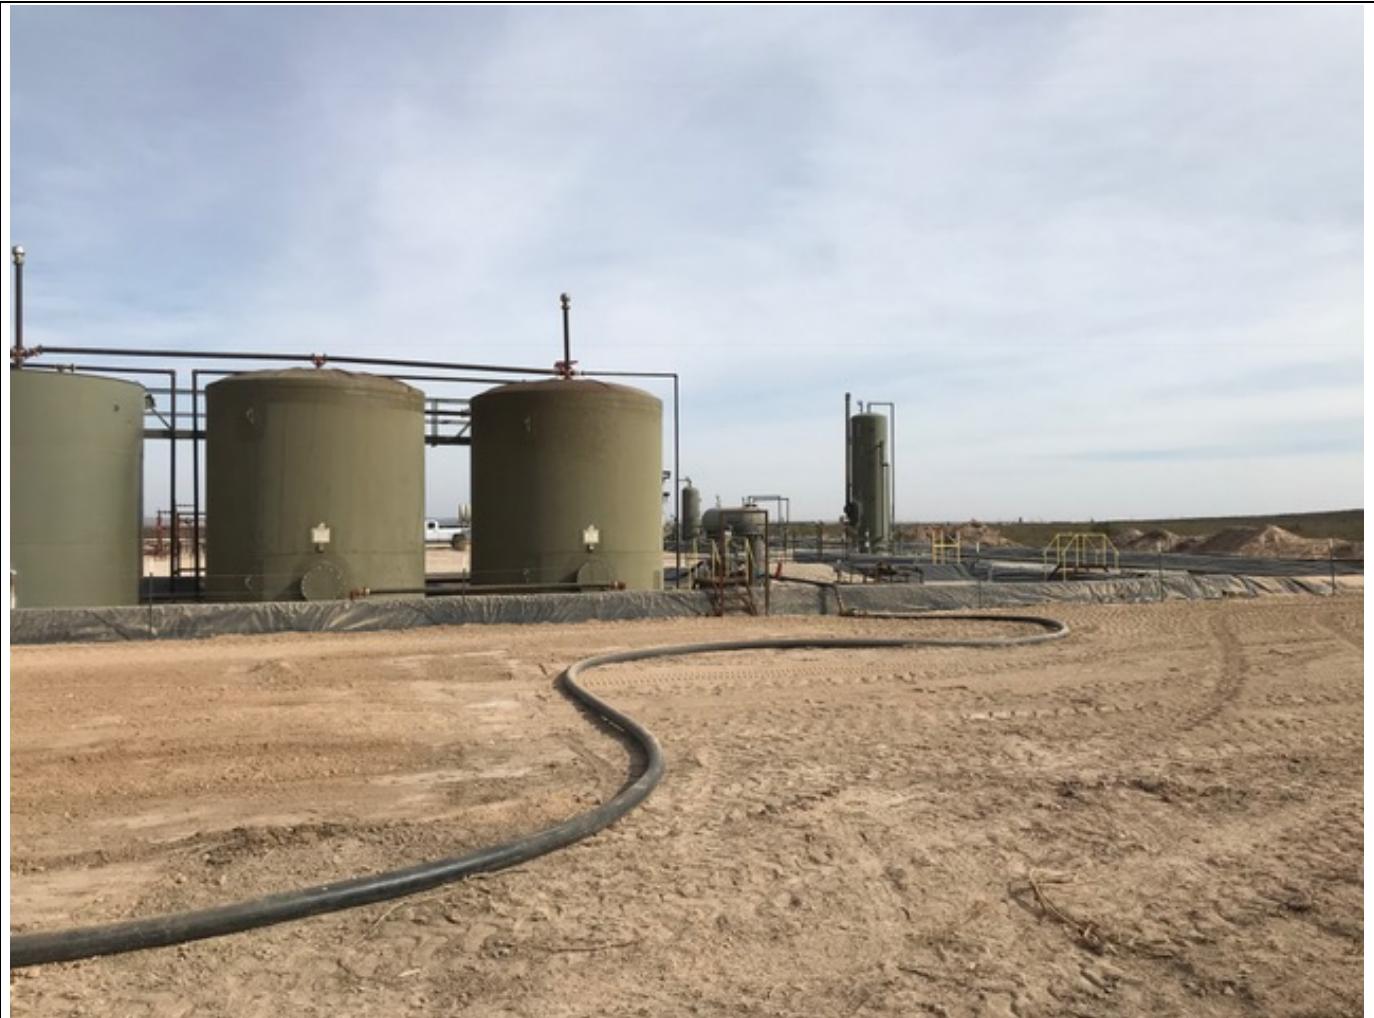
Figure 6 – View of the affected area after remediation activities, facing East.
