# Soil Assessment Report

Avalon Compressor Station Release

2RP-4657

ETC Texas Pipeline, LTD.

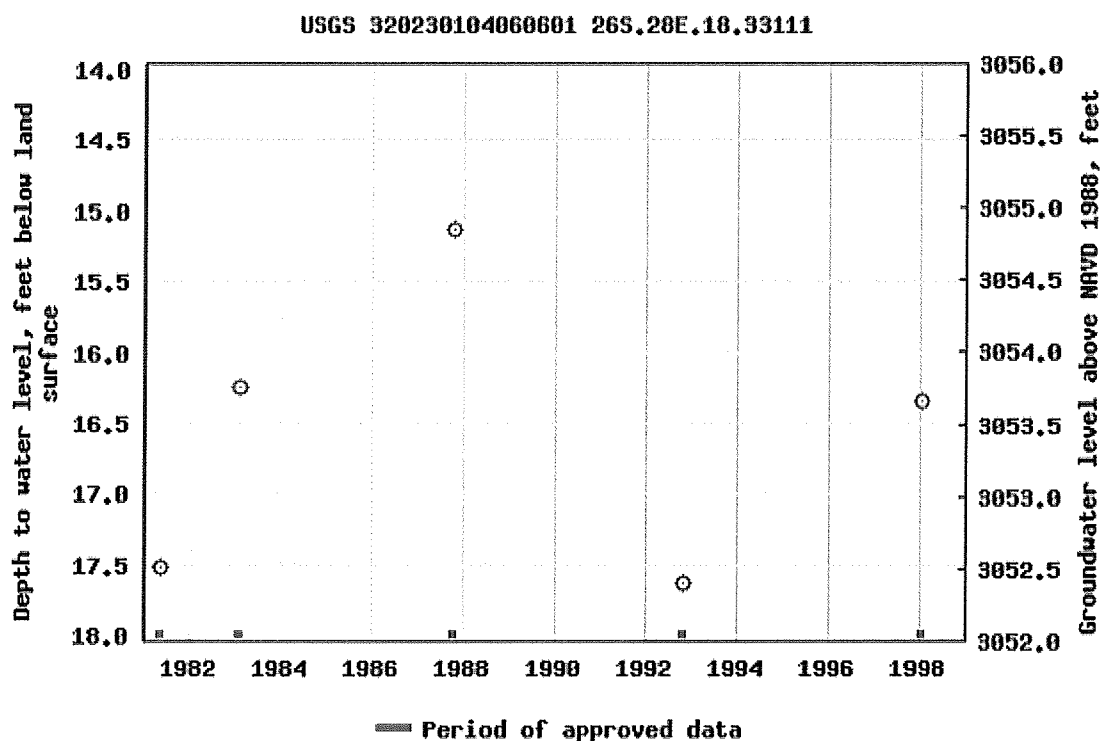
## USGS 320230104060601 26S.28E.18.33111

This well is completed in the Castile Gypsum (312CSTL) local aquifer.

Breaks in the plot represent a gap of at least one year between field measurements.

Localized depth to groundwater was estimated at a depth of approximately 15 to 20 feet below ground surface (bgs) based on depth to water records available on the United States Geological Survey (USGS) National Water System Information map. The nearest well to the site is approximately 1.38 miles to the west. Well records showing groundwater measurement data are included in Appendix A. Information available from various sources including the Petroleum Recovery Research Center (PRRC) Mapping Portal and the United States Geological Survey (USGS) Current Water Database for the Nation concludes:

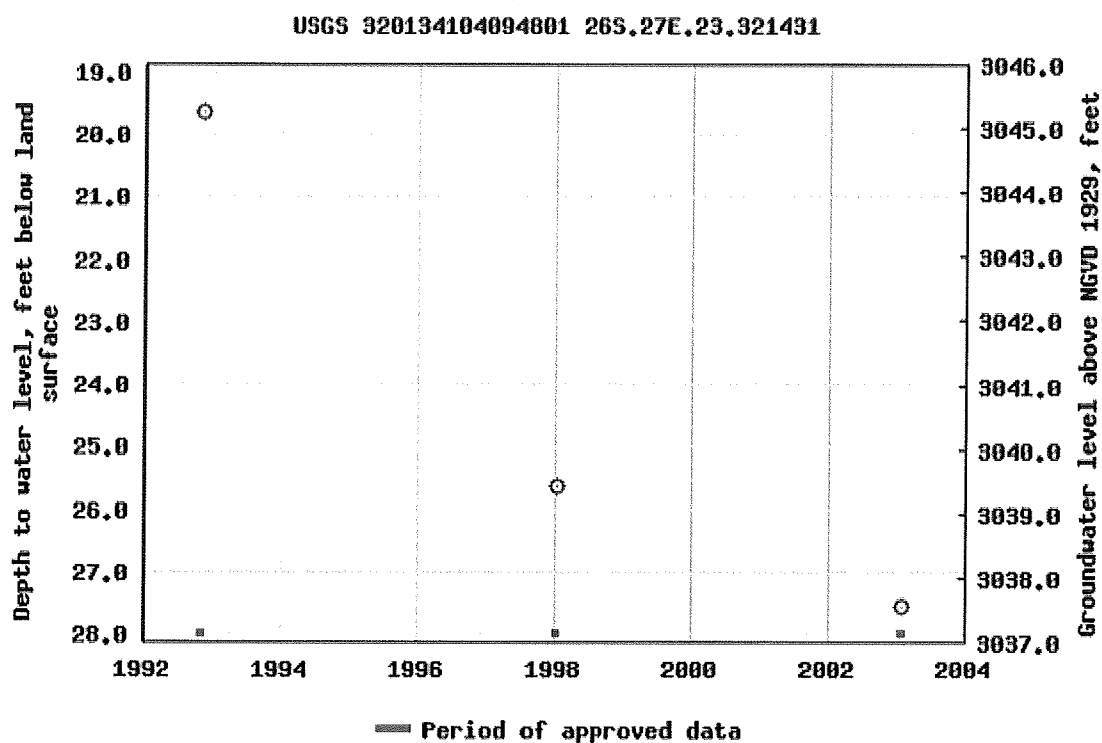
## USGS 320134104094801 26S.27E.23.321431

This well is completed in the Bell Canyon Formation (313BLCN) local aquifer.

Breaks in the plot represent a gap of at least one year between field measurements.
