## DELINEATION WORKPLAN

### OXY – CEDAR CANYON 15 1 WTF SOUTH (Leak Date: 8/15/18)

#### RP # 2RP-5037

# Oxy, Cedar Canyon 15 1 WTF South

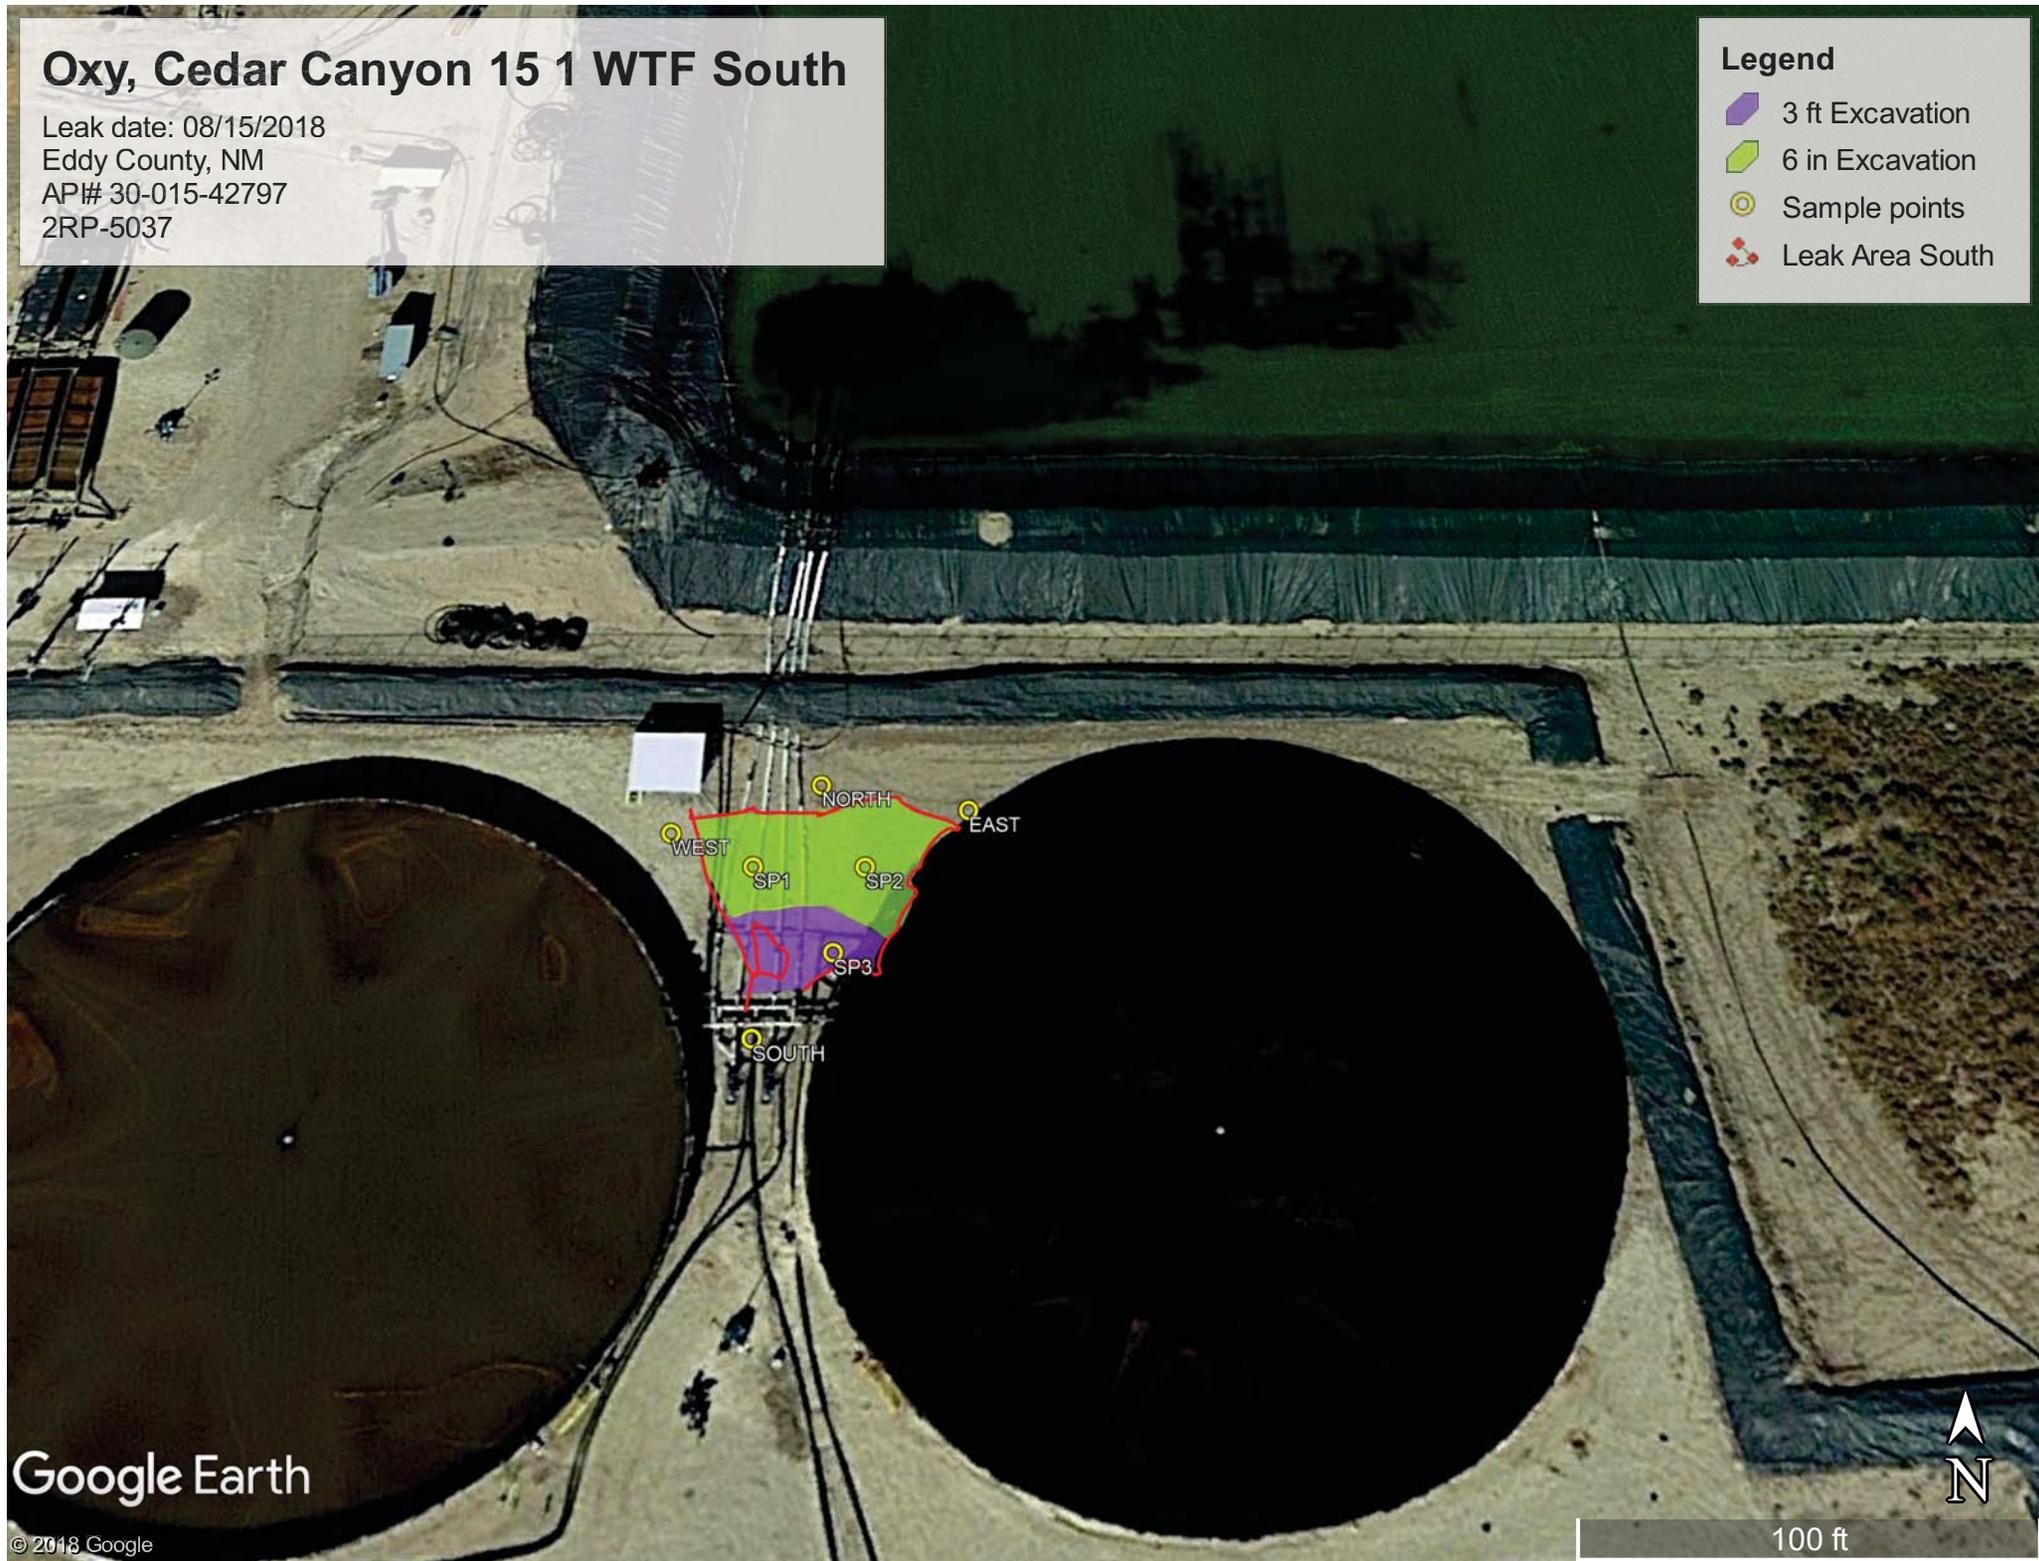
Leak Area South

***OXY will excavate the spill area as depicted on the following site diagram. The leak area near SP1 and SP2 (GREEN shade on diagram) will be excavated to a depth of 6 inches. The leak area near SP3 (PURPLE shade on diagram) will be excavated to a depth of 3 feet.***

3 ft Excavation
-

6 in Excavation
-

Sample points
-

SP1, N 32.21554 W-103.97517

SP2, N 32.21554 W-103.97508

SP3, N 32.21547 W-103.97510

NORTH, N 32.21560 W-103.97512

SOUTH, N 32.21540 W-103.97516

EAST, N 32.21558 W-103.97500

WEST, N 32.21556 W-103.97524

***Bottom confirmation samples will be collected at no greater than 50 ft. intervals. Estimated volume of material to be removed is 108 cubic yards. The remediation will be completed within 90 days of plan approval.***

The entire site will then be backfilled with clean soil and revegetated (if warranted) to the standards of the appropriate regulatory agency or private surface owner.

All excavated materials will be disposed of at an NMOCD-approved disposal facility.
