March 25, 2019

**RE: Closure Request  
Poker Lake Unit Big Sinks 22 Battery  
Remediation Permit Number 2RP-5182  
Eddy County, New Mexico**

LT Environmental, Inc. (LTE), on behalf of XTO Energy, Inc. (XTO), presents the following report detailing excavation of impacted soil and confirmation soil sampling activities at the Poker Lake Unit Big Sinks 22 Battery (Site) located in Unit P, Section 22, Township 24 South, Range 30 East, in Eddy County, New Mexico (Figure 1). The purpose of the excavation and soil sampling activities was to address impacts to soil after a release of crude oil and produced water at the Site.

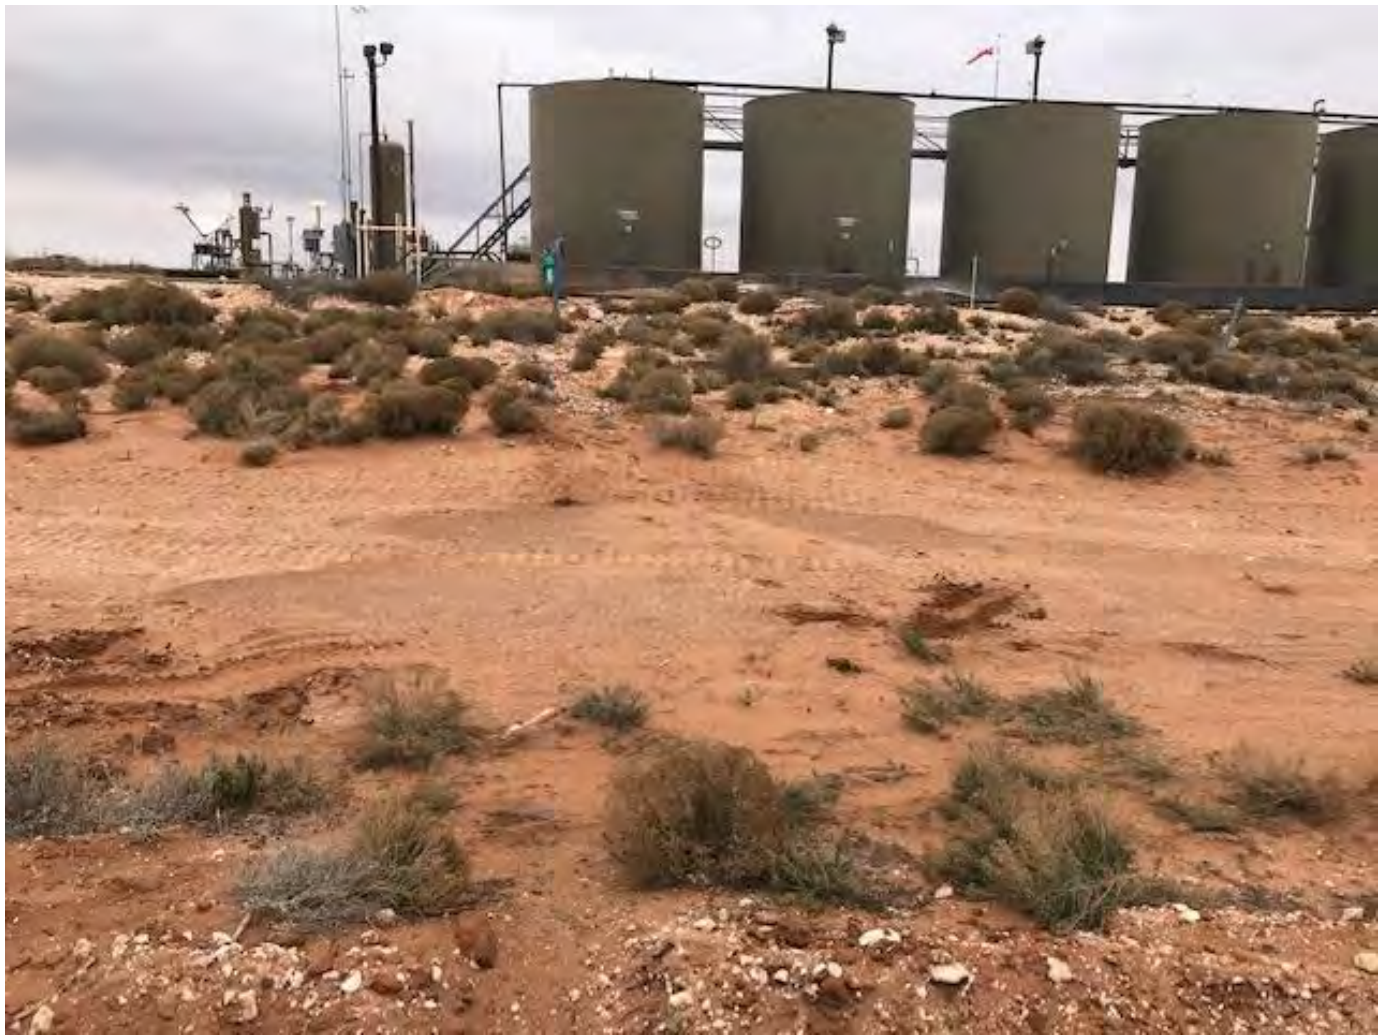
**Northern view of the release area prior to excavation activities.**

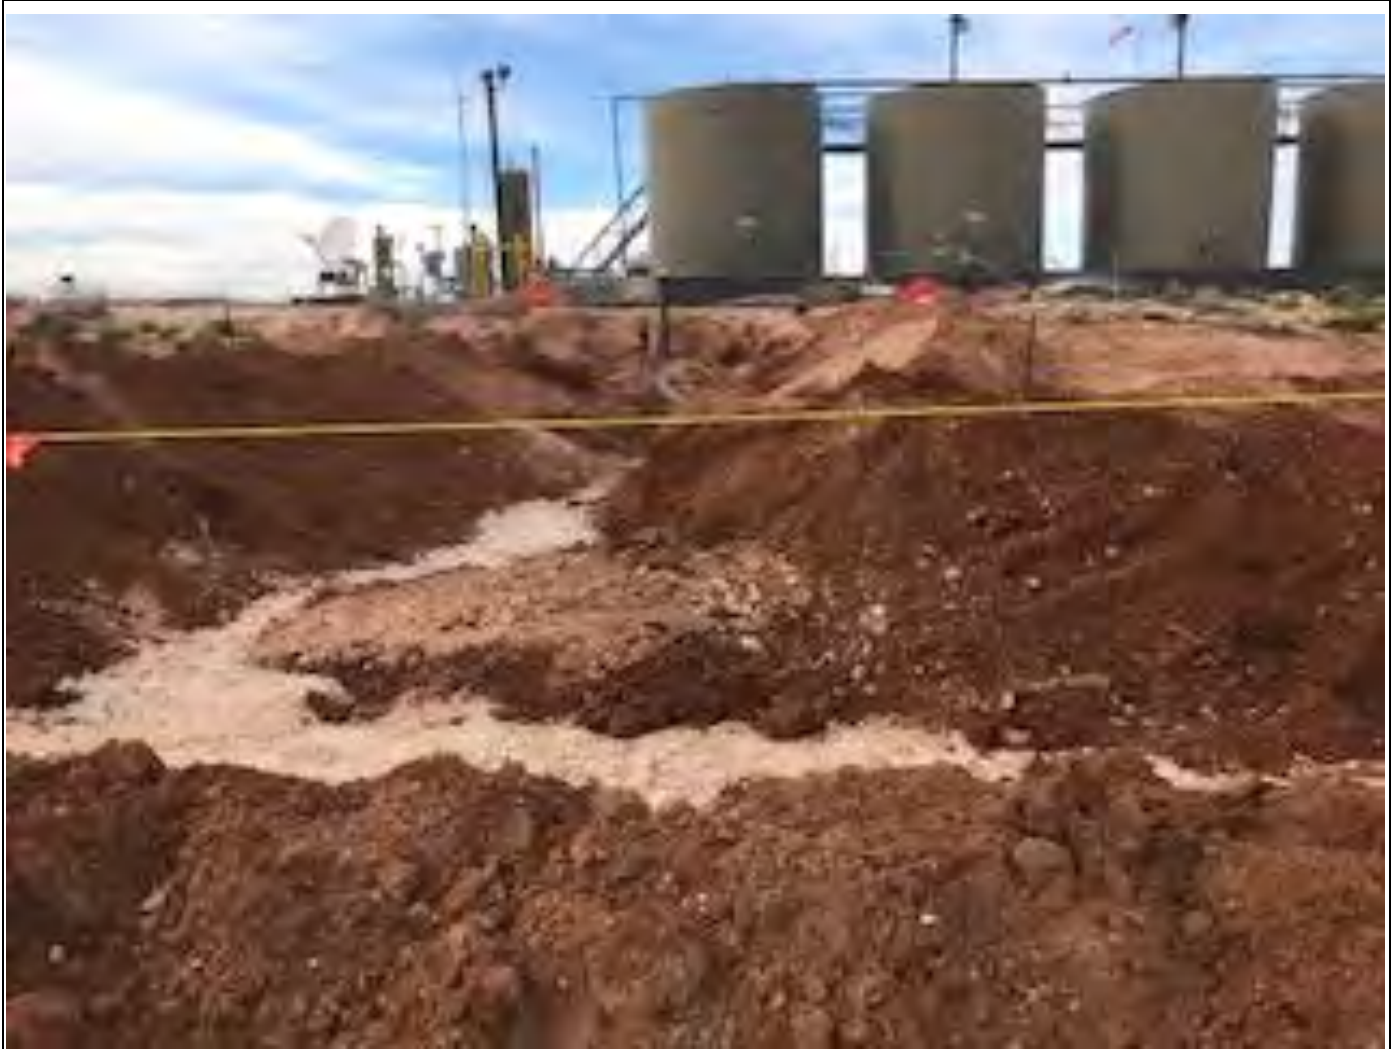
**Northern view of the larger excavation in the pasture.**

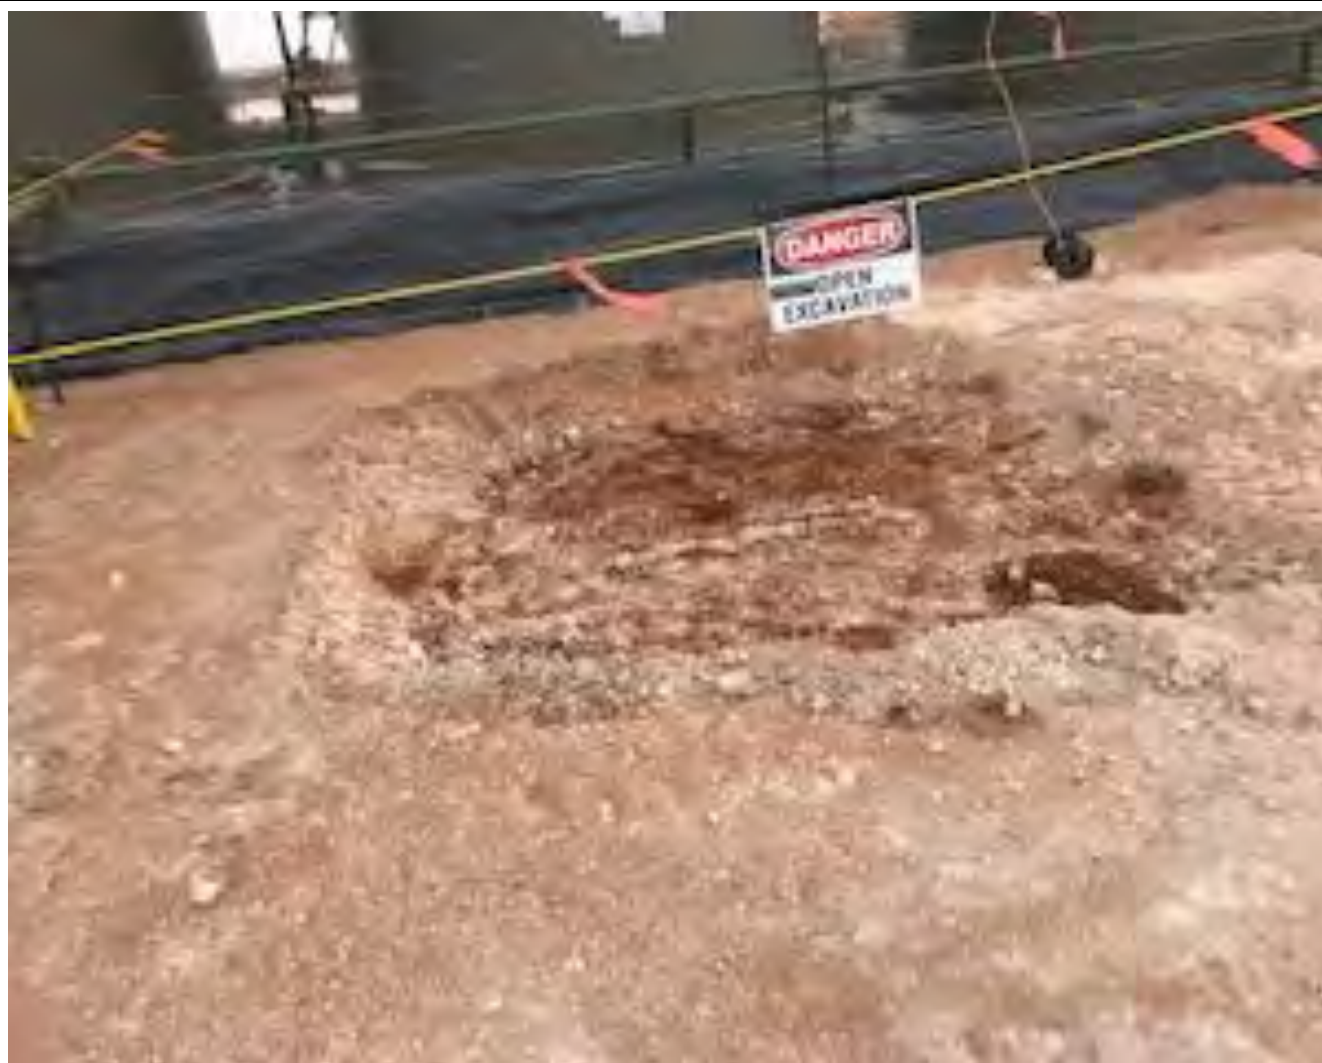
**Southern view of the smaller excavation on the well pad.**
