**RE: Closure Request  
Big Eddy Unit DI #4 Battery  
Remediation Permit Number 2RP-5162  
Eddy County, New Mexico**

LT Environmental, Inc. (LTE), on behalf of XTO Energy, Inc. (XTO), presents the following report detailing excavation and soil sampling activities at the Big Eddy Unit DI #4 Battery (Site) in Unit B, Section 5, Township 20 South, Range 31 East, in Eddy County, New Mexico (Figure 1). The purpose of the excavation and soil sampling activities was to address impacts to soil after produced water was released within the process equipment berm.

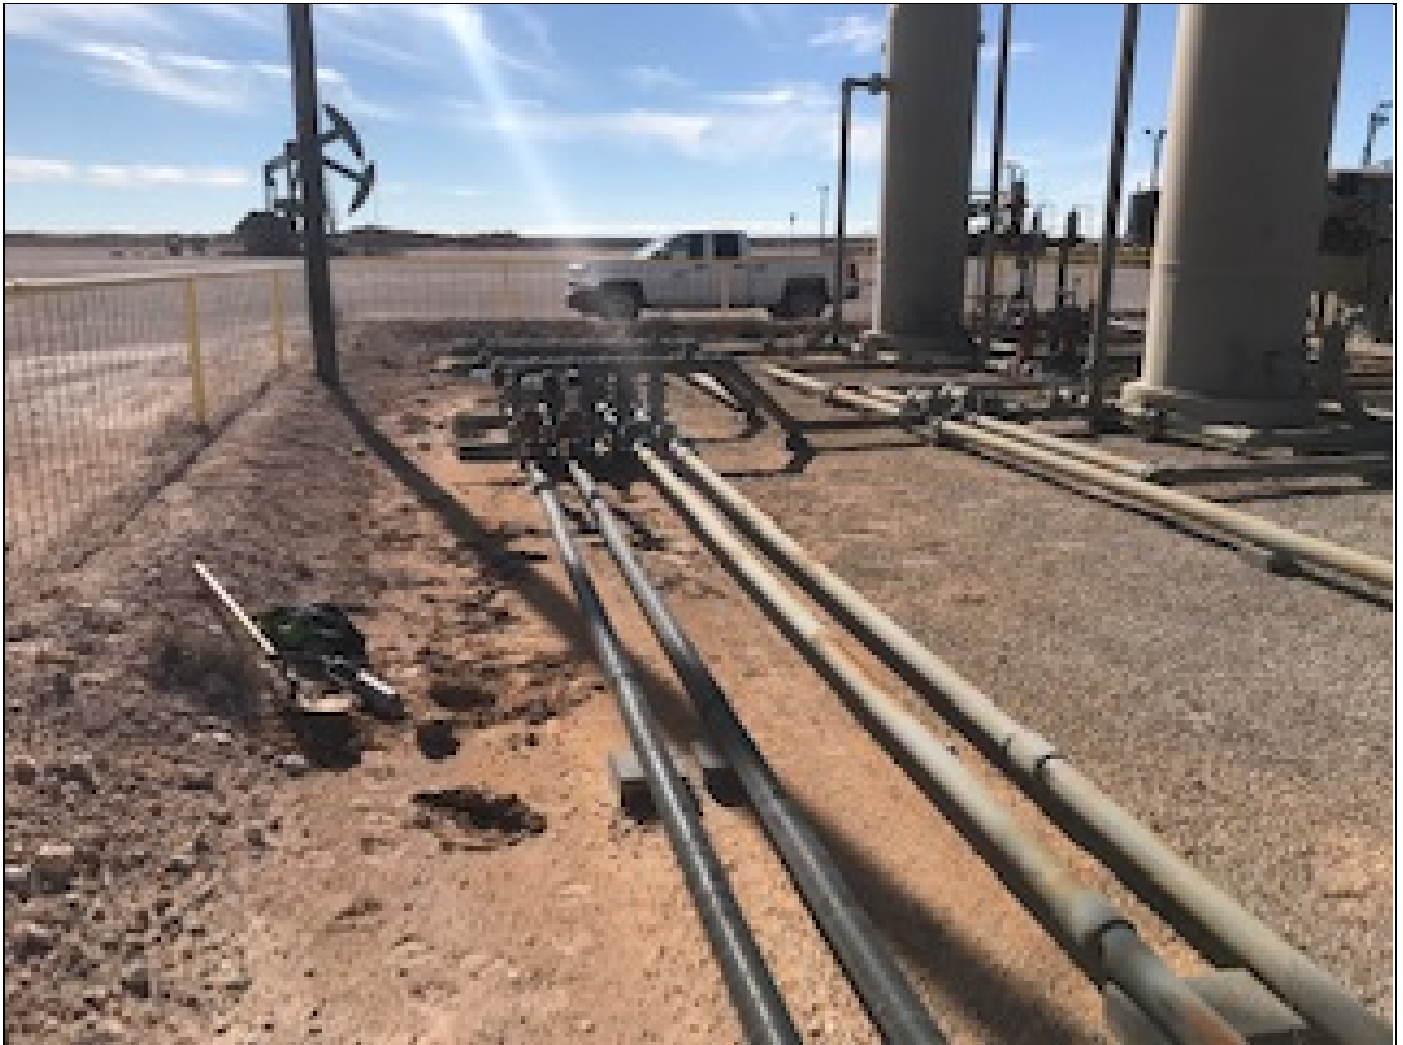
Impacted soil was excavated to the extent possible. Further excavation of impacted soil was limited by active process equipment and pipelines. XTO safety policy restricts soil disturbing activities to a 2-foot radius of any on-site process equipment and pipelines. This XTO safety policy is established to protect workers and to reduce the likelihood of compromising the foundation of the process equipment. This policy was enforced where impacted soil was identified within two feet of active process equipment or pipelines. Laboratory analytical results are presented on Figures 2 and Figure 3 and summarized in Table 1, and the complete laboratory analytical reports are included in Attachment 2.

**View south showing piping density in release area.**

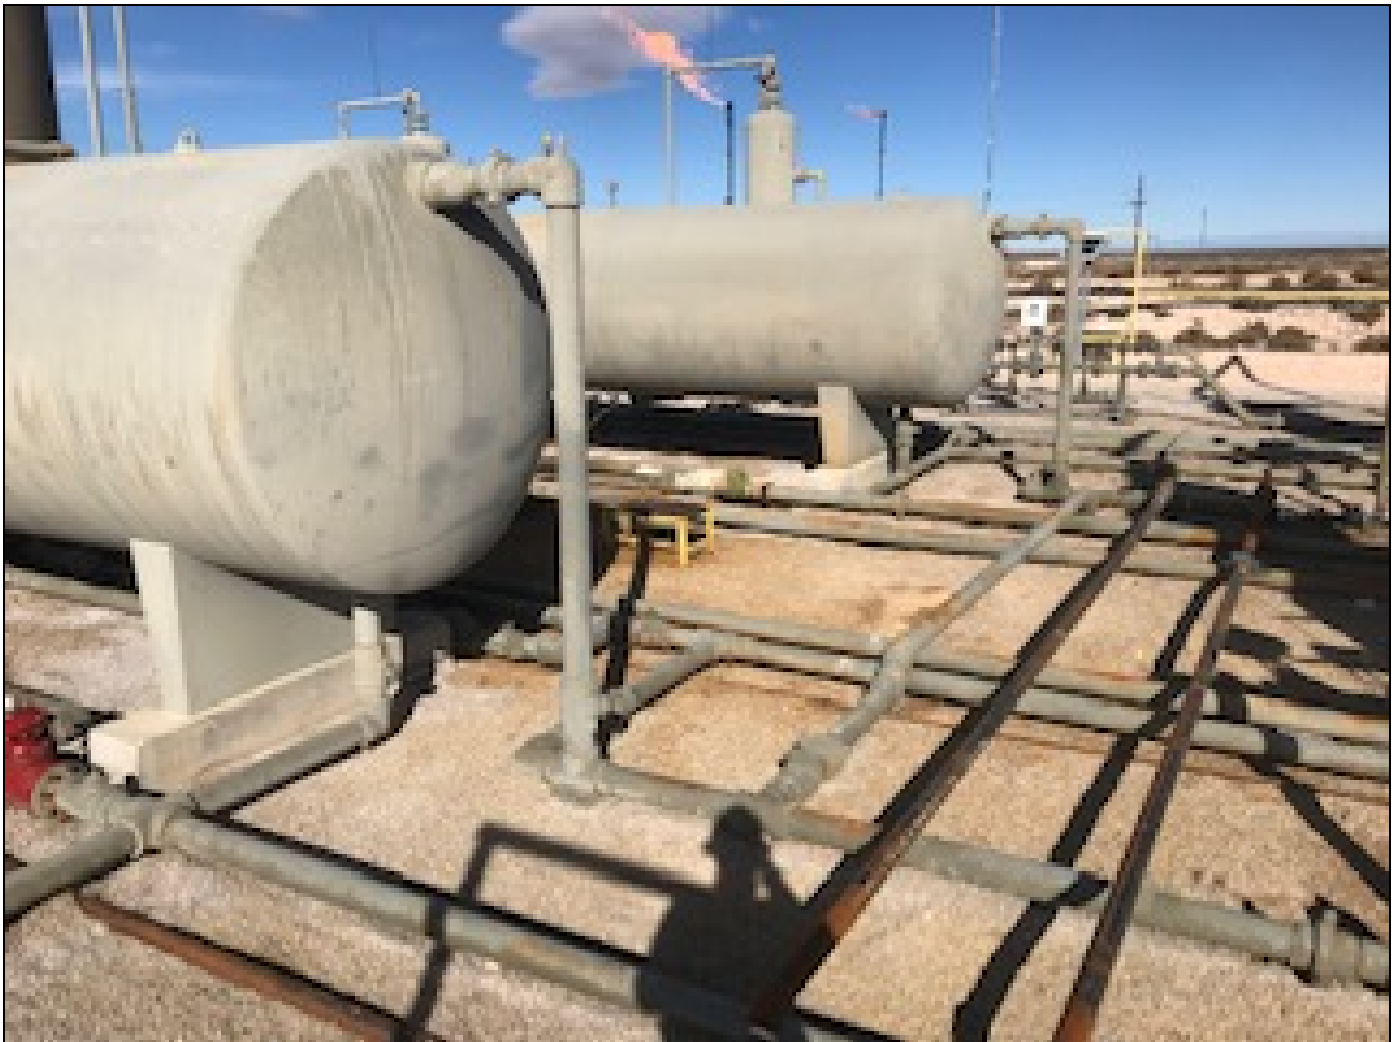
On December 22, 2018, approximately 23.8 barrels (bbls) of produced water were released from a connection on a free-water knockout (FWKO) line due to corrosion. Vacuum trucks were used to recover the free-standing fluid; approximately 15 bbls of produced water were recovered. The fluids were routed through the alternate FWKO until the connection was repaired. XTO reported the release to the New Mexico Oil Conservation Division (NMOCD) on a Release Notification and Corrective Action Form C-141 on January 4, 2019, and was assigned Remediation Permit Number (RP) 2RP-5162 (Attachment 1). Based on the excavation activities and results of the soil sampling events, XTO is requesting no further action for this release.

**View northeast of free-water knockout tanks and soil impacts around piping.**

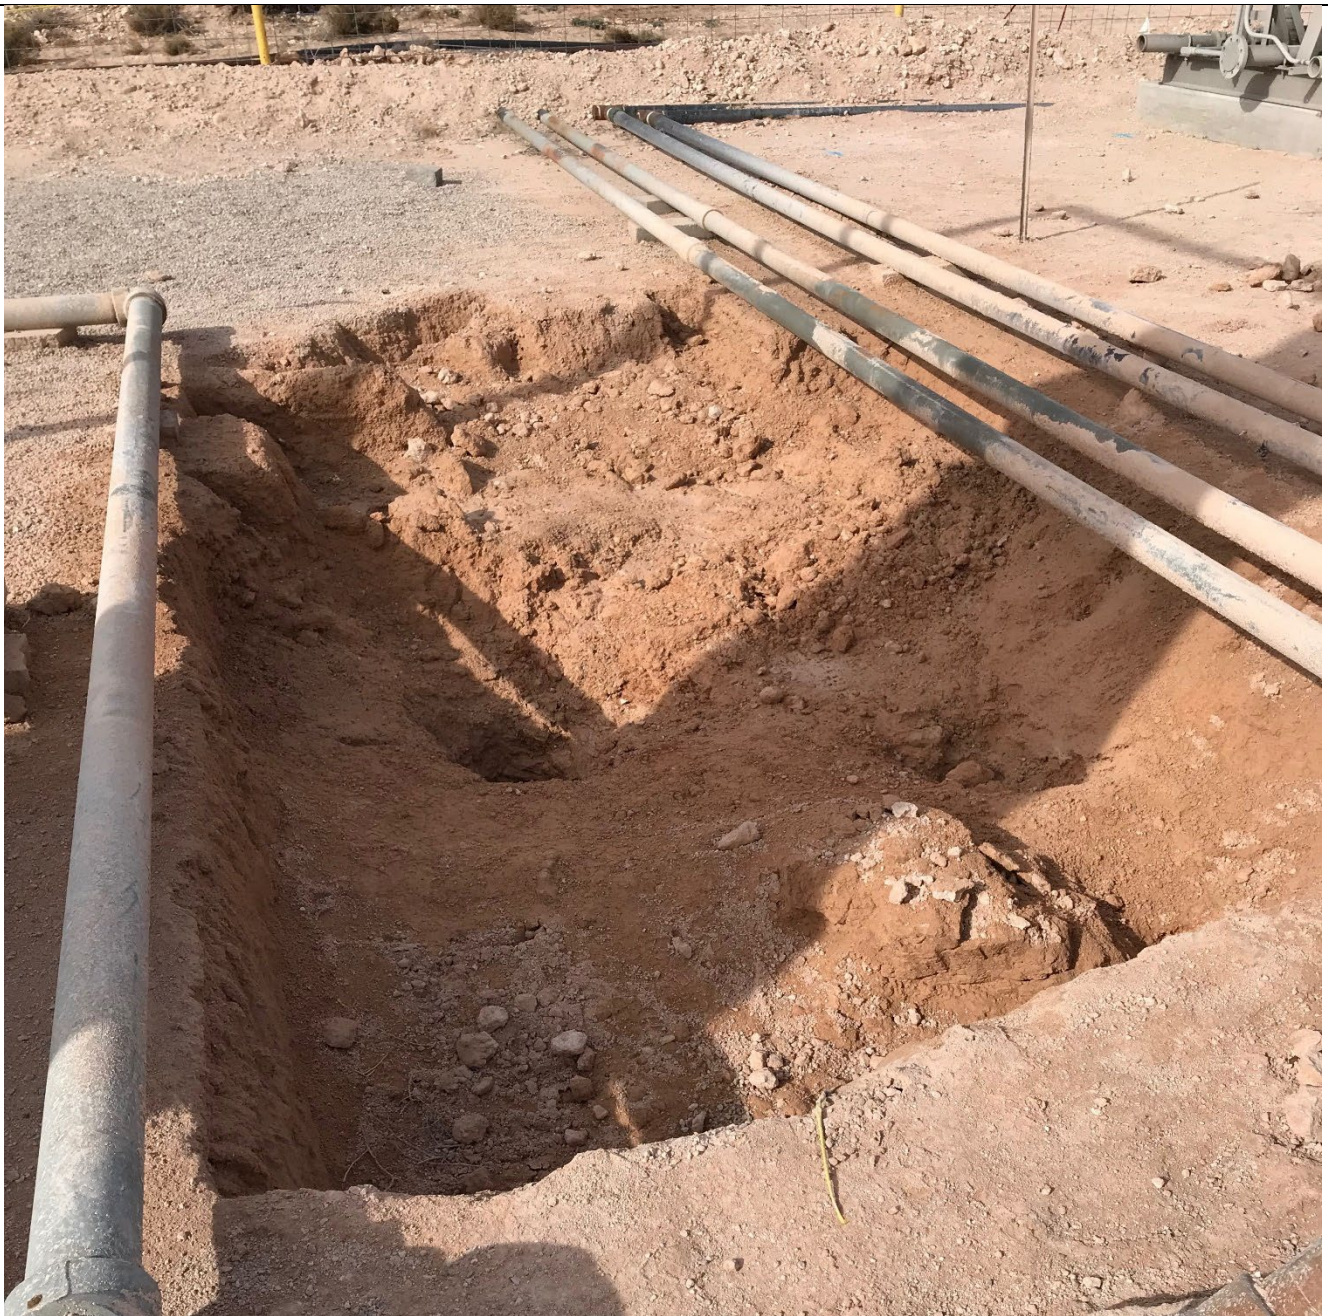
The southeast excavation was completed in the area around preliminary soil sample SS03. The final excavation measured approximately 260 square feet in area with a depth of 2 feet to 4 feet bgs. Approximately 19 cubic yards of impacted soil were removed from the excavation via hydro-vacuum. Soil sample FS1 was collected from the floor of the excavation from a depth of 4 feet bgs.

**View south of southeastern excavation.**

XTO requests to backfill the existing excavations and complete remediation during any future major well pad construction/alteration or final plugging and abandonment, whichever occurs first. LTE and XTO do not believe deferment will result in imminent risk to human health, the environment, or groundwater. Free-standing fluids were recovered during initial response activities and no saturated soil remains in place. The impacted soil remaining in place is delineated vertically and laterally by soil samples collected from potholes PH1 through PH13.
