**RE: Deferral Request  
Muy Wayno 7 State 1H  
Remediation Permit Number 2RP-5023  
Eddy County, New Mexico**

LT Environmental, Inc. (LTE), on behalf of XTO Energy, Inc. (XTO), presents the following letter report detailing excavation of impacted soil and confirmation soil sampling activities at the Muy Wayno 7 State 1H tank battery (Site) located in Unit C, Section 07, Township 25 South, Range 30 East, in Eddy, New Mexico (Figure 1). The purpose of the soil sampling and excavation activities was to address impact to soil after 25 barrels (bbls) of crude oil and 35.2 bbls of produced water were released from the tank battery. The majority of the released fluids were contained within the lined tank battery containment berm. A light mist impacted the surface soil northwest of the tank battery. The release was discovered on October 3, 2018. Vacuum trucks were dispatched to the Site and used to recover the standing fluid; approximately 25 bbls of crude oil and 35 bbls of produced water were recovered from the lined containment and returned to the tanks. XTO reported the release to the New Mexico Oil Conservation Division (NMOCD) on a Release Notification and Corrective Action Form C-

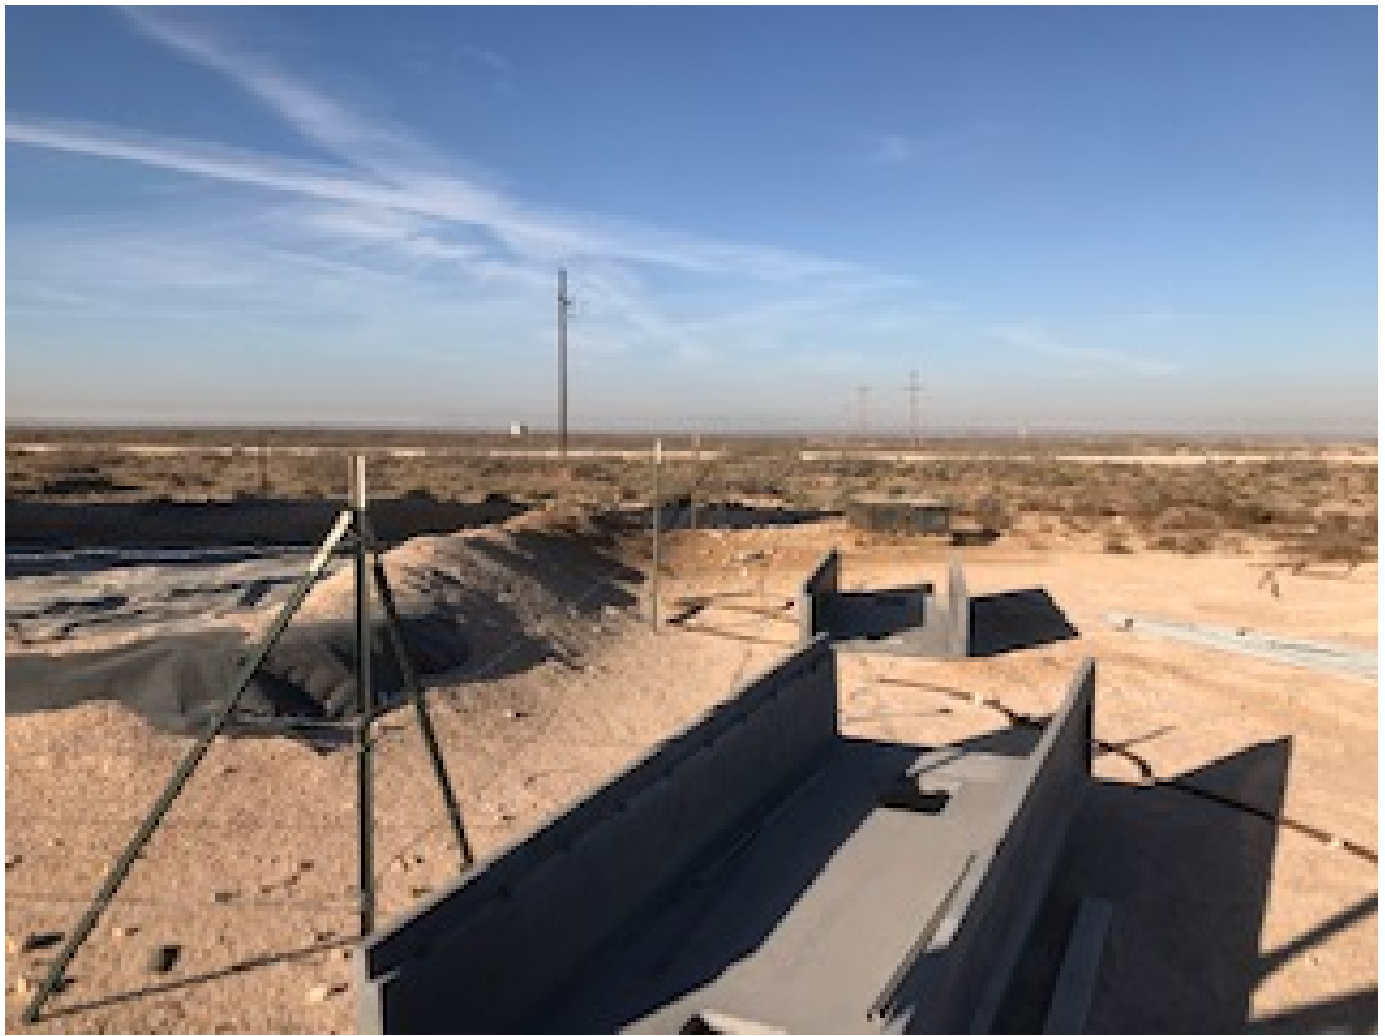
**View of lined containment and release area.**

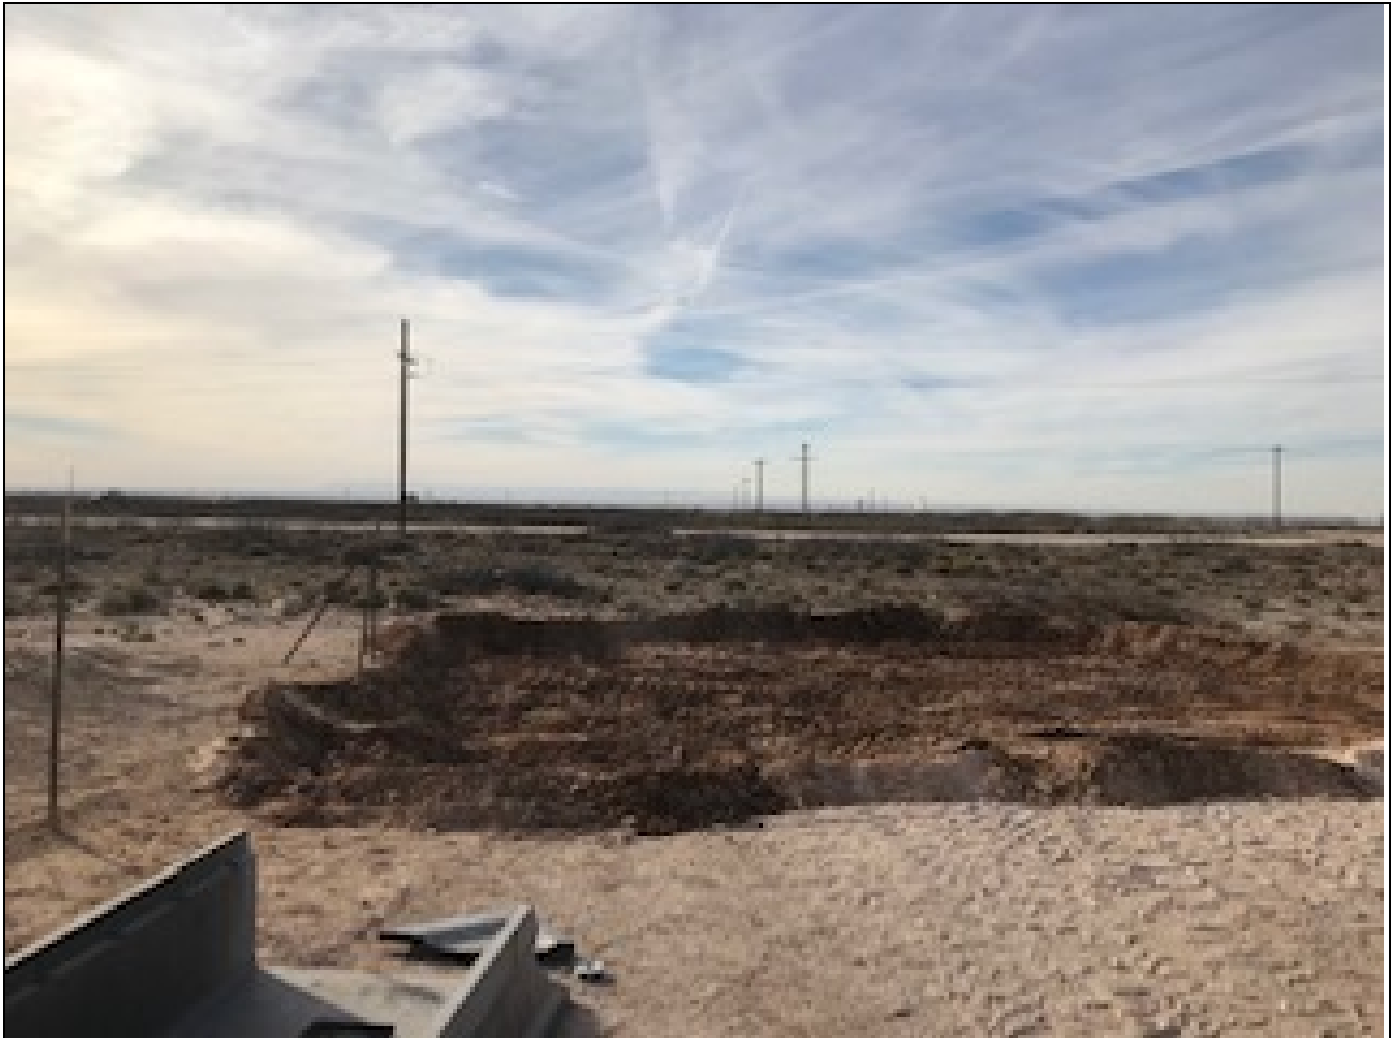
The excavation measured approximately 600 square feet in area with a depth ranging from 0.5 feet to 1.5 feet bgs. The horizontal extent of the excavation is illustrated on Figure 2. Approximately 28 cubic yards of impacted soil were removed from the excavation. The impacted soil will be transported and properly disposed of at the R360 Landfill Facility or Lea Land Landfill Facility, in Hobbs, New Mexico.

**West facing view of the excavation area.**

Upon approval of the deferral request, XTO will backfill the excavation with material purchased locally and recontour the Site to match pre-existing site conditions. An updated NMOCD Form C-141 is included as Attachment 1. A photographic log of the Site is included as Attachment 3.

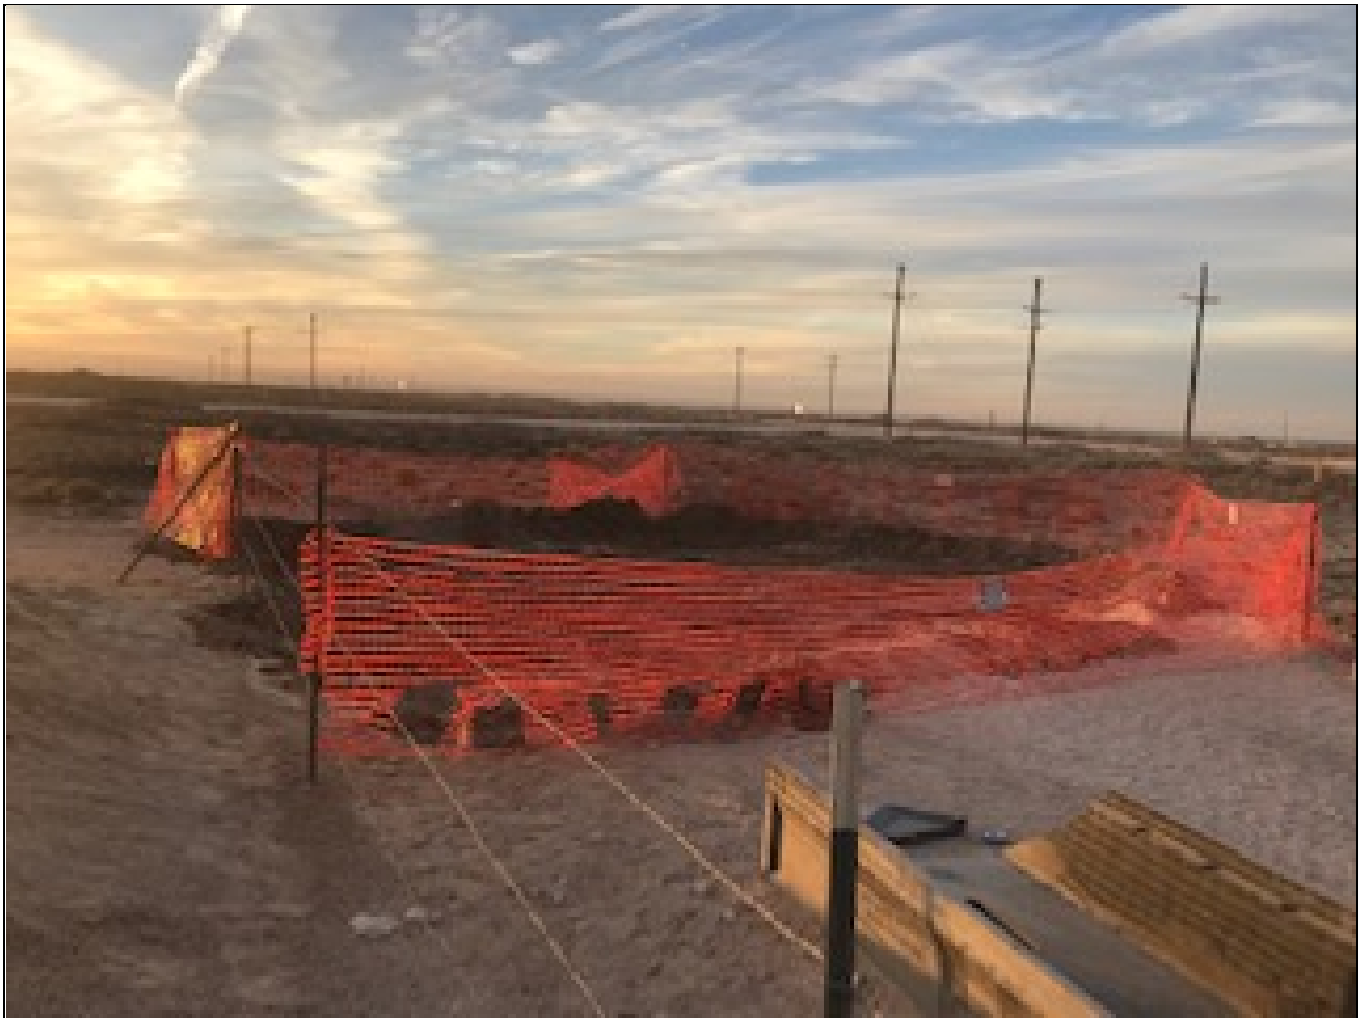
**West facing view of the fenced excavation area.**
