**RE: Closure Request
Remuda North 25 State 902H
Remediation Permit Number 2RP-5187
Eddy County, New Mexico**

LT Environmental, Inc. (LTE), on behalf of XTO Energy, Inc. (XTO), presents the following report detailing excavation of impacted soil and confirmation soil sampling activities at the Remuda North 25 State 902H (Site) located in Unit L, Section 25, Township 23 South, Range 29 East, in Eddy County, New Mexico (Figure 1). The purpose of the excavation and soil sampling activities was to address impacts to soil after a fire at the Site.

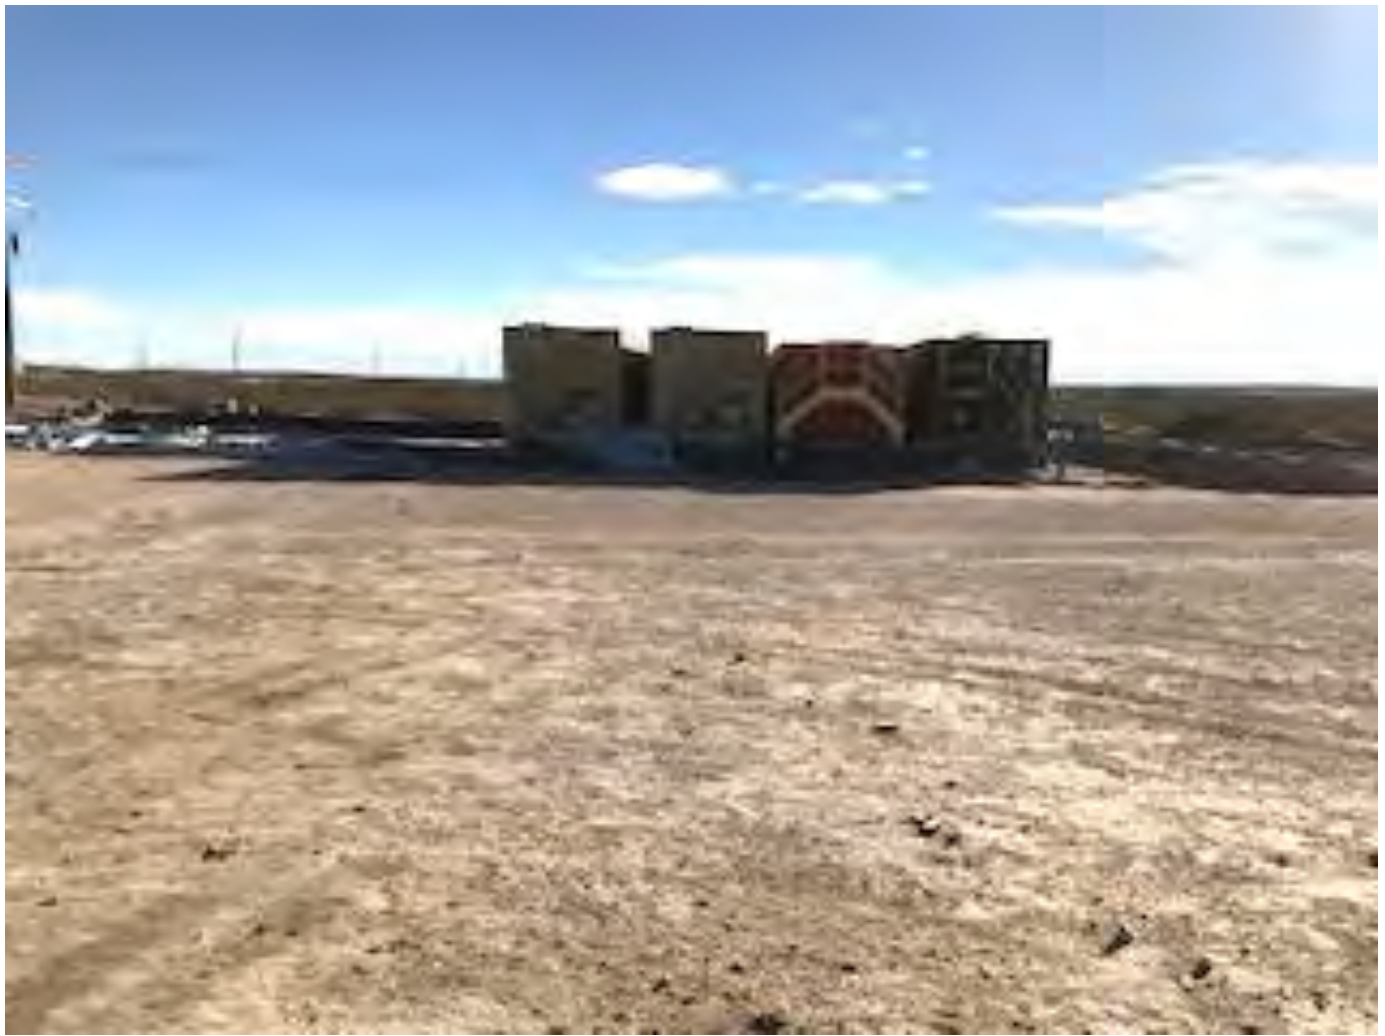
Location of Release Source

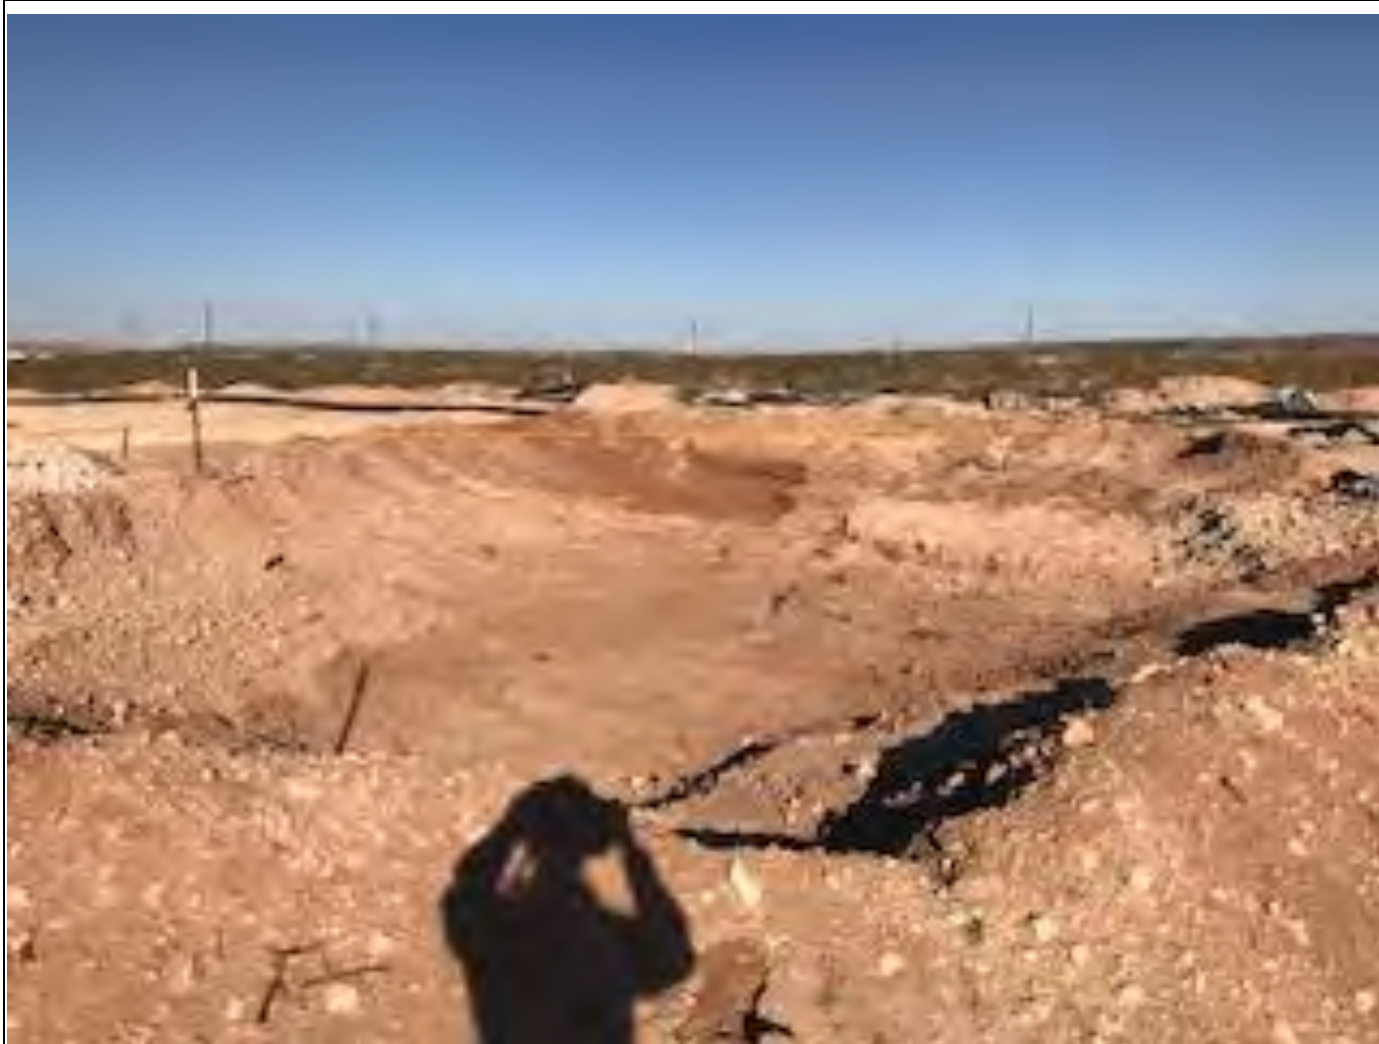
Nature and Volume of Release
