Report Type: Closure Report 2RP-5134

Site:	Crapshoot 13 Federal #1H					
Company:	COG Operating LLC					
Section, Township and Range	Unit A	Sec. 24	T 20S	R 29E		
Lease Number:	API No. 30-015-42323					
County:	Eddy County					
GPS:	32.56562			-104.02292		
Surface Owner:	Federal					
Directions:	From the intersection of Burton Flats Rd (238) and Buckeye Rd. head east on Buckeye Rd for 1.25 miles, turn north onto unnamed lease rd and go 0.84 miles, turn west and go 0.3 miles and arrive at location

Re: Closure Report for the COG Operating, LLC, Crapshoot 13 Federal #1H, Unit A, Section 24, Township 20 South, Range 29 East, Eddy County, New Mexico. 2RP-5134

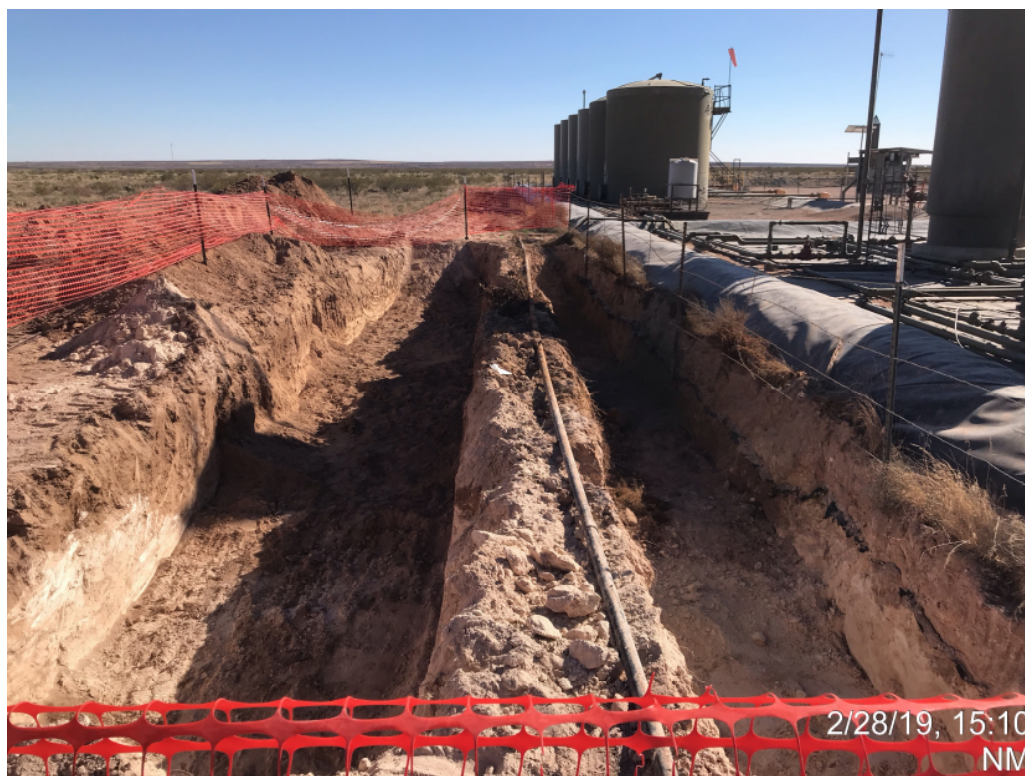
Area of Excavation – View South

Tetra Tech personnel were onsite from February 28 through March 1, 2019 to supervise the remediation activities. The areas of auger holes (AH-1 and AH-2) were excavated to total depths between 4.0' to 4.5' below surface. Three (3) bottom hole composite samples and five (5) sidewall composite samples were collected every 200 square feet to ensure proper removal of the impacted soils. The samples were submitted to the laboratory to be analyzed for TPH method 8015 extended, BTEX method 8021B, and Chloride by EPA Method 300.0. The sampling results are summarized in Table 2. The excavation depths and sample locations are shown in Figure 4.

Approximately 85 cubic yards of material was excavated and transported offsite for proper disposal. The area was then backfilled with clean material to surface grade.

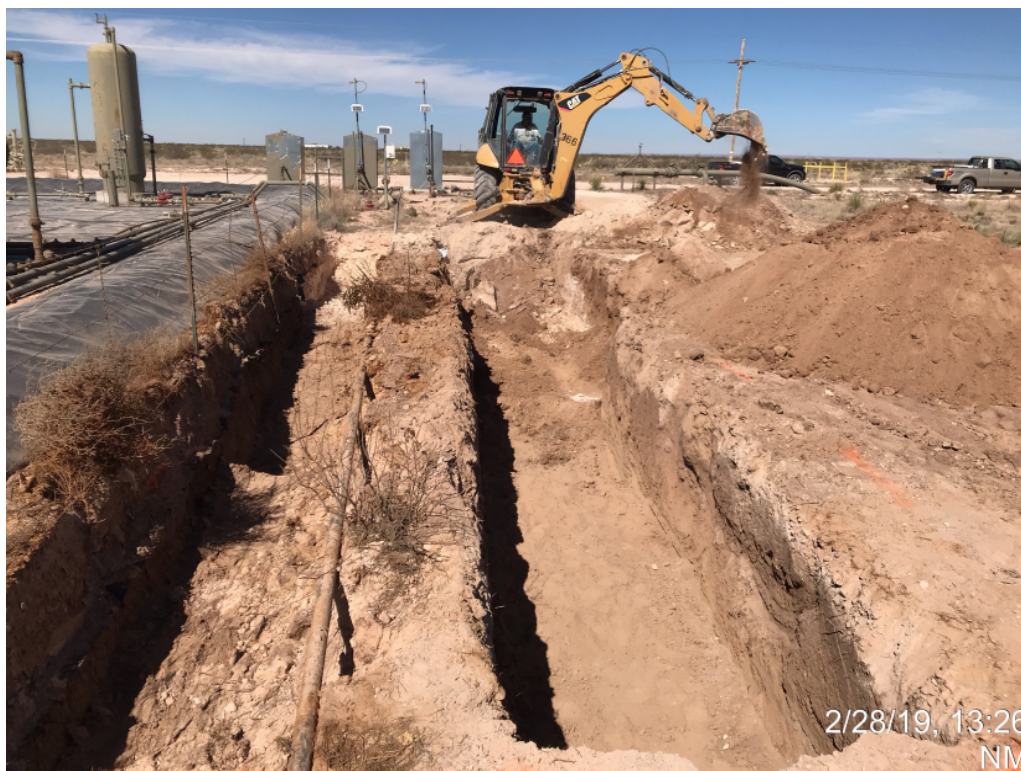
Area of Excavation – View North
