Remediation and Closure Report

Atoka San Andreas Unit #149
API # 30-015-00204
Talon Project No. 701307.117.01

Subject: **Remediation and Closure Report**
Atoka San Andreas Unit #149
API # 30-015-00204

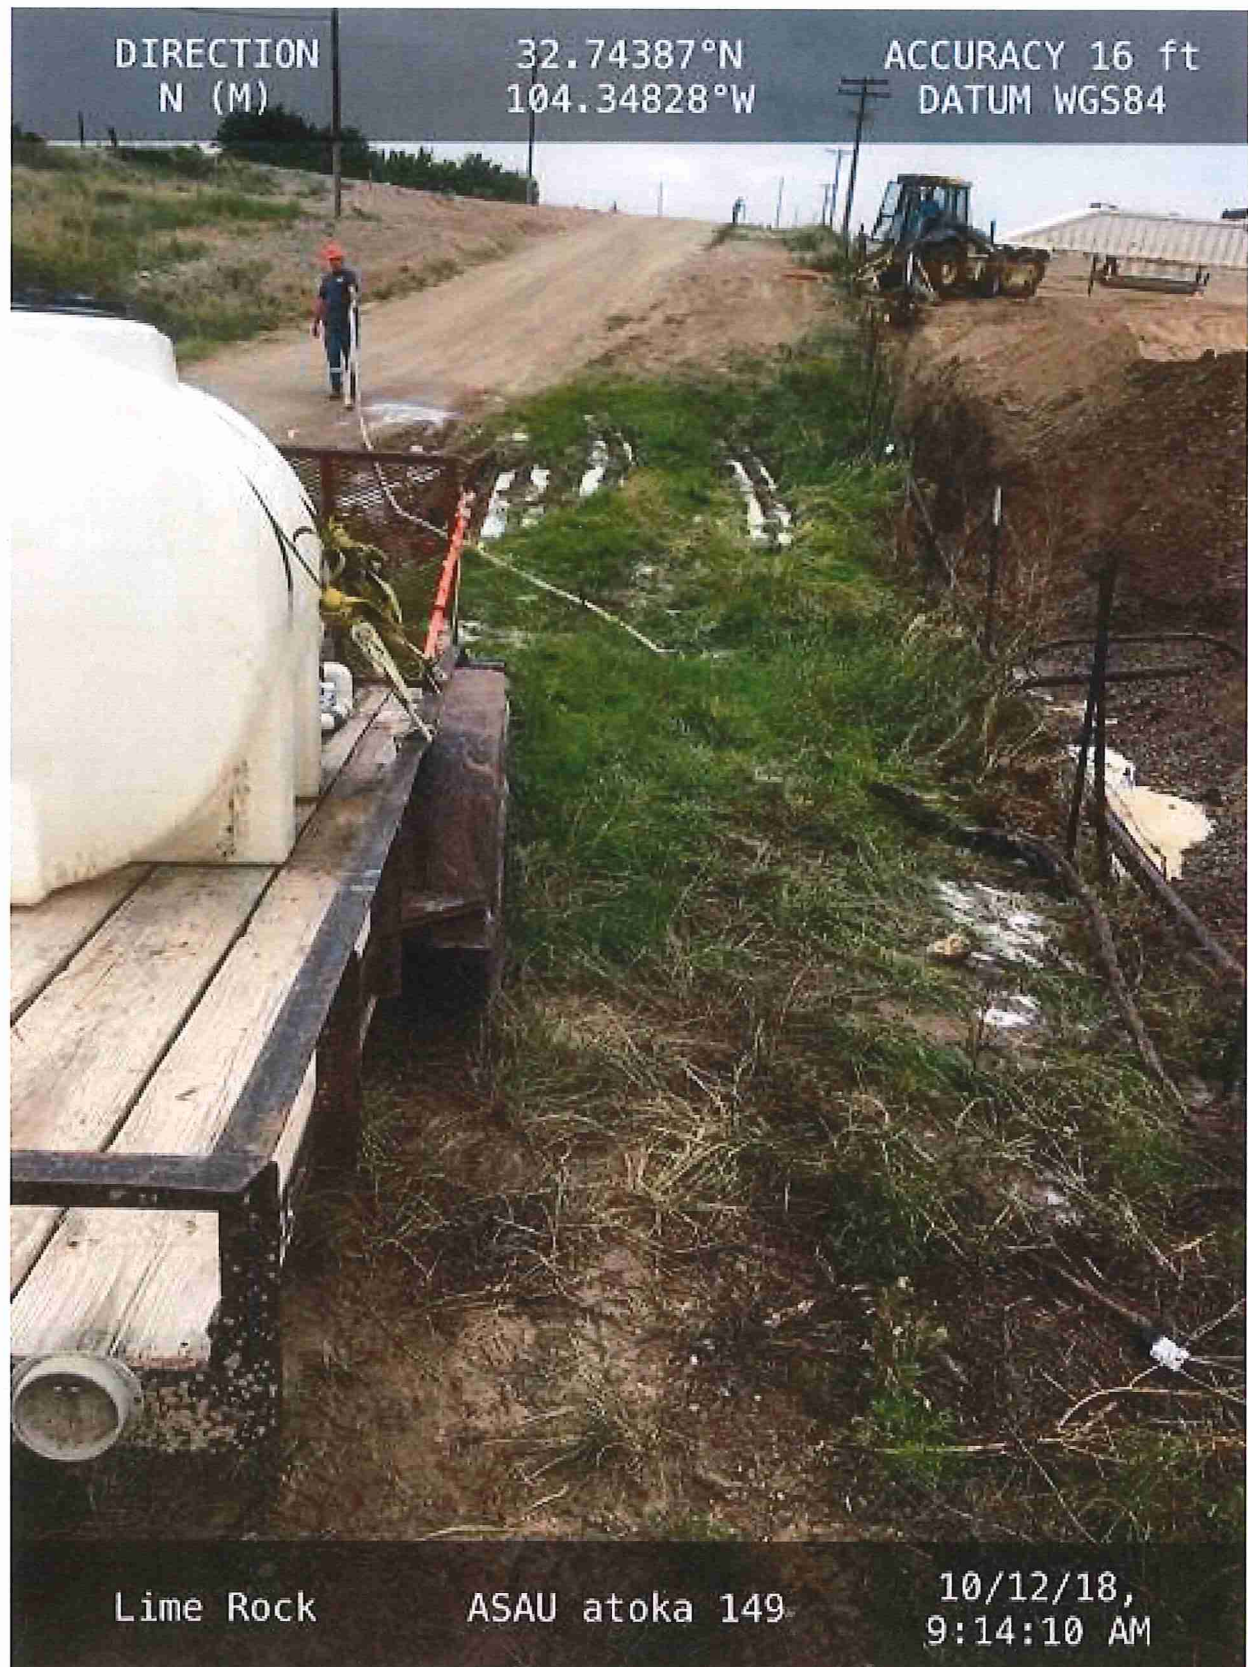
Bioremediation Activity

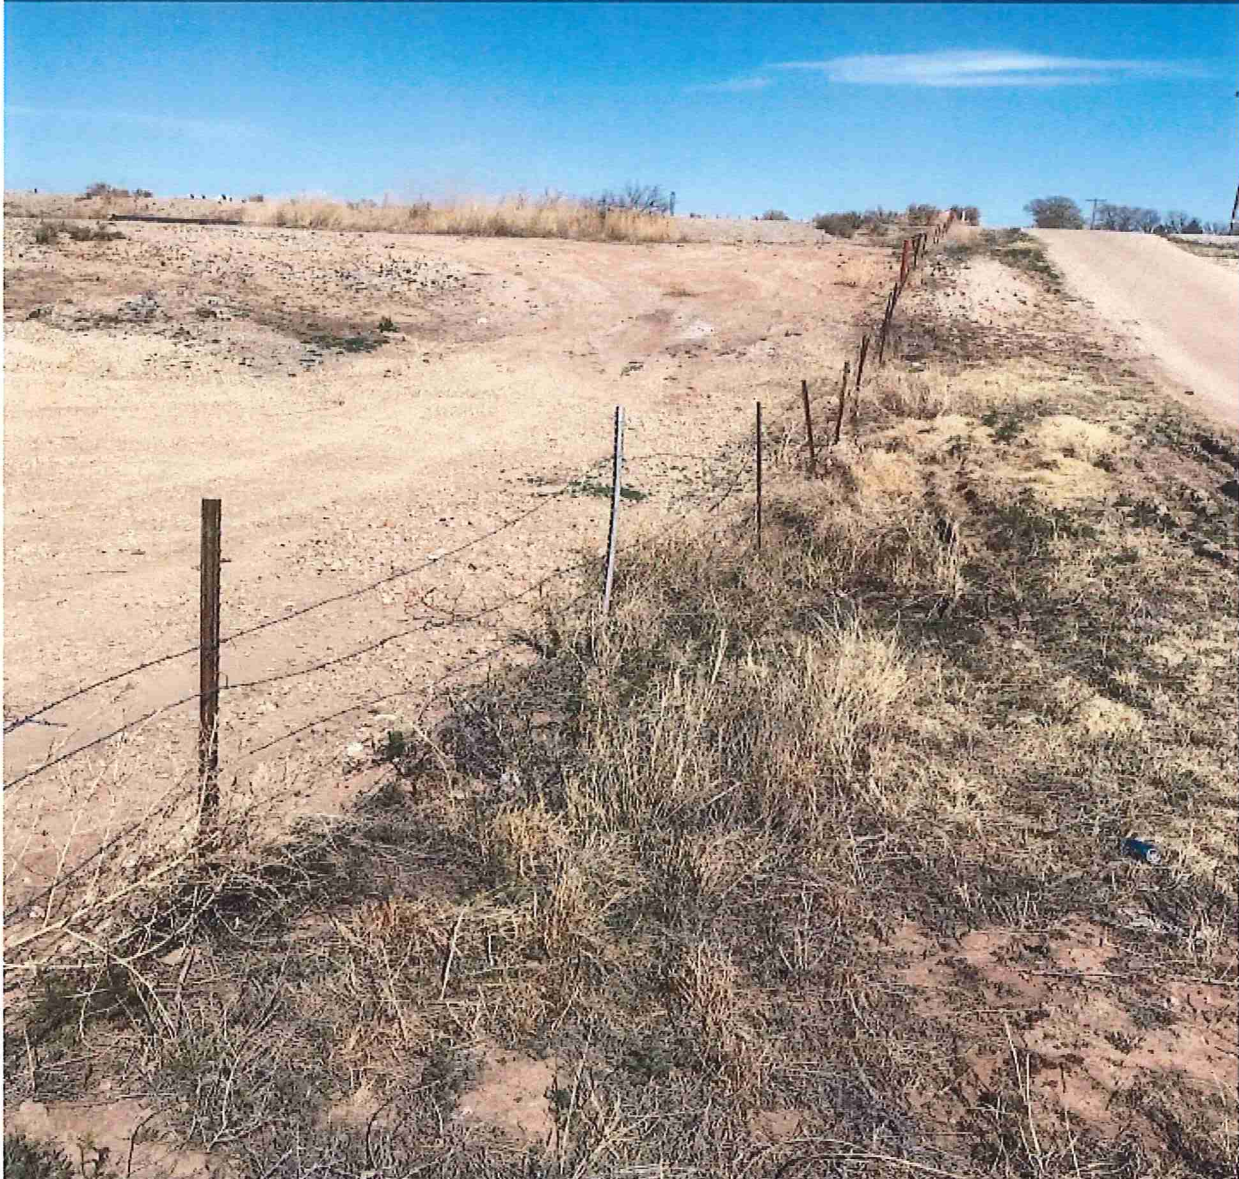
Completed Photos

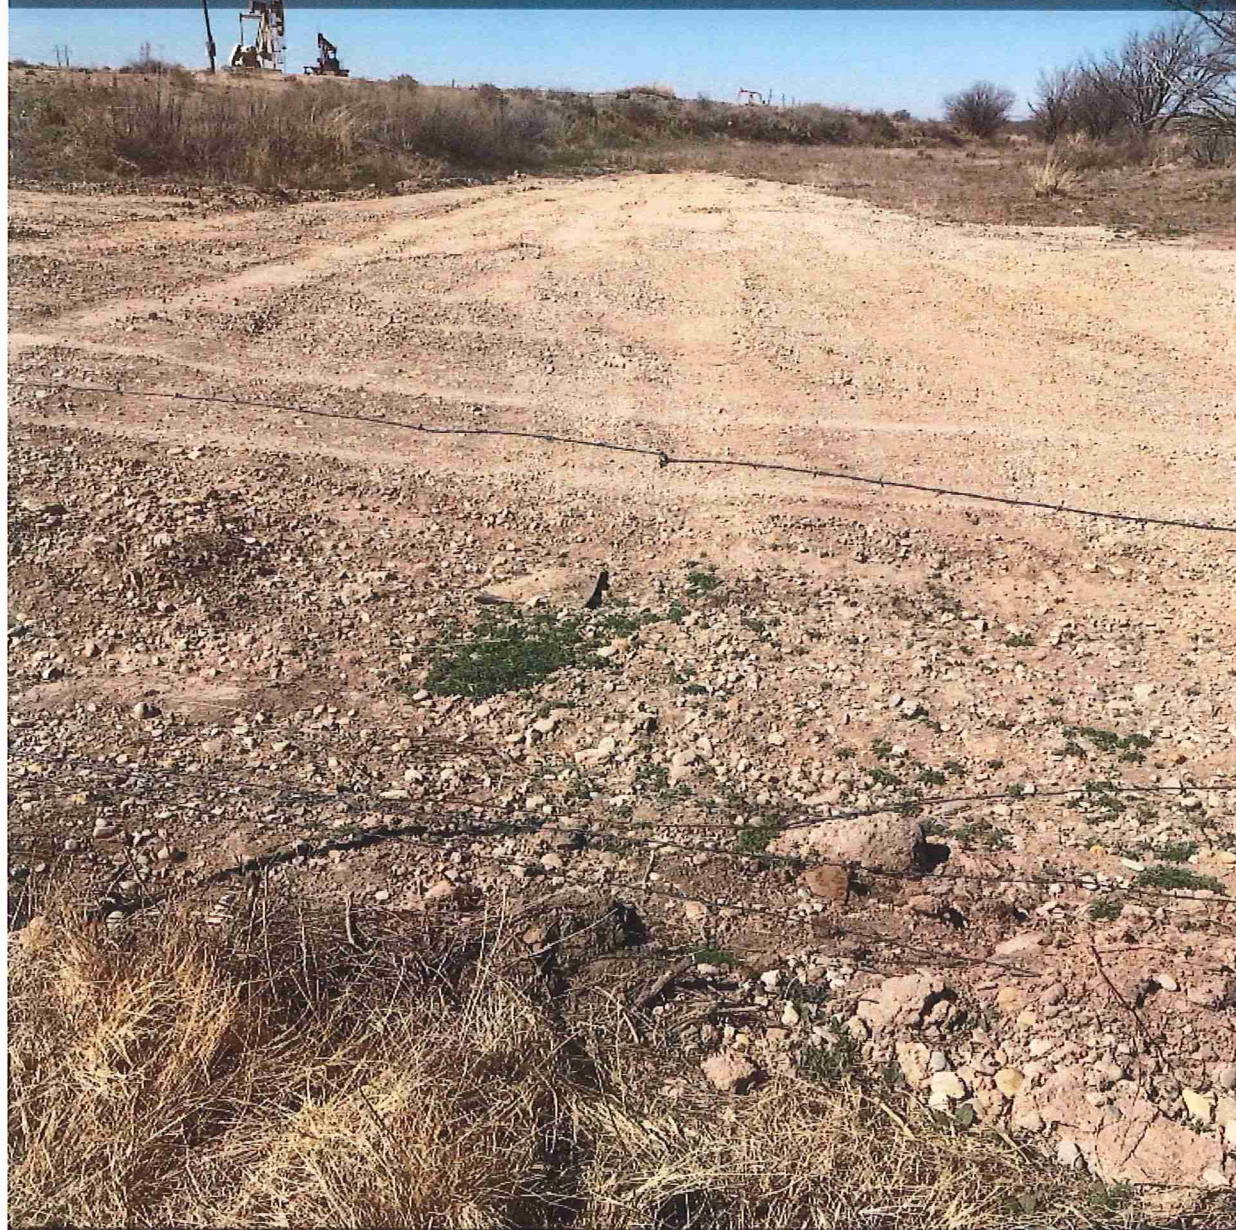
Complete

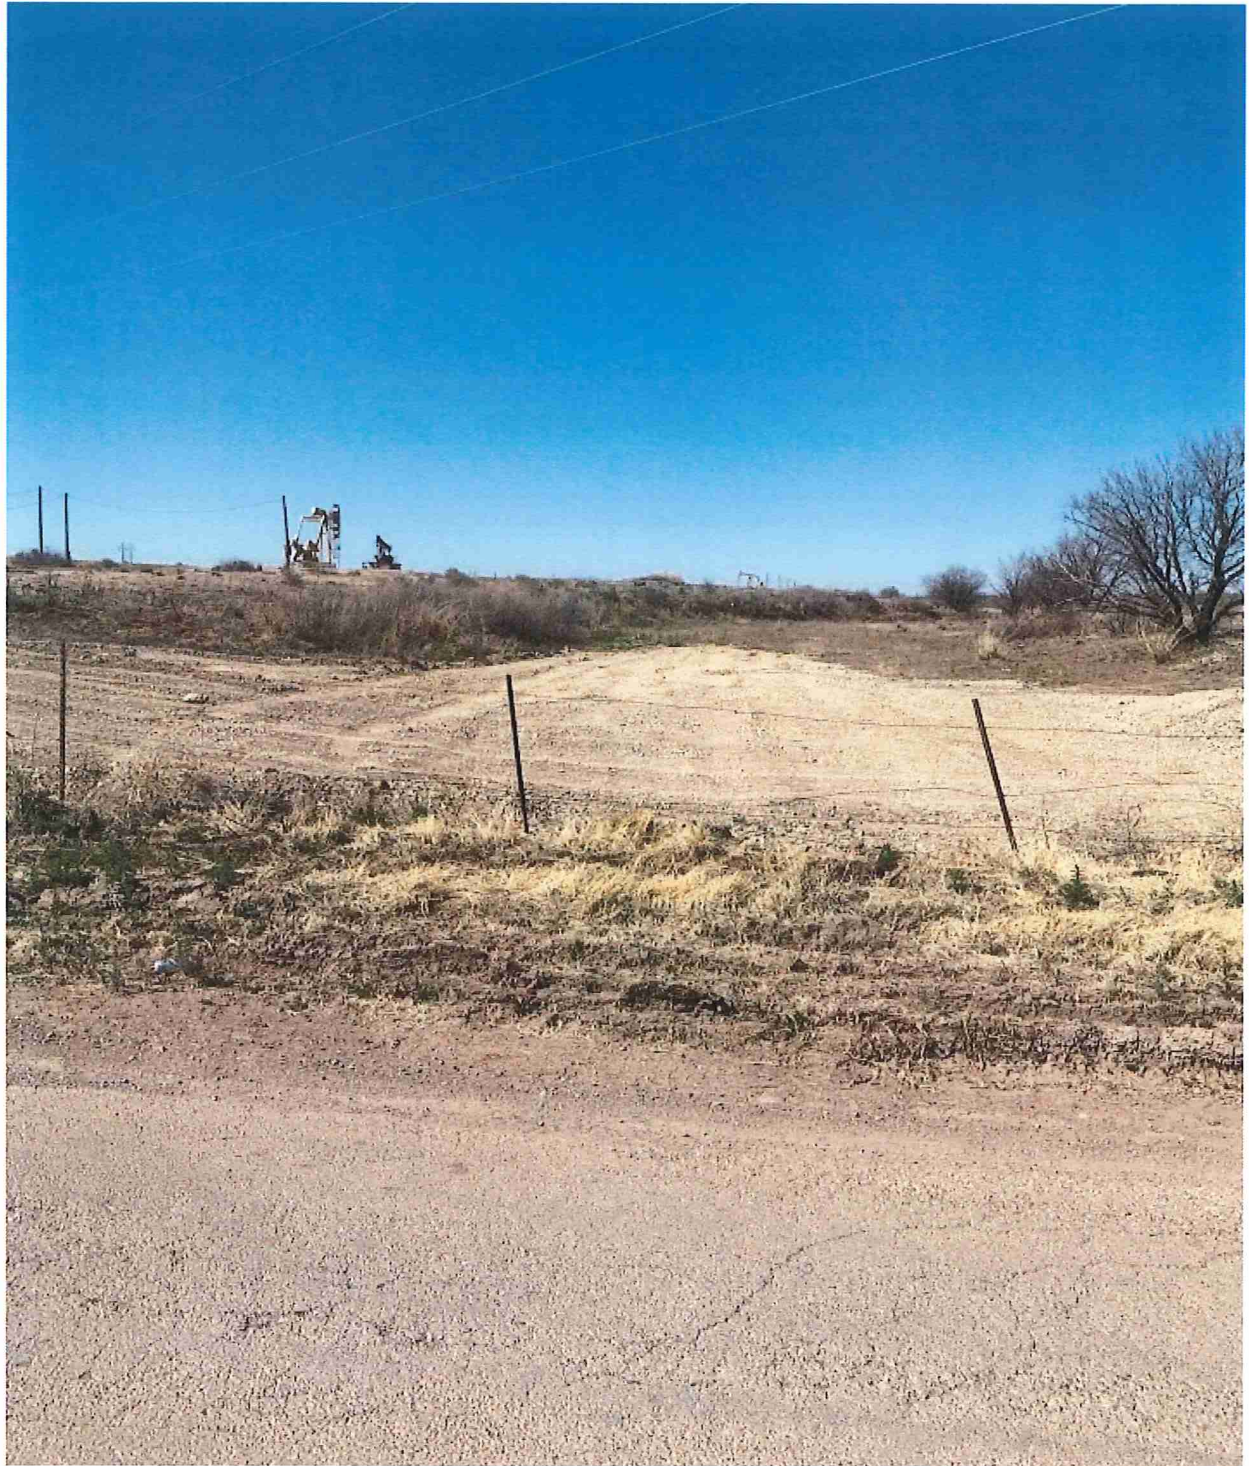
Complete
