**RE: Closure Request  
Remuda North 25 State 122H  
Remediation Permit Number 2RP-4968  
Eddy County, New Mexico**

LT Environmental, Inc. (LTE), on behalf of XTO Energy, Inc. (XTO), presents the following report detailing excavation of impacted soil and confirmation soil sampling activities at the Remuda North 25 State 122H (Site) in Unit L, Section 25, Township 23 South, Range 29 East, in Eddy County, New Mexico (Figure 1). The purpose of the soil sampling and excavation activities was to address impacts to soil after a release from an acid tank at the Site.

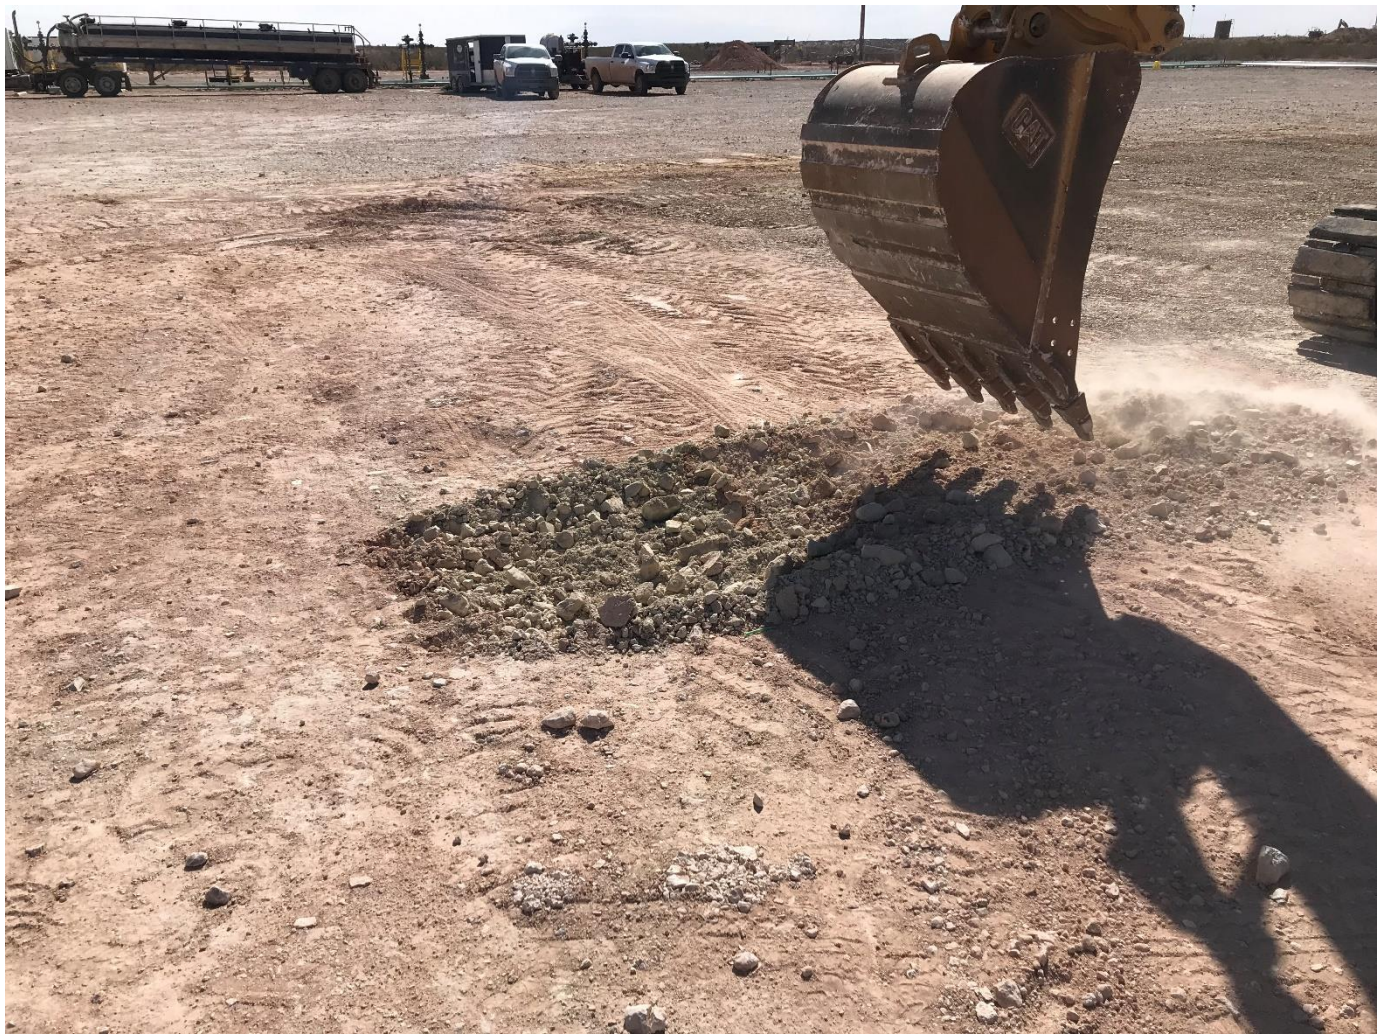
**View of release area during delineation activities, prior to excavation activities.**

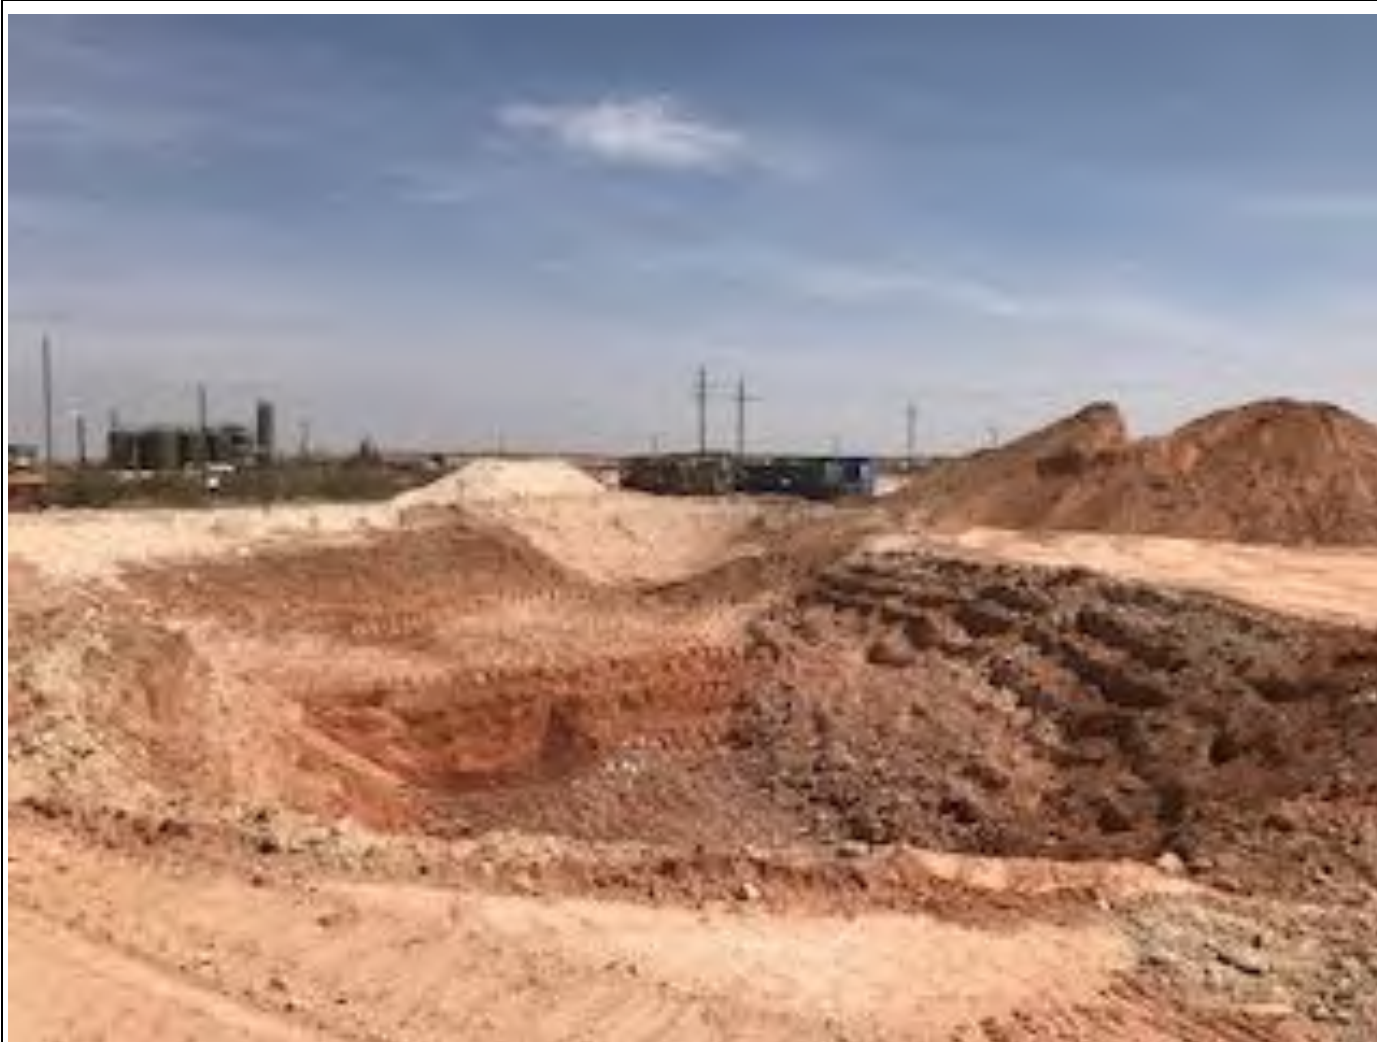
**Western view of final excavation extent.**

Impacted soil was excavated from the release area and laboratory analytical results for the confirmation soil samples collected from the final excavation extent indicated that BTEX, TPH, and chloride concentrations were compliant with the NMOCD Table 1 closure criteria. Initial response efforts and excavation of impacted soil have mitigated impacts at this Site. XTO requests no further action for this release. Upon approval of the no further action request, XTO will backfill the excavation with material purchased locally and recontour the Site to match pre-existing site conditions. An updated NMOCD Form C-141 is included as Attachment 1. A photographic log of the Site is included as Attachment 4.
