Vertex Project #: 19E-00614-007

**Spill Closure Report:** Taylor Deep 12 Federal #009 (Section 12, Township 18 South, Range 31 East)  
API: 30-015-39764  
County: Eddy  
Incident Report: 2RP-5349

**Prepared For:** **Marathon Oil Permian LLC**  
4111 S. Tidwell Road  
Carlsbad, New Mexico 88220

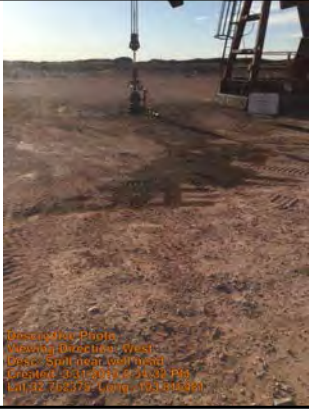
**Viewing Direction: West**

Descriptive Photo  
Viewing Direction: West  
Spill near well head  
Created: 2019/04/01 05:28 PM  
Latitude: 32.8277 Longitude: 104.8124

Spill near well head

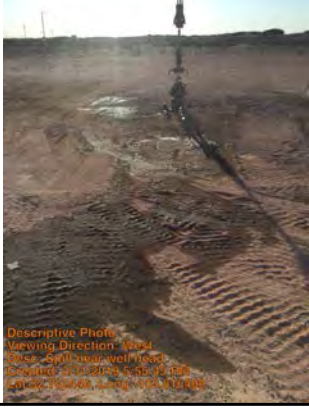
**Viewing Direction: West**

Descriptive Photo  
Viewing Direction: West  
Spill near well head  
Created: 2019/04/01 05:28 PM  
Latitude: 32.8277 Longitude: 104.8124

Spill near well head

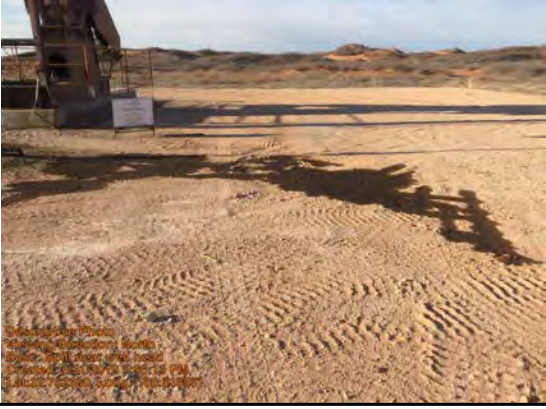
**Viewing Direction: North**

Descriptive Photo  
Viewing Direction: North  
Spill near well head  
Created: 2019/04/01 05:28 PM  
Latitude: 32.8277 Longitude: 104.8124

Spill near well head

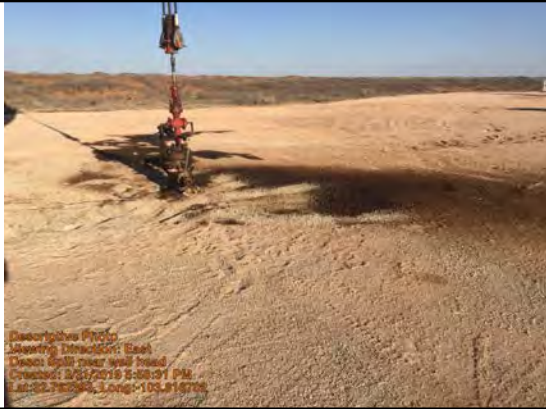
Viewing Direction: East

Spill near well head

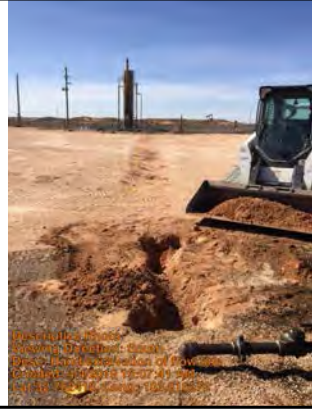
Viewing Direction: South

Hand excavation of flow line

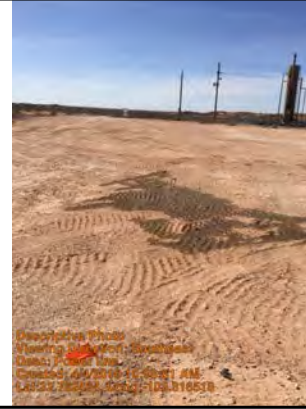
Viewing Direction: Southeast

Power line

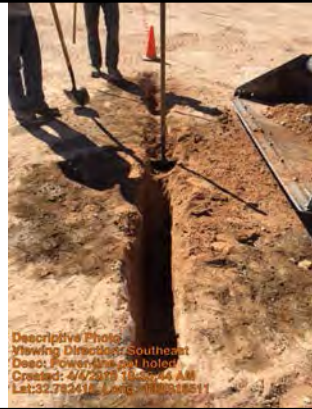
Viewing Direction: Southeast

Power-line pot holed

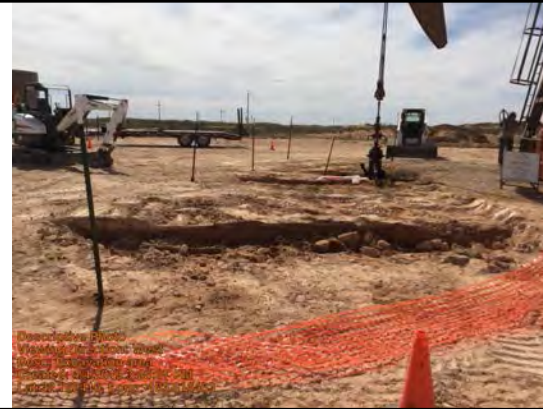
Viewing Direction: West

Excavation area

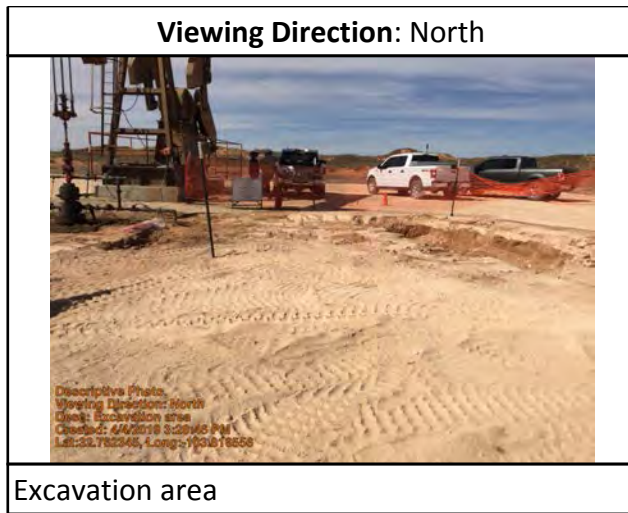
Excavation area

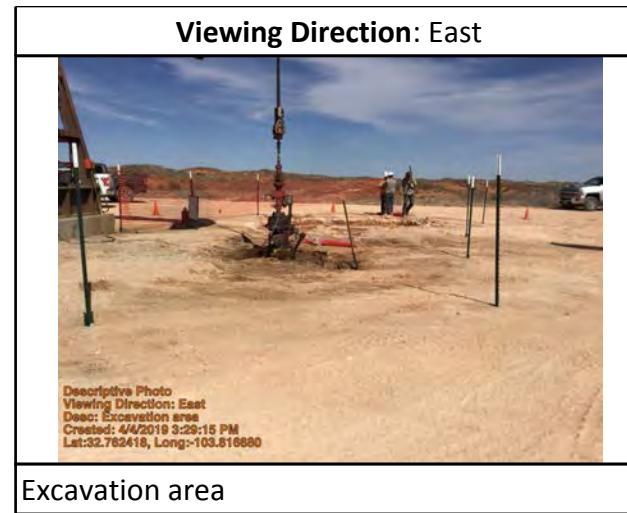
Excavation area

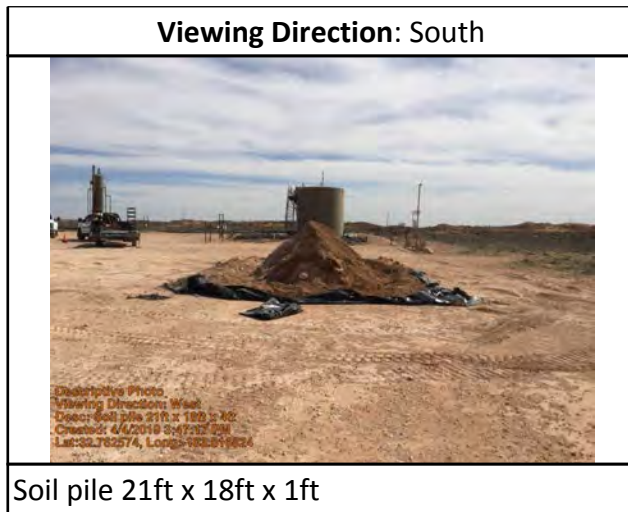
Soil pile 21ft x 18ft x 1ft

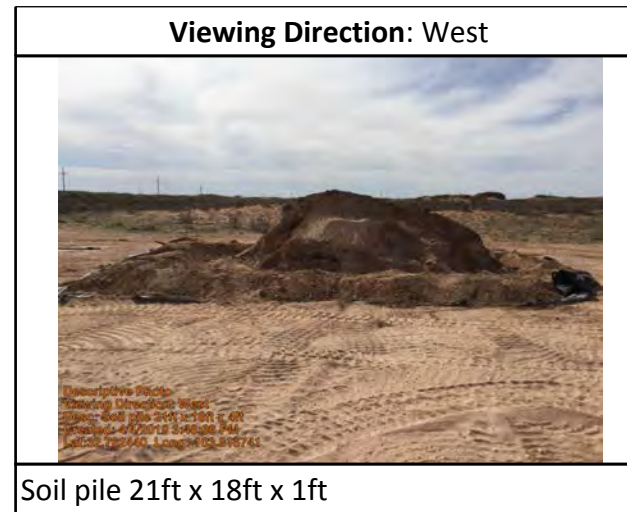
Soil pile 21ft x 18ft x 1ft

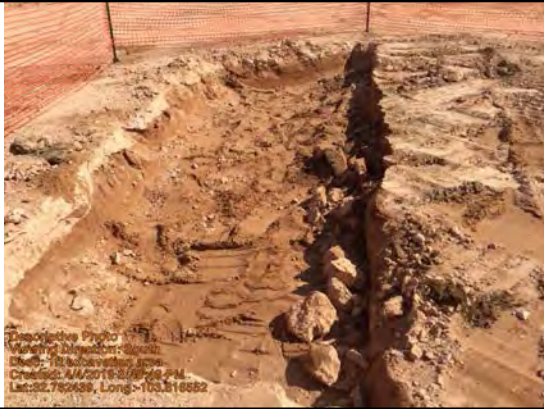
Descriptive Photo  
Viewing Direction: South  
Desc: 1ft excavation area  
Created: 4/4/2019 3:09:08 PM  
Lat:32.782283, Long:-103.816720

1ft excavation area

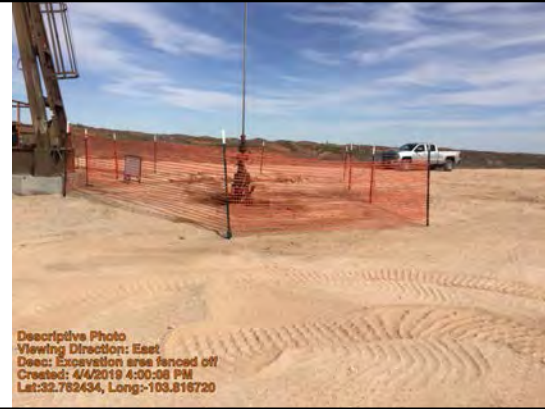
Descriptive Photo  
Viewing Direction: East  
Desc: Excavation area fenced off  
Created: 4/4/2019 4:00:08 PM  
Lat:32.782434, Long:-103.816720

Excavation area fenced off

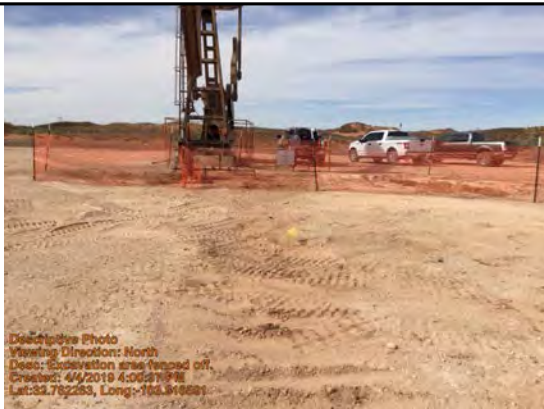
Descriptive Photo  
Viewing Direction: North  
Desc: Excavation area fenced off  
Created: 4/4/2019 4:00:37 PM  
Lat:32.782283, Long:-103.816661

Excavation area fenced off.

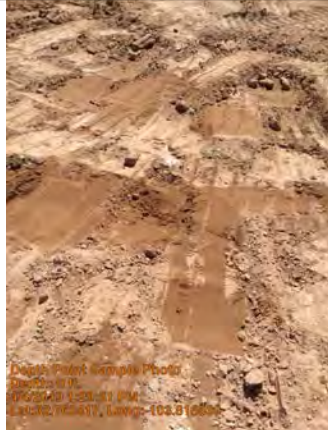
Sample Point ID: SS19-02

Depth: 0ft.

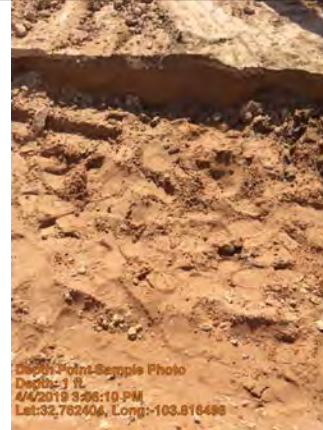
Sample Point ID: SS19-01

Depth: 1ft.

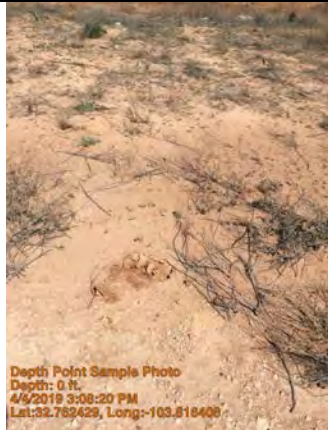
Sample Point ID: SS19-05

Depth: 0ft.

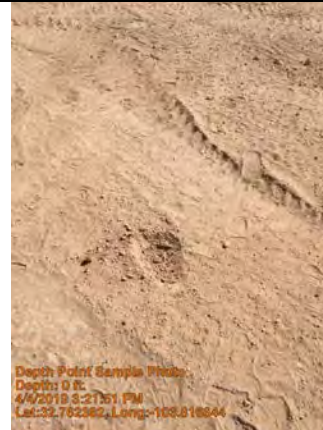
Sample Point ID: SS19-04

Depth: 0ft.

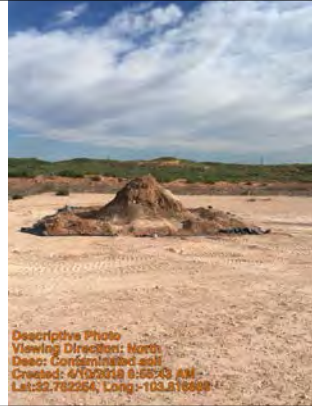
Descriptive Photo  
Viewing Direction: North  
Desc: Contaminated soil  
Created: 4/10/2019 8:55:03 AM  
Lat:32.782264, Long:-103.618699

Contaminated soil

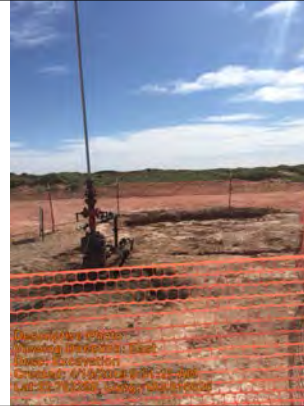
Descriptive Photo  
Viewing Direction: East  
Desc: Excavation  
Created: 4/10/2019 9:01:22 AM  
Lat:32.782264, Long:-103.618699

Excavation

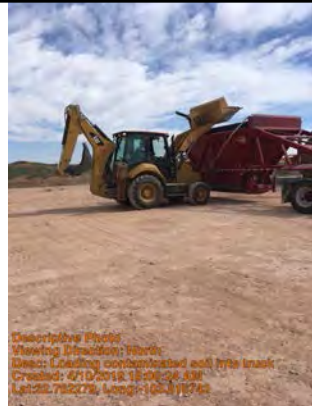
Descriptive Photo  
Viewing Direction: North  
Desc: Loading contaminated soil into truck  
Created: 4/10/2019 12:00:04 AM  
Lat:32.782279, Long:-103.618744

Loading contaminated soil into truck

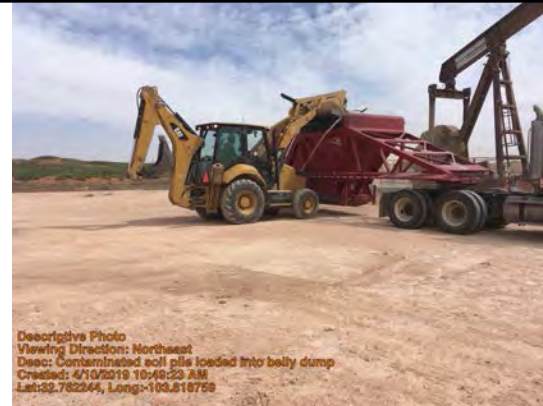
Descriptive Photo  
Viewing Direction: Northeast  
Desc: Contaminated soil pile loaded into belly dump  
Created: 4/10/2019 10:49:23 AM  
Lat:32.782244, Long:-103.618759

Contaminated soil pile loaded into belly dump

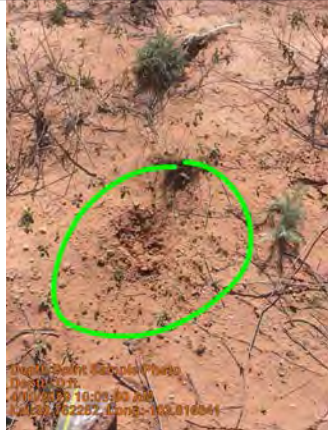
Sample Point ID: SS19-05

Depth: 0ft.

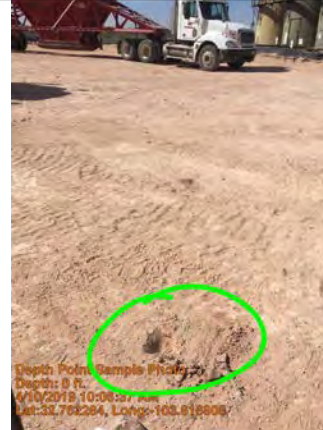
Sample Point ID: SS19-04

Depth: 0ft.

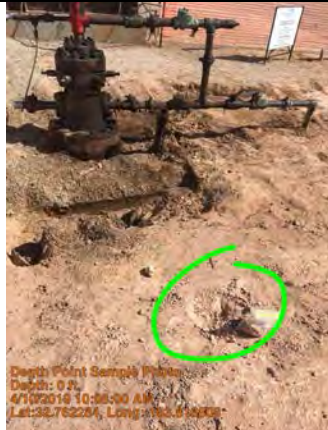
Sample Point ID: SS19-03

Depth: 0ft.

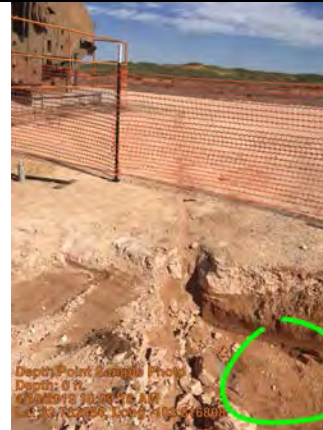
Sample Point ID: SS19-02

Depth: 0ft.
