**RE: Closure Request  
Big Eddy Unit DI2 323H  
Remediation Permit Number 2RP-5295  
Eddy County, New Mexico**

LT Environmental, Inc. (LTE), on behalf of XTO Energy, Inc. (XTO), presents the following report detailing the excavation of impacted soil and soil sampling activities at the Big Eddy Unit DI2 323H (Site) in Unit A, Section 34, Township 19 South, Range 31 East, in Eddy County, New Mexico (Figure 1). The initial Form C-141 misidentified the Site unit letter as B. The purpose of the soil sampling and excavation activities was to address impacts to soil after a produced water release at the Site.

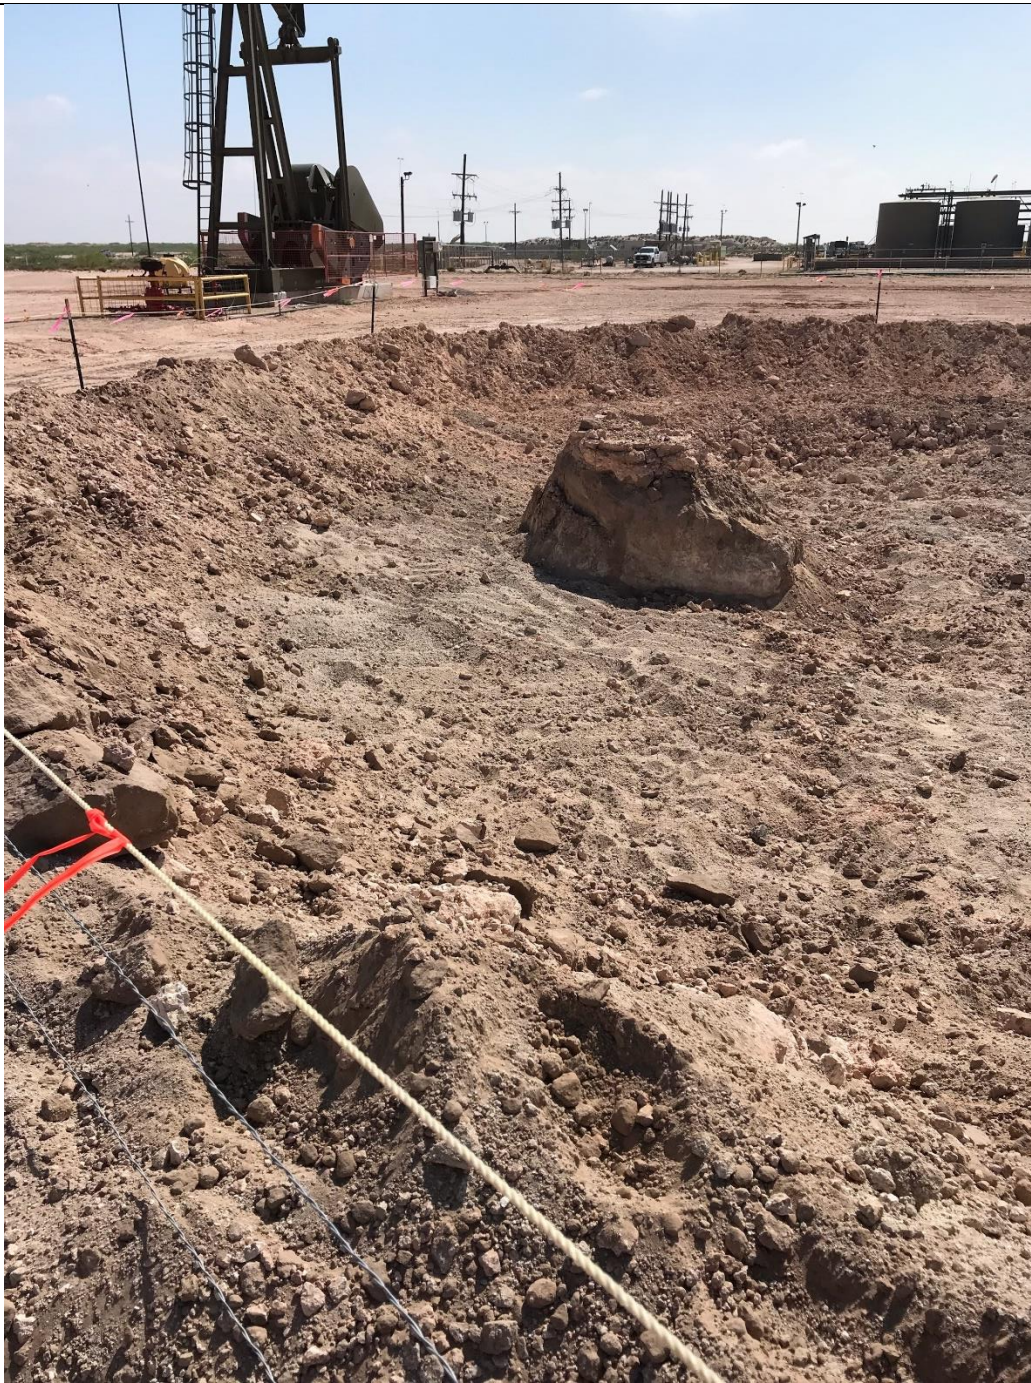
**Northeastern view of final excavation extent.**

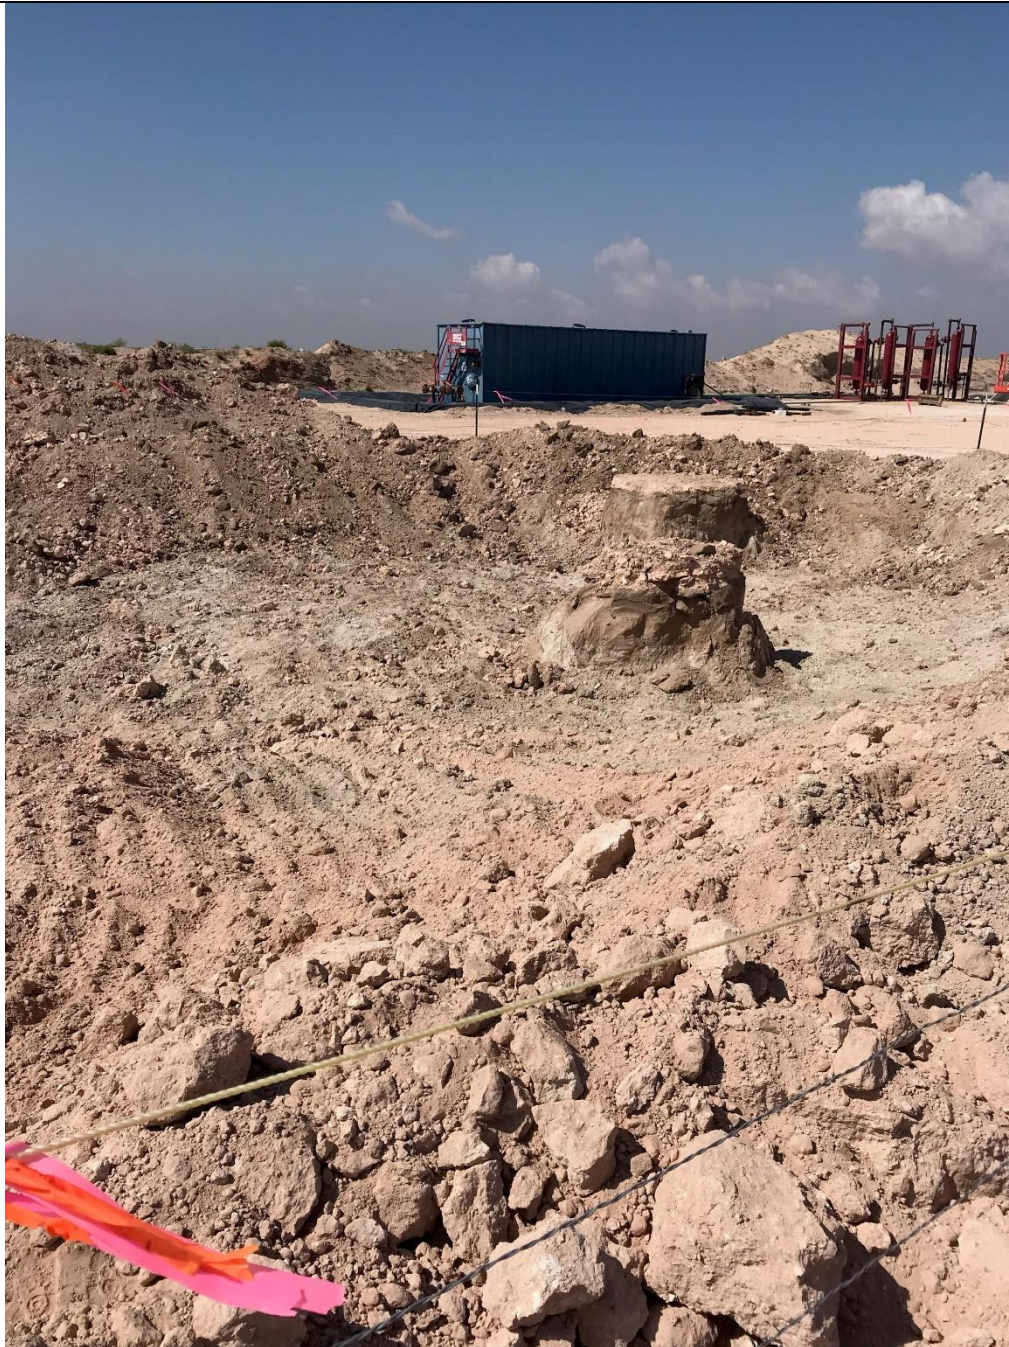
**Northwestern view of final excavation extent.**
