Report Type: Deferment Report 2RP-4954

Site:	Graham Cracker 2 State #1H					
Company:	COG Operating LLC					
Section, Township and Range	Unit P	Unit 02	T 26S	R 28E		
Lease Number:	API No. 30-015-42282					
County:	Eddy County					
GPS:	32.06543			-104.050695		
Surface Owner:	State					
Mineral Owner:						
Directions:	From the intersection of HWY 285 and Longhorn Rd, travel north on HWY 285 and continue for 1.5 mi, turn east on lease road and continue for 1.27 mi to location.

**Re: Deferment Request for the COG Operating, LLC, Graham Cracker 2 State #1H, Unit P, Section 02, Township 26 South, Range 28 East, Eddy County, New Mexico.
2RP-4954**

EXCAVATED AREA & DEPTH MAP

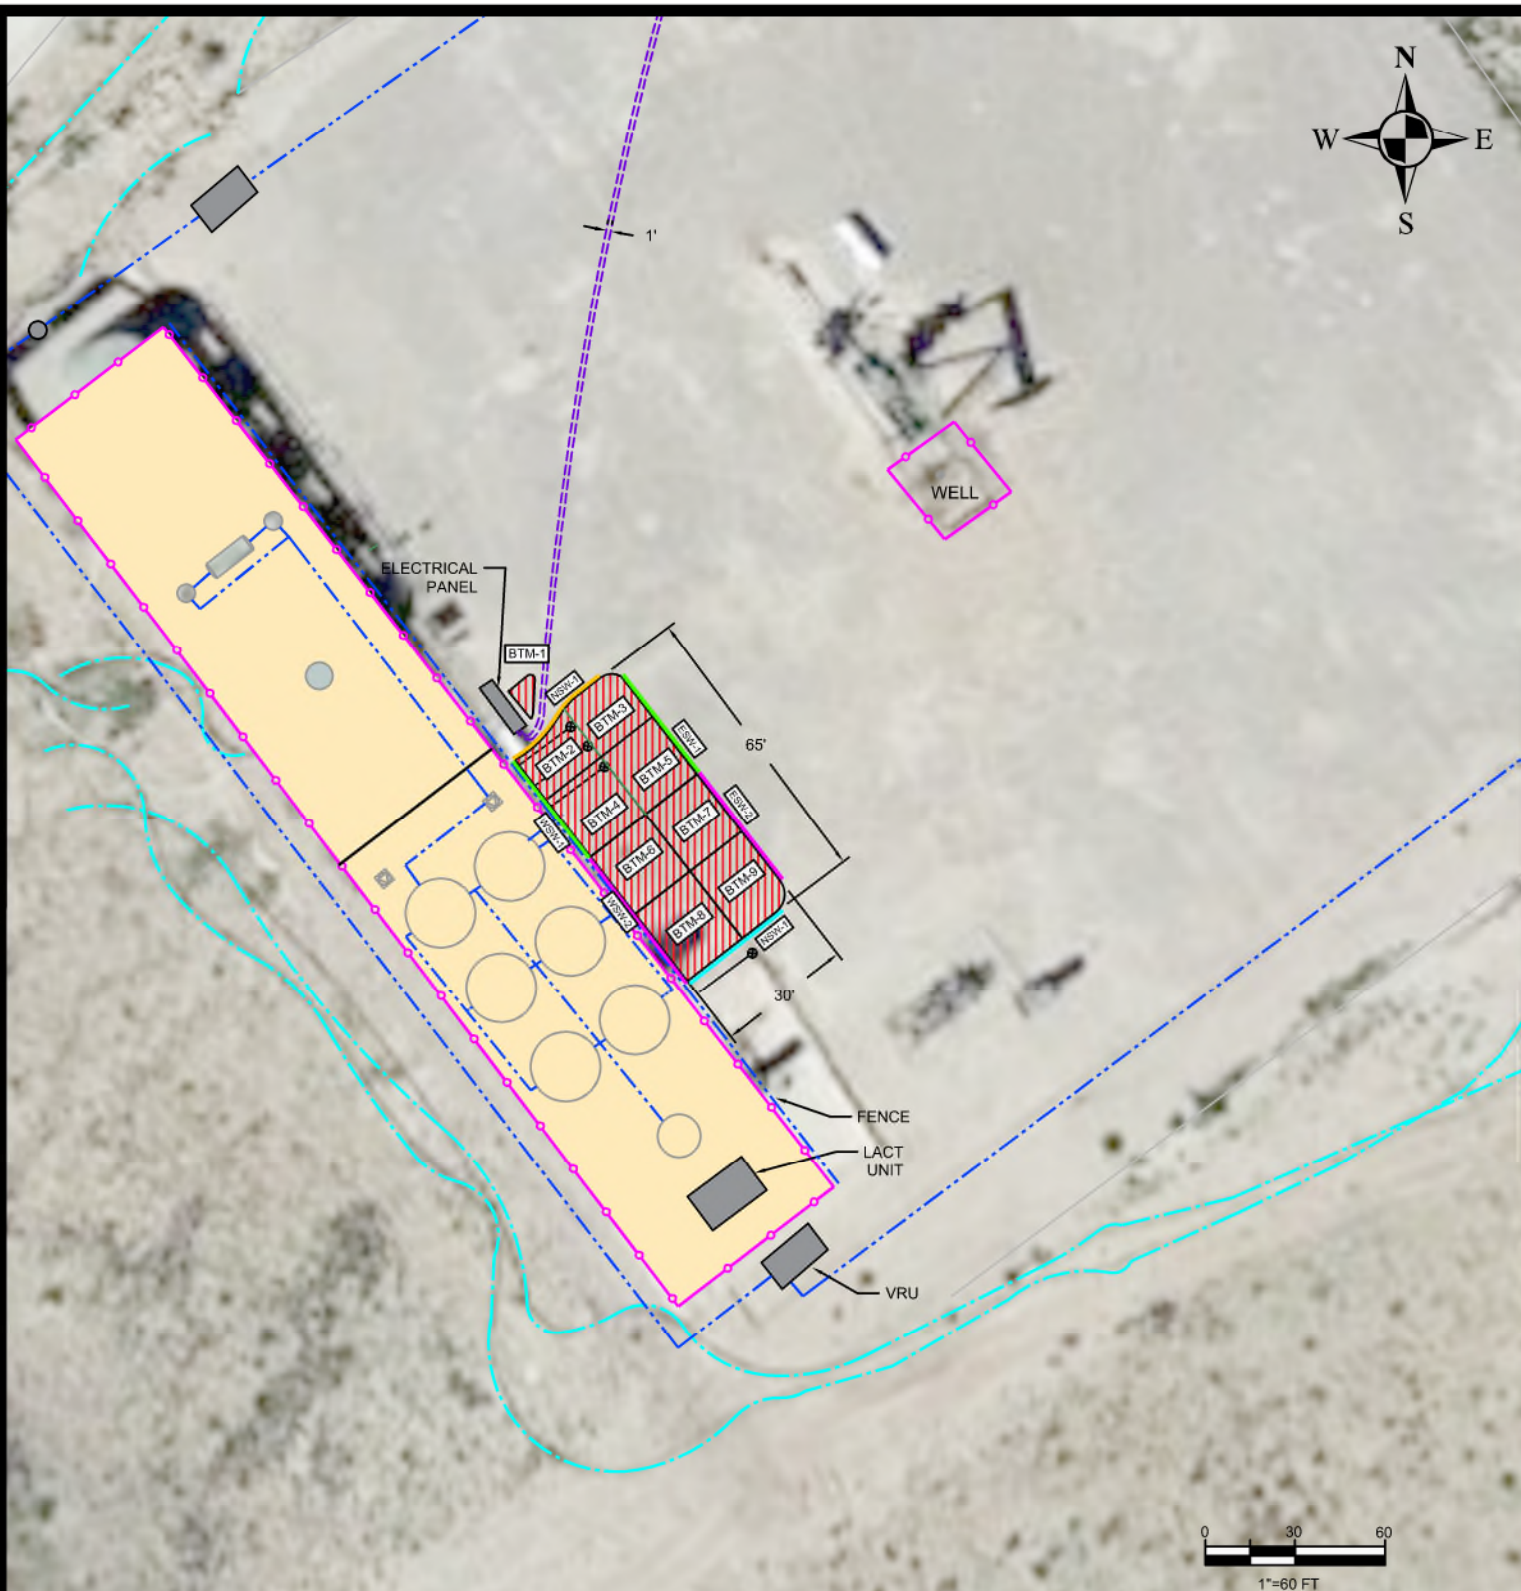
FIGURE 4

Between May 14 and May 17, 2019, Tetra Tech personnel were onsite to supervise the remediation activities. The areas of trenches (T-1 and T-2) were excavated to approximately 4.0' below surface. Once the areas were excavated to the appropriate depths, confirmation bottom hole and sidewall samples were collected every 200 square feet to ensure proper removal of the impacted soils. A total of eleven (11) bottom hole confirmation samples (Bottomhole-1 through Bottomhole-11) and a total of six (6) sidewall samples (WSW-1, WSW-2, ESW-1, ESW-2, SWS-1, and NSW-1) were collected. Selected soil samples were collected and submitted to the laboratory for TPH analysis by EPA method 8015 modified, BTEX by EPA Method 8021B, and chloride by EPA method 300.0.

The excavation area was then lined with a 20-mil plastic liner to prevent vertical migration of the deeper chloride concentrations detected. The area of sidewall sample (WSW-1) could not be expanded due to the location of the existing facility and onsite equipment.

- BTM BOTTOM HOLE SAMPLE LOCATIONS
- 4.0' EXCAVATED AREA w/20 MIL LINER
- EQUIPMENT
- ABOVE GROUND POLYPIPE
- STEEL PIPE
- BURIED PIPE
- SIDEWALL DESIGNATIONS

Once the excavation was completed, the areas were backfilled with clean material to surface grade. Approximately 560 cubic yards were excavated and hauled for proper disposal.

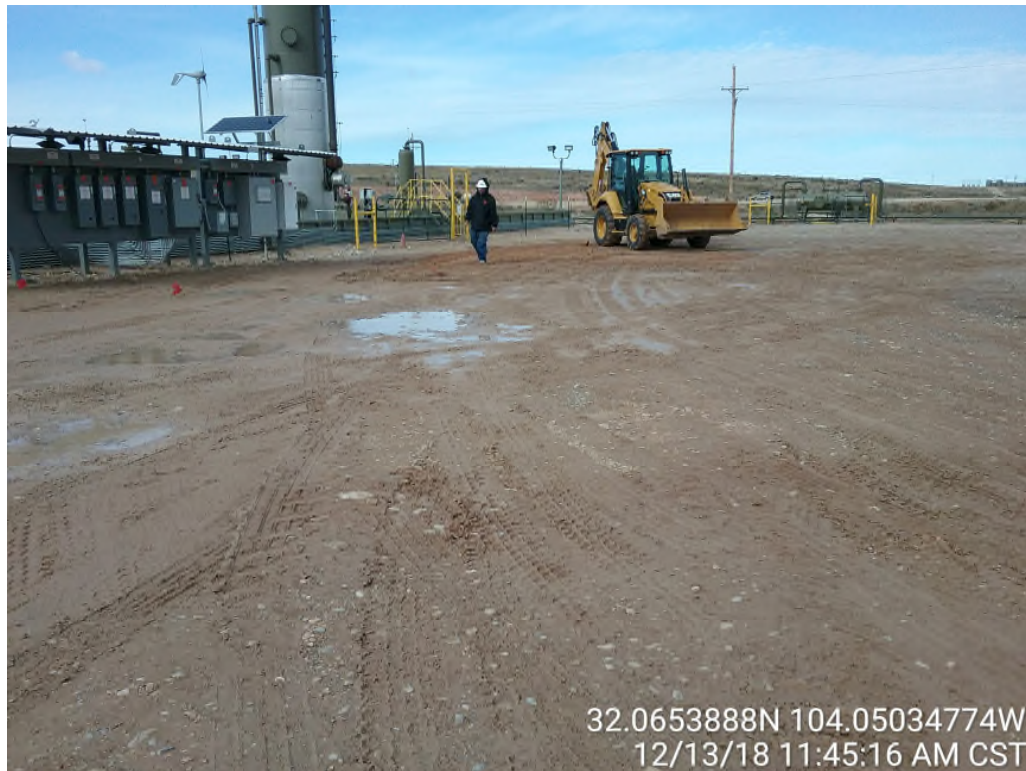
View Northwest – Area of T-1

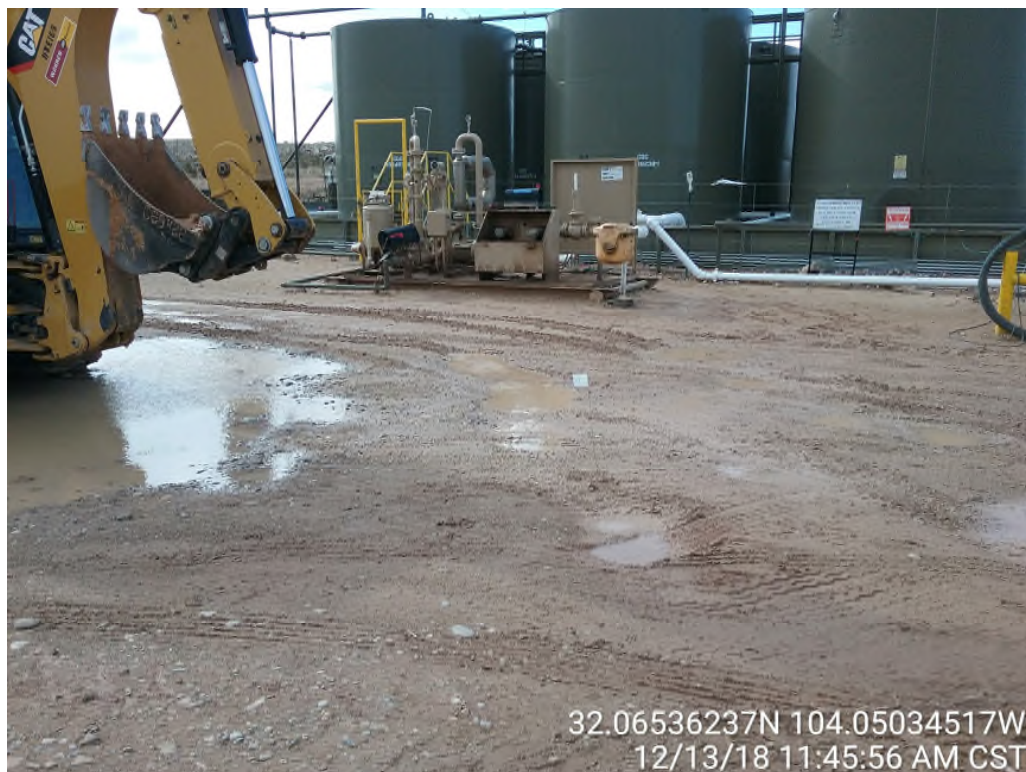
View West – Area of T-2

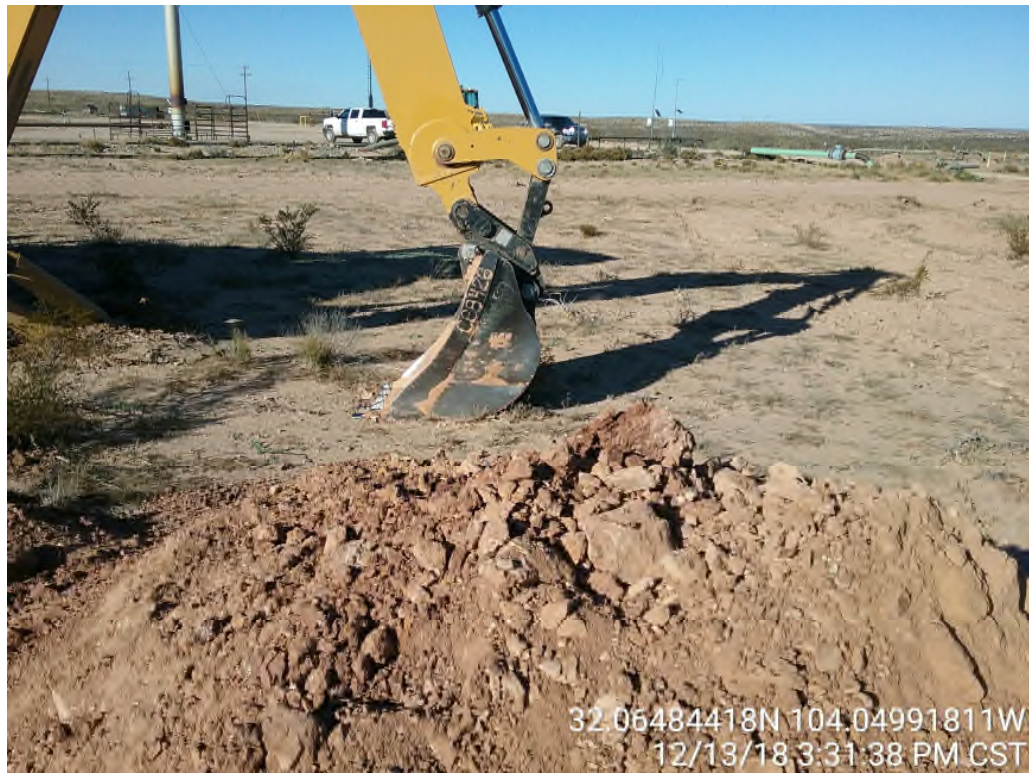
View Northeast – Area of Background 1

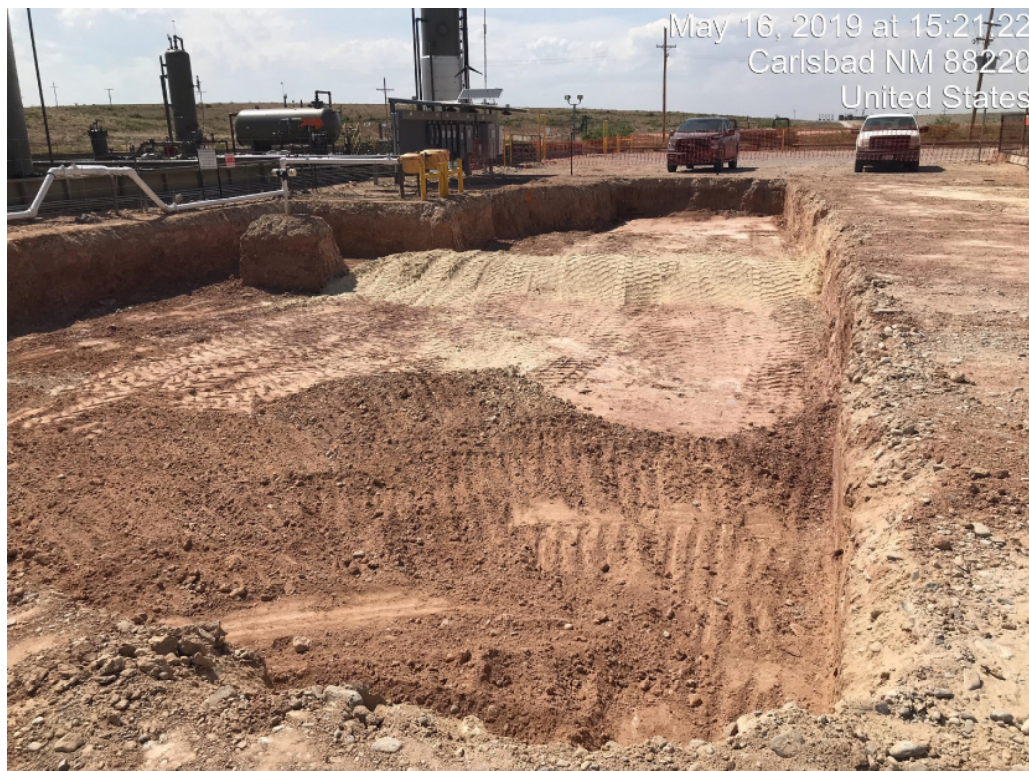
View North – Excavated Area

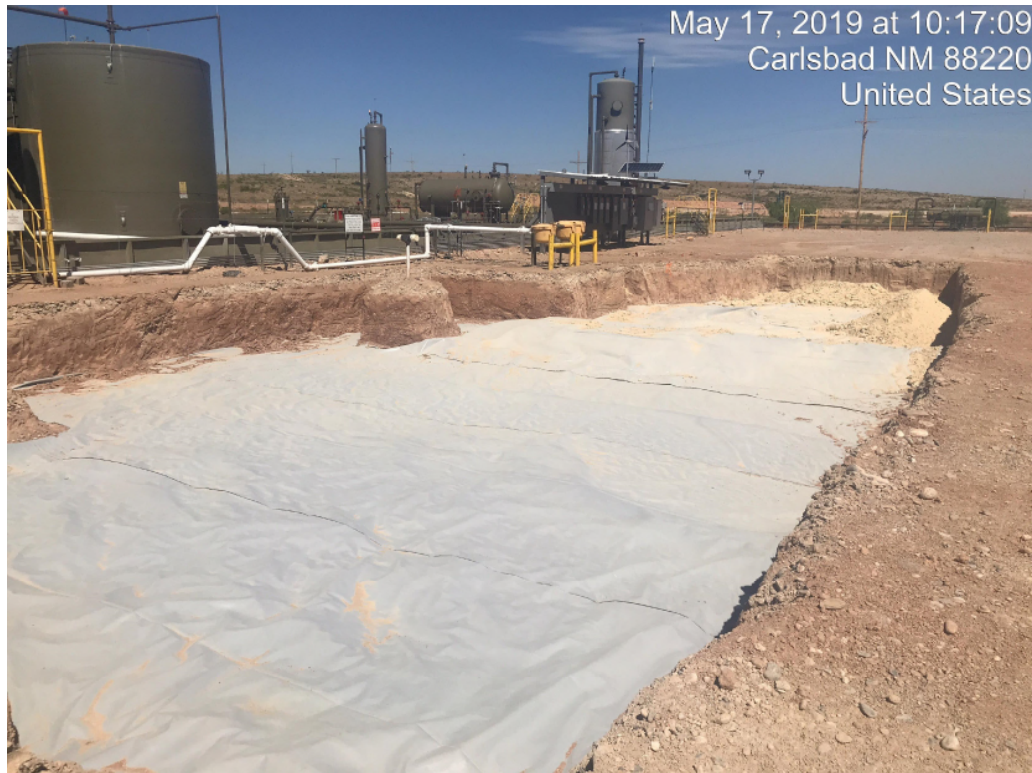
View North – Lined Excavation Area

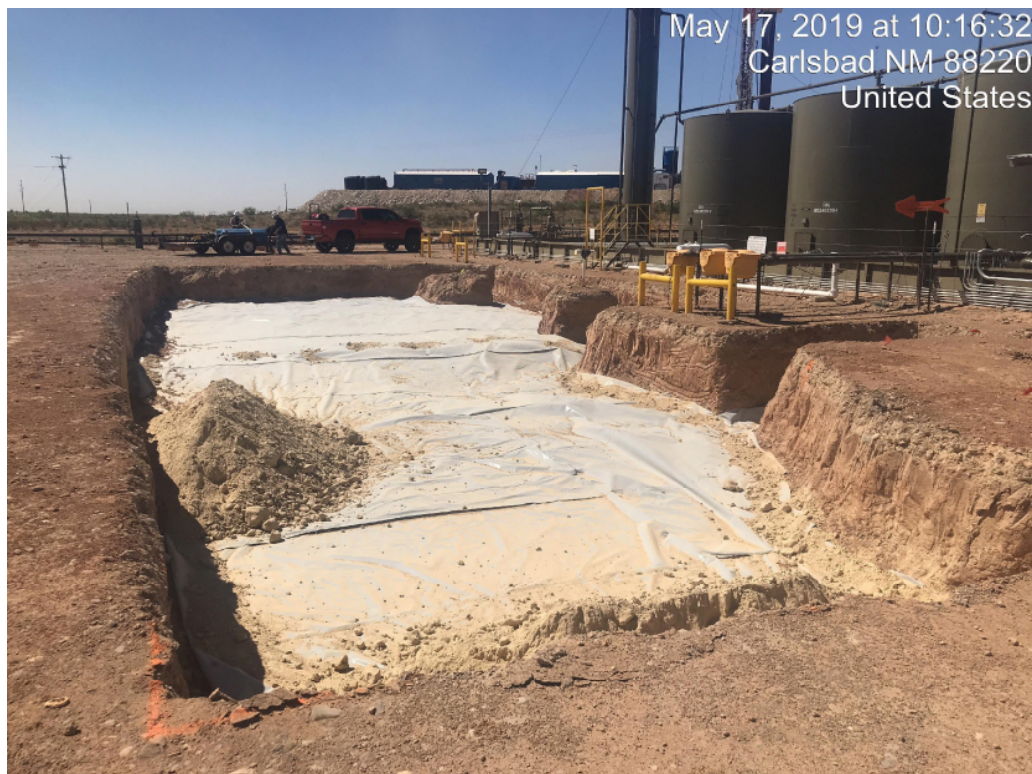
View South – Lined Excavation Area
