DELINEATION WORKPLAN

OXY – RIVERBEND FEDERAL B-11 CTB (Leak Date: 10/30/18)

RP # 2RP-5057

Oxy, Riverbend Federal B-11 CTB

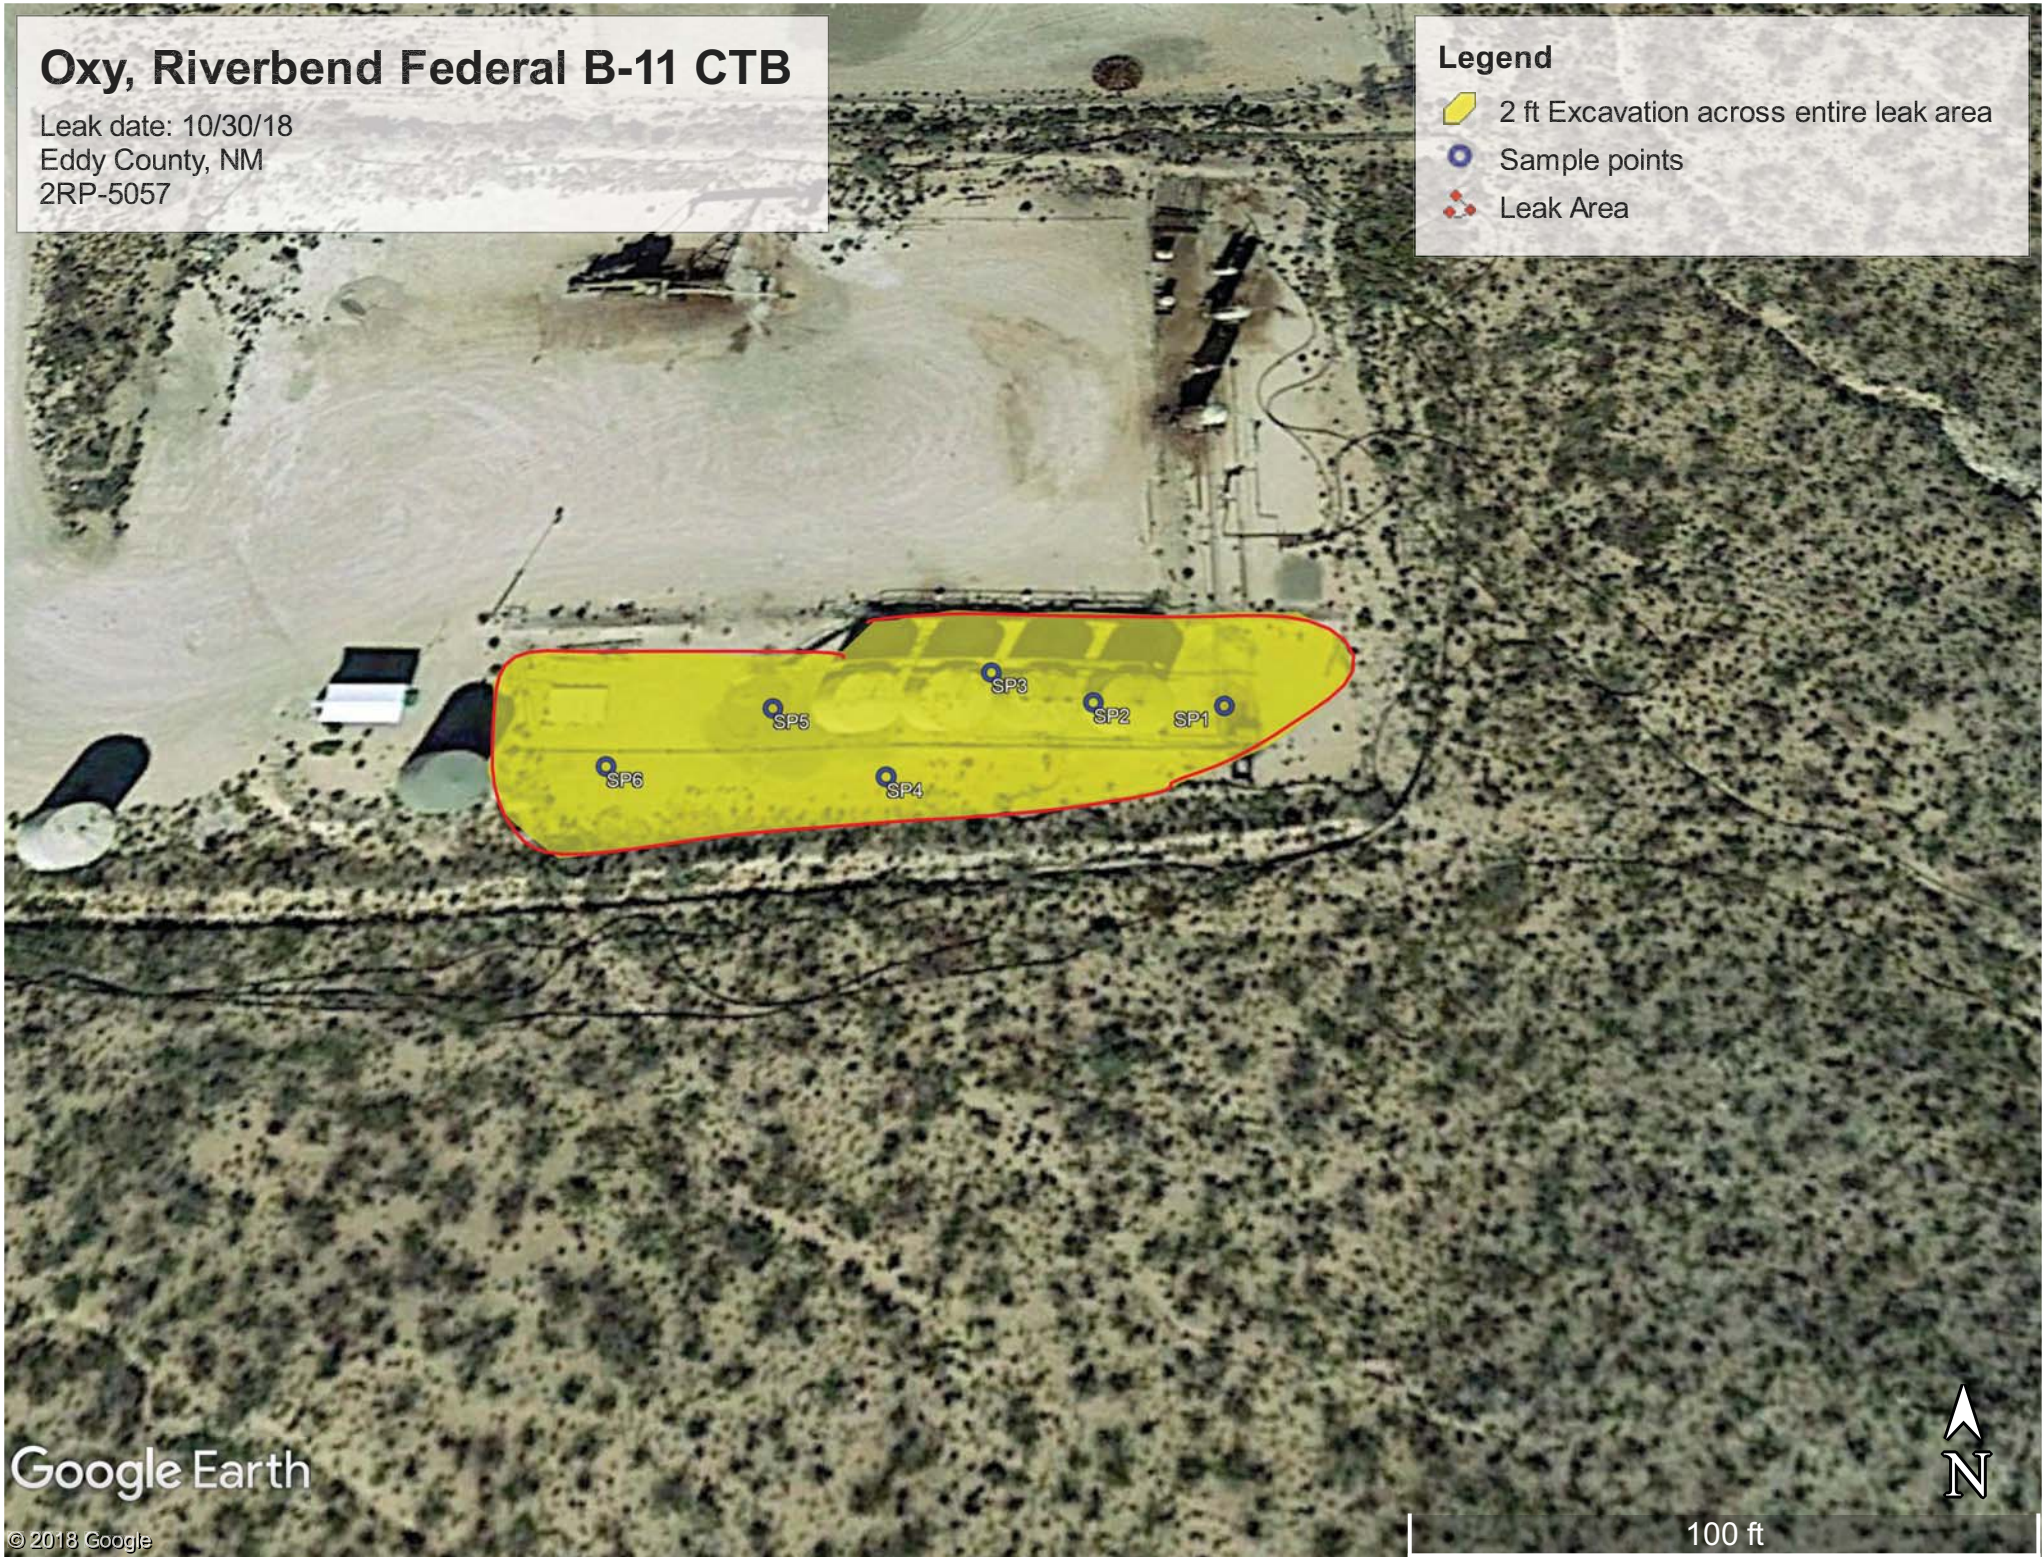
OXY will excavate the spill area as depicted on the following site diagram. The entire leak area (YELLOW shade on diagram) will be excavated to a depth of 2 feet.

2 ft Excavation across entire leak area
-

Sample points
-

Leak Area

Bottom confirmation samples will be collected at no greater than 50 ft. intervals. Estimated volume of material to be removed is 609 cubic yards. The remediation will be completed within 90 days of plan approval.

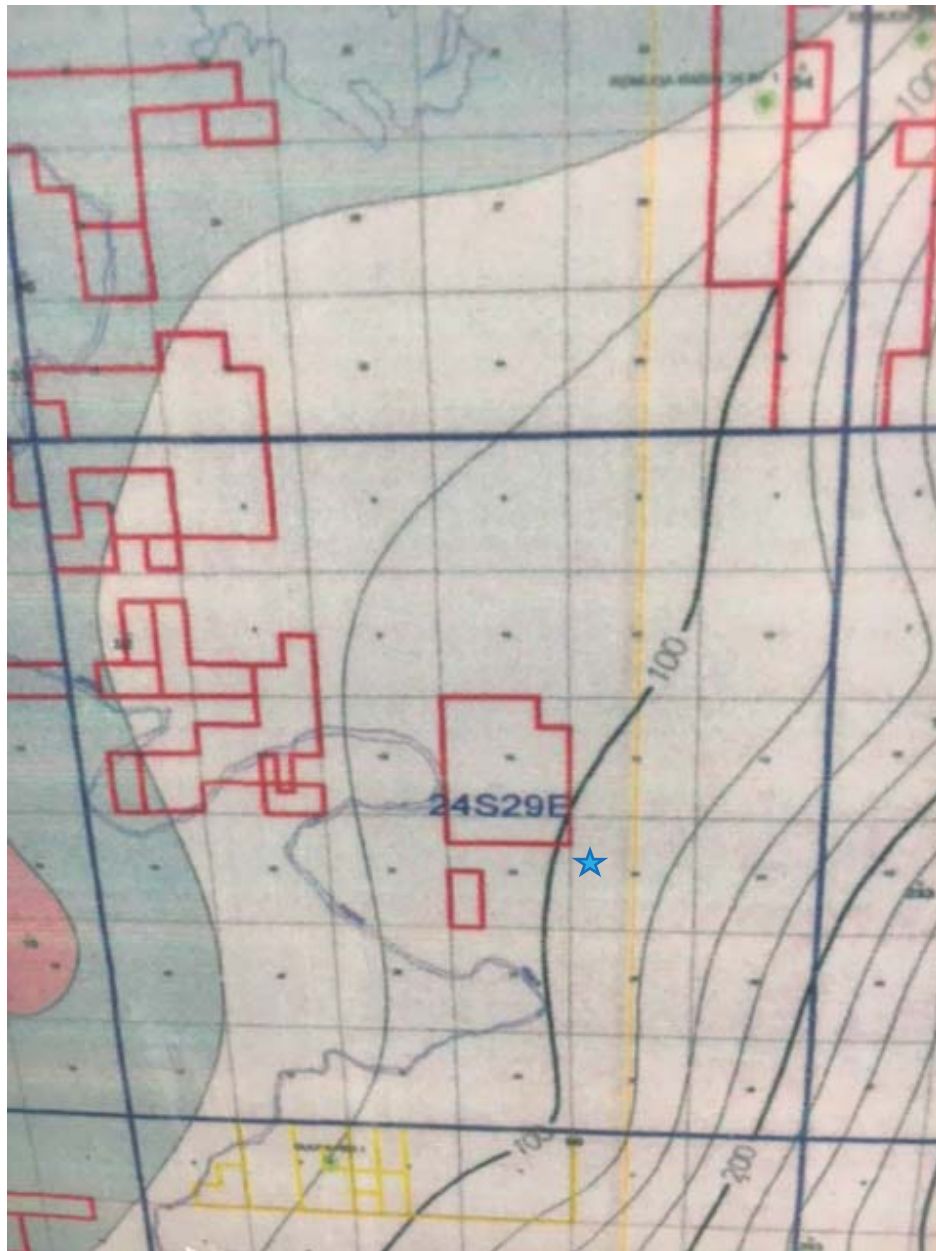
Oxy, Riverbend Federal B-11 CTB

U/L E, Section 23, T24S, R29E

Groundwater: 100'-125'
