Release Notification

Site Name Big Sinks 2-24-30 Battery	Site Type Bulk Storage and Separation Facility
Date Release Discovered 5/15/2019	API# (if applicable) 30-015-39246

Project: 012919119	XTO Energy, Inc. Big Sinks 2-24-30 Battery

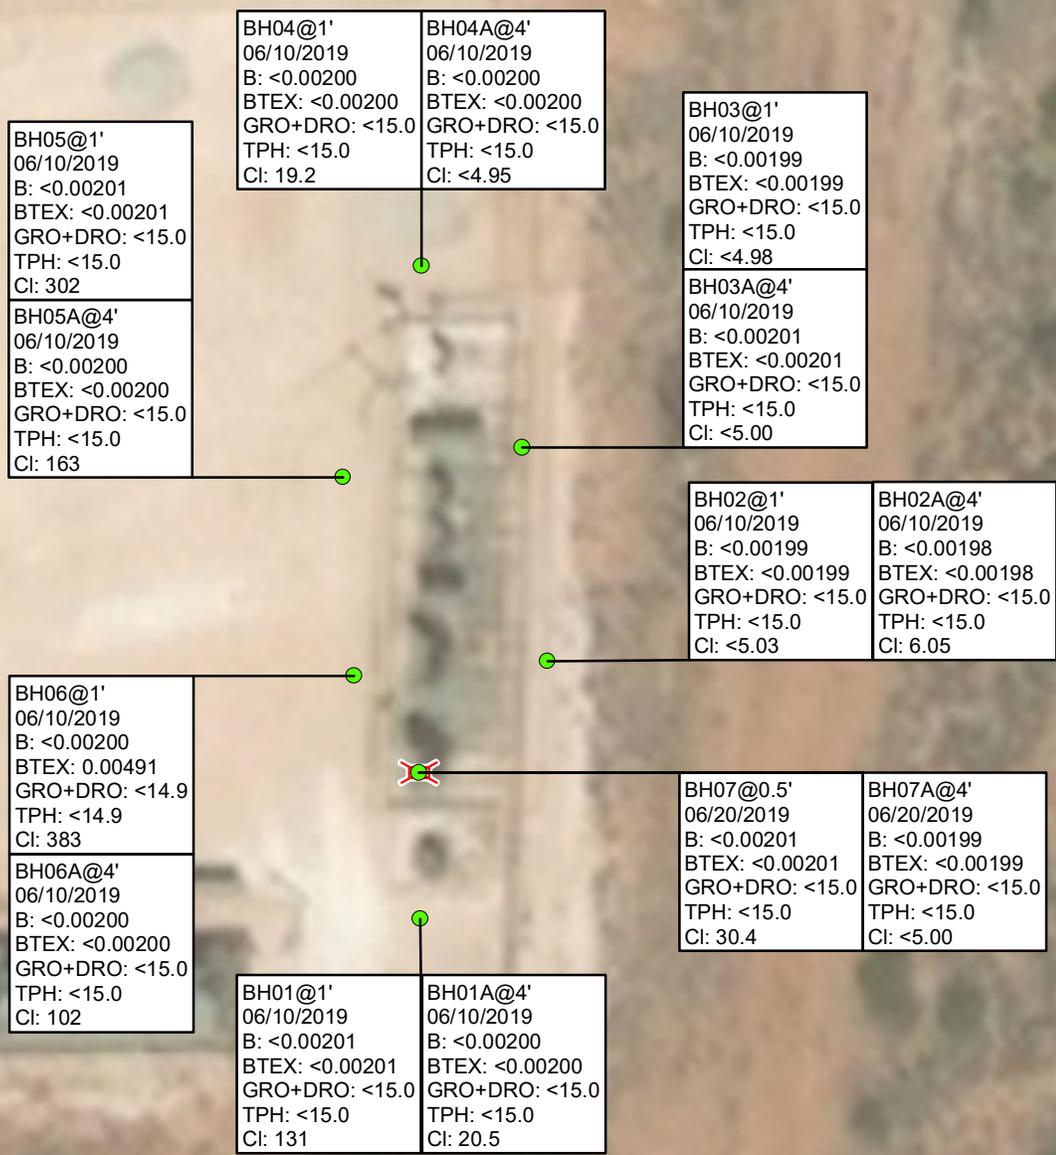
Soil samples from boreholes BH01 through BH07 were collected in and around the lined tank battery containment from intervals ranging from 0.5 feet to 4 feet bgs to assess the presence or absence of soil impacts as a result of the May 19, 2019 release and subsequently identified compromised liner. Field screening of soil from boreholes BH01 through BH07 indicated volatile aromatic hydrocarbons and chloride concentrations were not elevated. Soil staining and petroleum hydrocarbon odors were not observed within boreholes BH01 through BH07. Laboratory analytical results for all soil samples indicated benzene, BTEX, TPH, and chloride concentrations were compliant with the NMOCD Table 1 Closure Criteria. Based on the absence of elevated field screening results, no visual or olfactory observations indicative soil impact, and laboratory analytical results, it appears all of the crude oil and produced water released were recovered and the compromised liner did not allow for the release of fluids to the well pad.

- SOIL SAMPLE IN COMPLIANCE WITH APPLICABLE CLOSURE CRITERIA
- ✕ LINER TEAR LOCATION

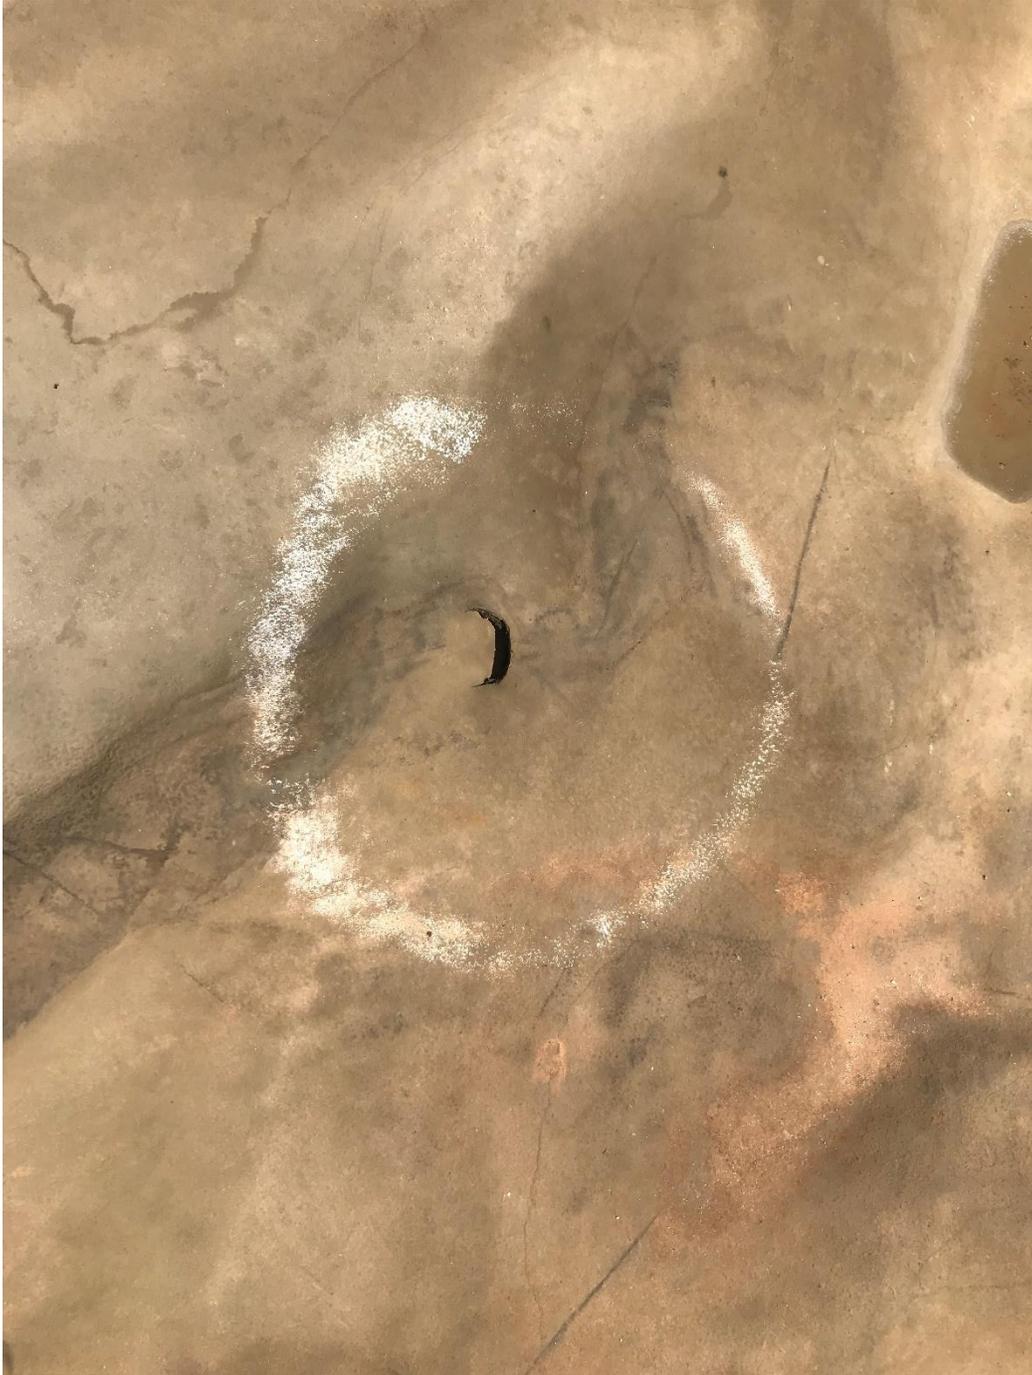
On June 4, 2019, XTO personnel was on site to evaluate the integrity of the containment liner and to assess the presence or absence of soil impacts. A small tear, measuring approximately 1-inch in diameter, was observed in the southwestern portion of the containment liner (Figure 2). No other tears or compromises to liner integrity were observed. Photographic documentation was conducted during this site visit. Photographs of the lined tank battery containment and tear and included in Attachment 2.

Small tear in containment liner found during liner integrity inspection.

Liner is scheduled to be repaired and returned to impervious condition. XTO requests deferral of potential impacts under liner until facility upgrades or abandonment of facility. It is XTO safety policy to restrict ground and subsurface disturbance activities to within 3 feet of equipment. The containment is congested by lines and process vessels, making it impossible to access for vertical delineation via heavy equipment or drill rig.

As a result of soil screening and sampling activities at the Big Sinks 2-24-30 Battery, XTO requests no further action for RP Number 2RP-5487 following repair to the small tear in the liner. An updated Form C-141 is included as Attachment 1.

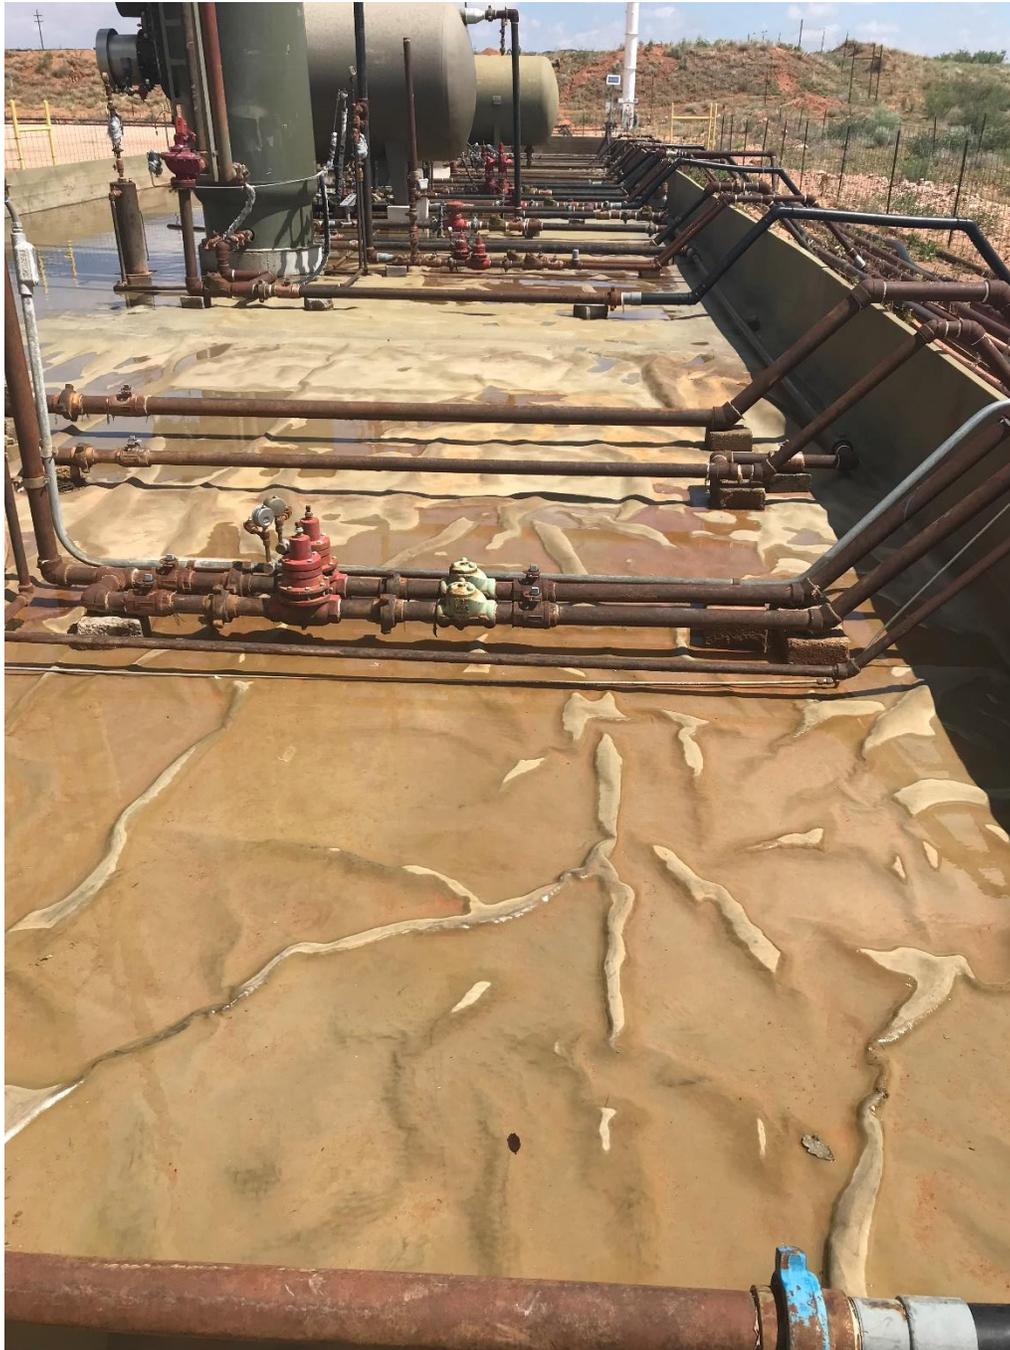
Western view of release area during delineation activities.
