Release Notification

Site Name Remuda North 30 State 111H	Site Type Production Well Facility
Date Release Discovered 2/11/2019	API# (if applicable) 30-015-44400

Initial response efforts and excavation of impacted soil have mitigated impacts at this Site. XTO requests no further action for release numbers 2RP-5273, 2RP-5312, and 2RP-5311. Upon approval of this closure request, XTO will backfill the excavation with material purchased locally and recontour the Site to match pre-existing site conditions. An updated Form C-141 for each release is included as Attachment 1.

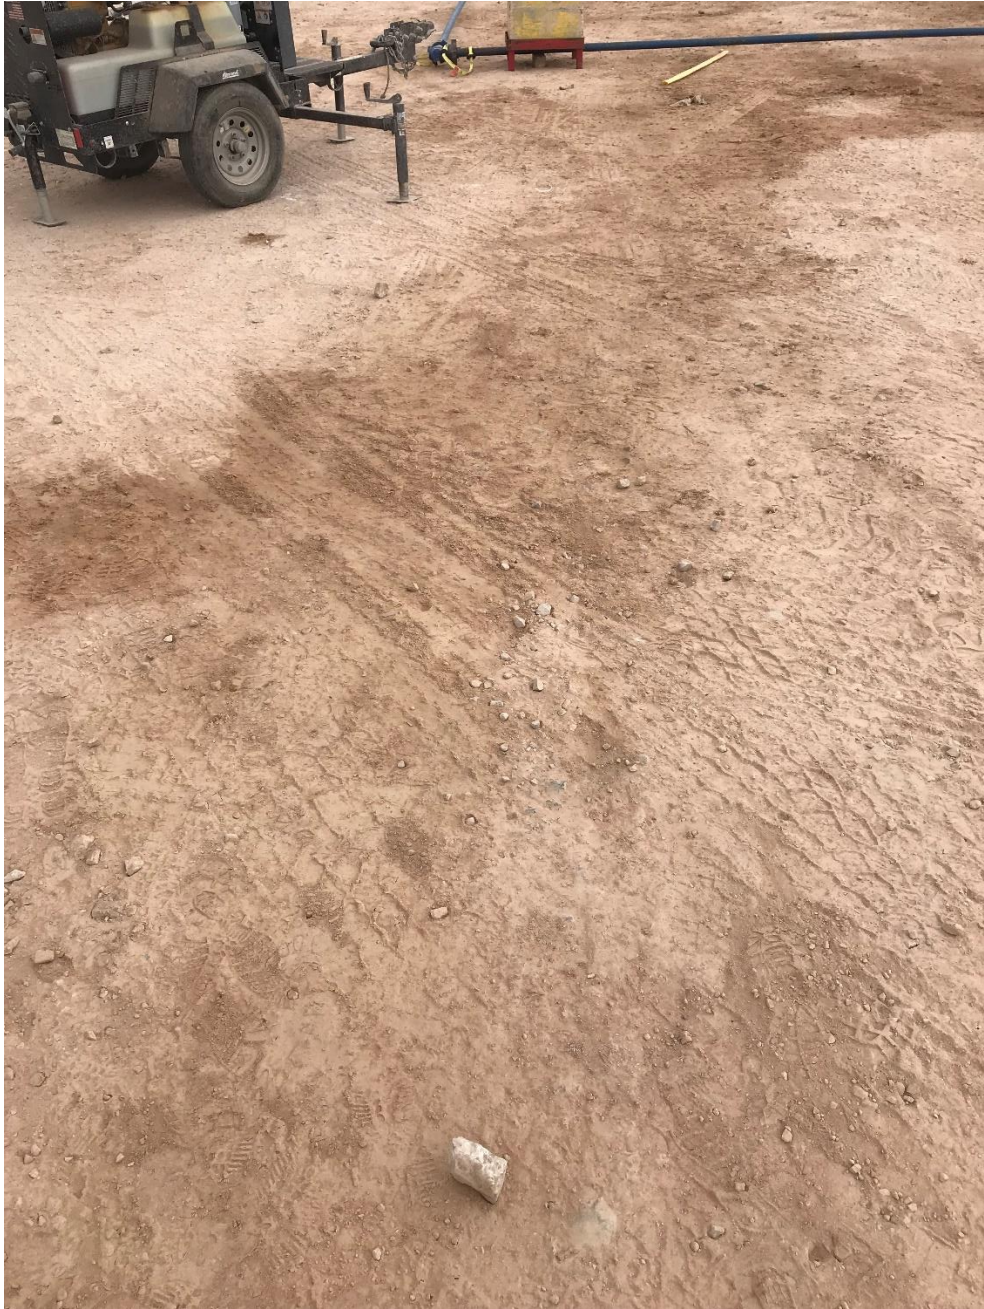
Western view of release extent during preliminary soil sampling and site assessment.

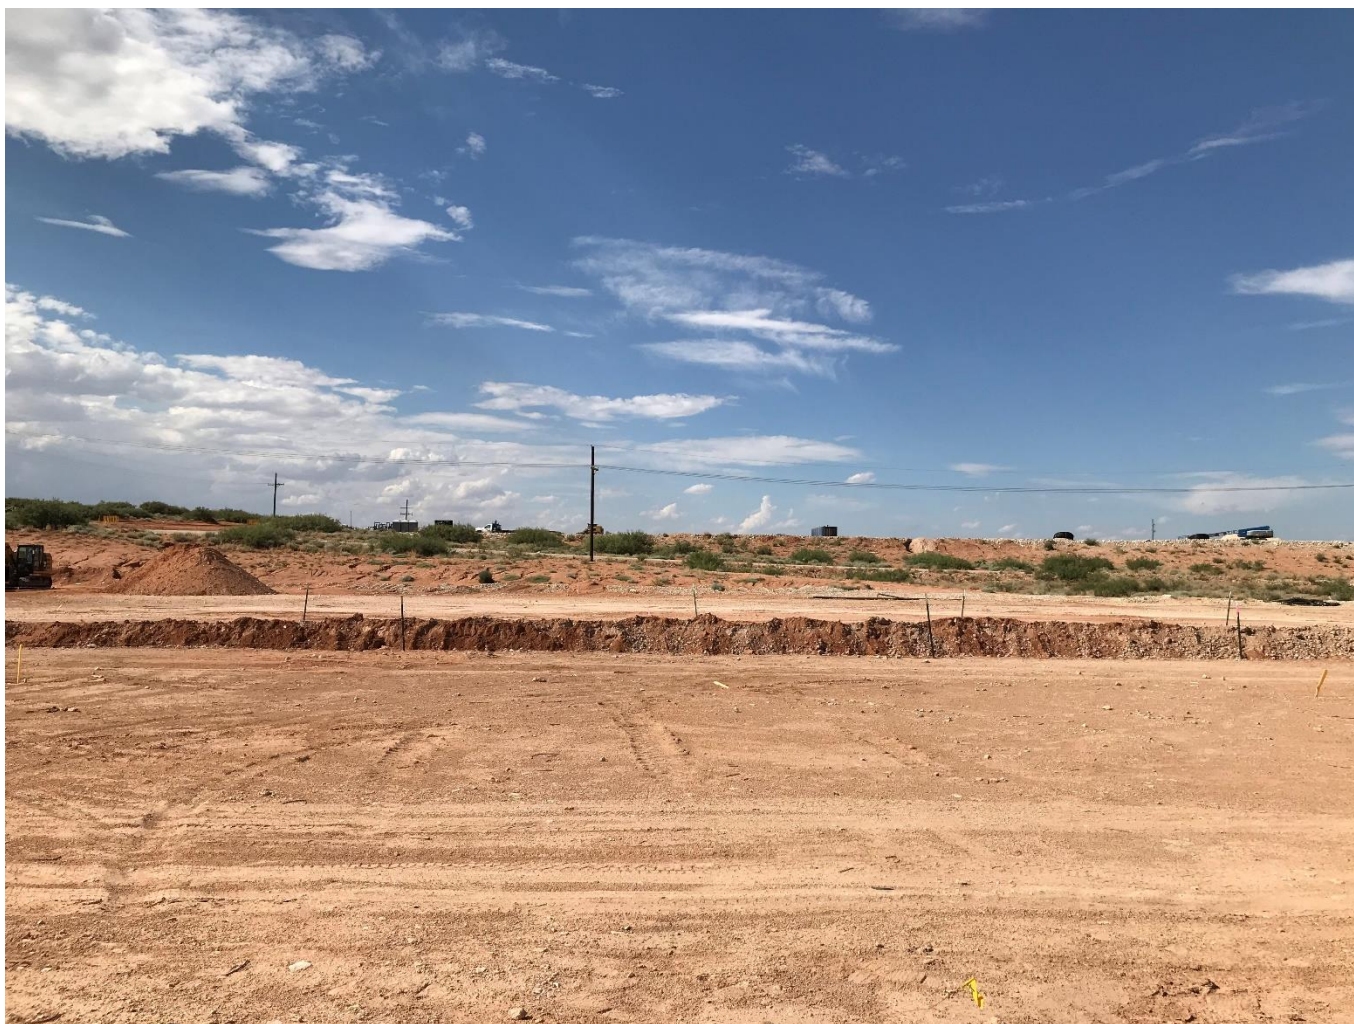
Northern view of final excavation extent.
