Report Type: Closure Report 1RP-5297

Site:	Corazon State Unit Section 4 Tank Battery					
Company:	COG Operating LLC					
Section, Township and Range	Unit C	Sec. 04	T 21S	R 33E		
Lease Number:	API No.					
County:	Lea County					
GPS:	32.519712			-103.580101		
Surface Owner:	State					
Mineral Owner:						
Directions:	From the Intersection of HWY 176 and County Rd 27-A go West 3.37 miles and turn South and go .20 miles and location is on East side

Re: Closure Request for the COG Operating, LLC, Corazon State Unit Section 4 Tank Battery, Unit C, Section 34, Township 21 South, Range 33 East, Lea County, New Mexico. 1RP-5297

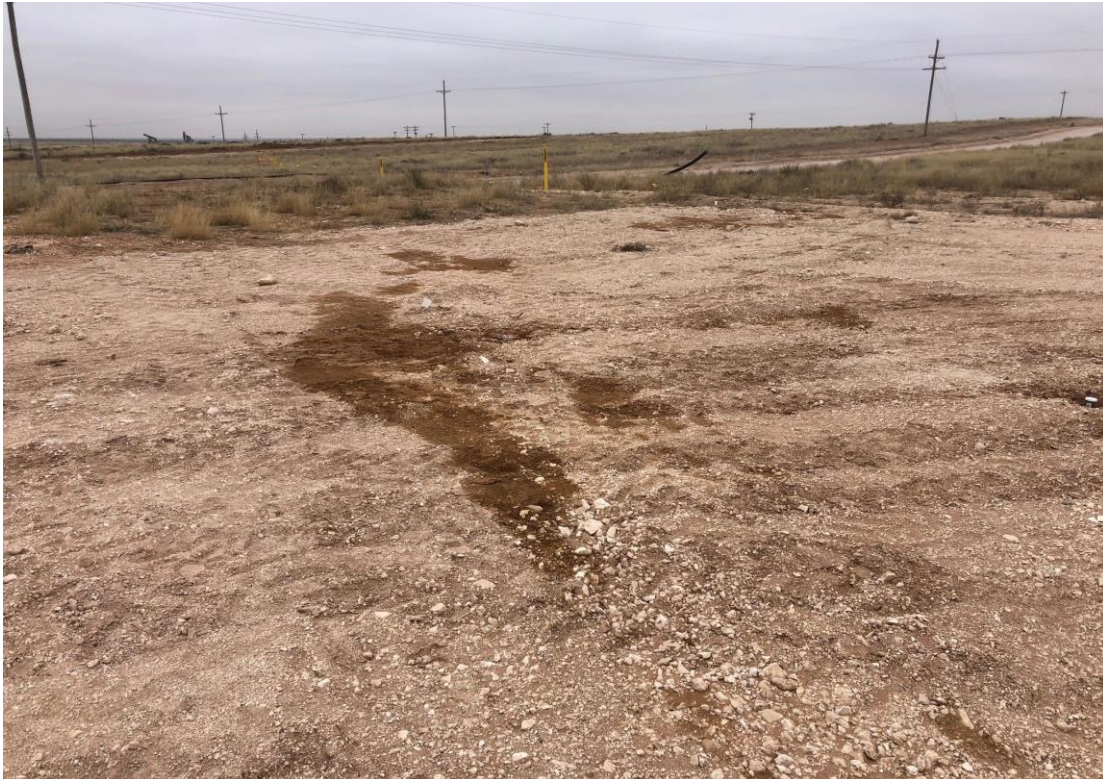
View Northwest – Area of AH-1 and AH-2

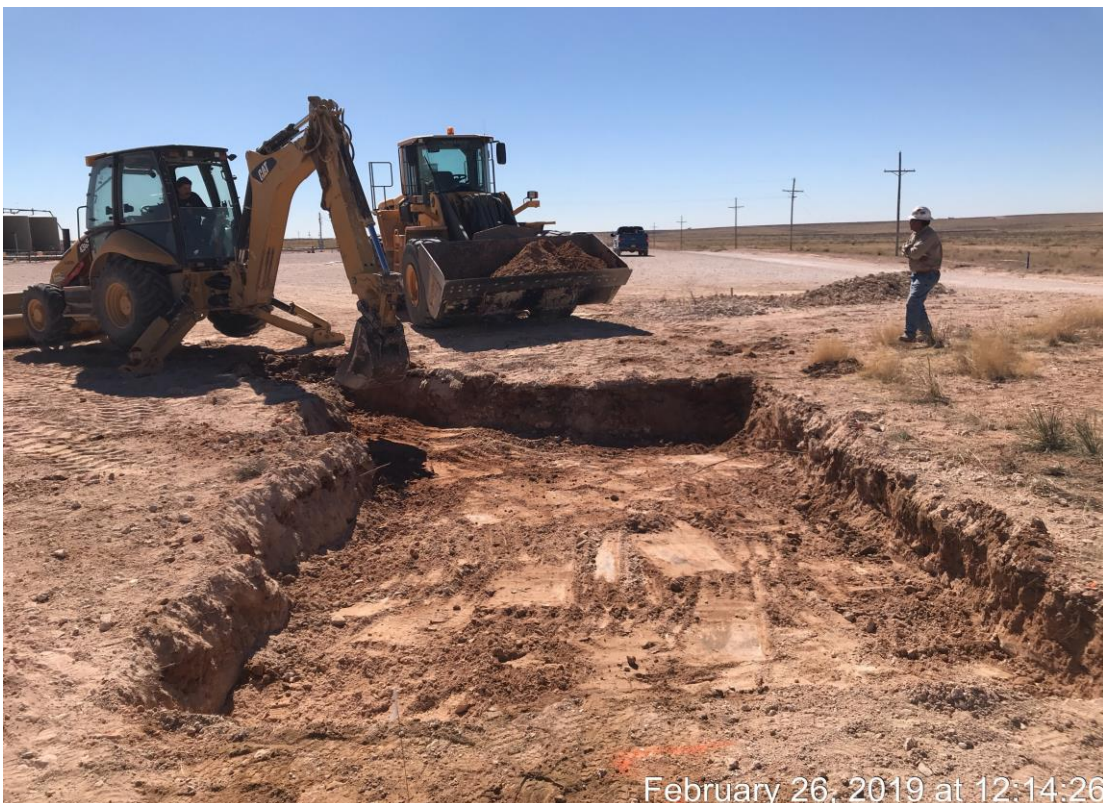
View North – Excavated Area of Bottom Hole 3 and Bottom Hole 4

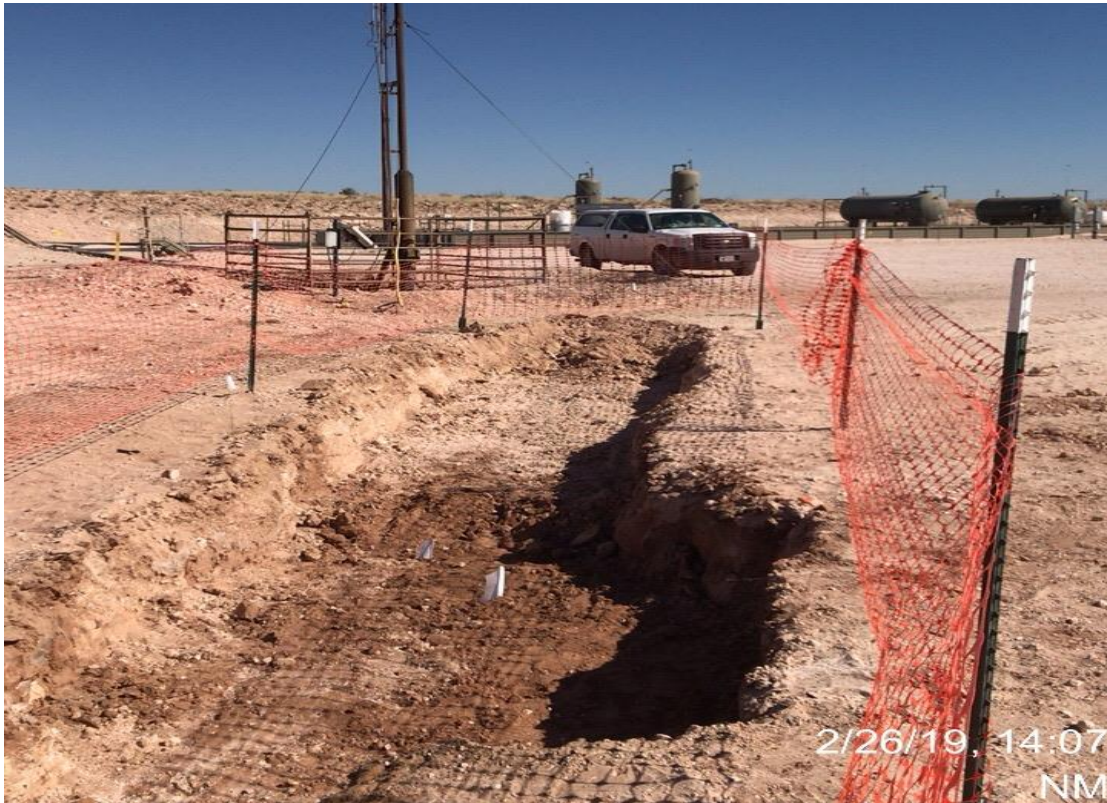
View East – Excavated Area of Bottom Hole 1 and Bottom Hole 2

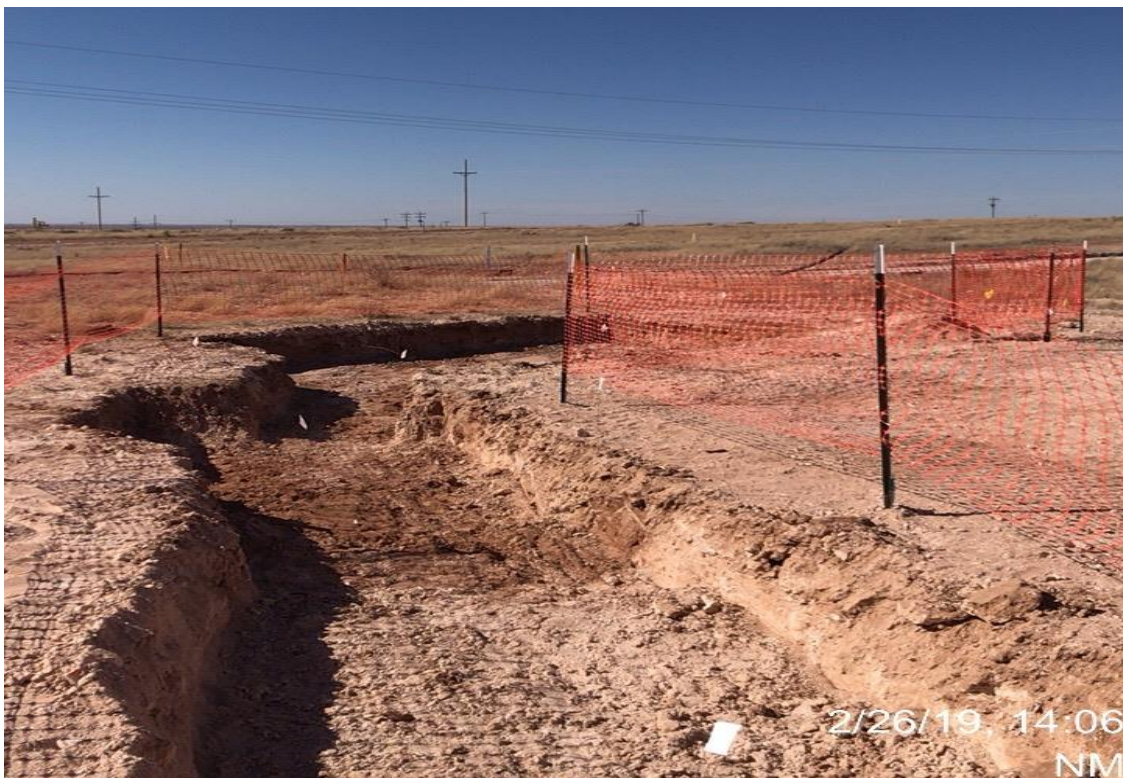
View West– Excavated Area of Bottom Hole 1 and Bottom Hole 2
