## **Closure Report**

Lonesome Dove 25 Federal #001  
API# 30-015-31698, 2RP-5541  
Talon Project # 702513.001.01

Subject: **Soil Remediation and Closure Report**  
Lonesome Dove 25 Federal #001  
Eddy County, NM  
API# 30-015-31698, 2RP-5541

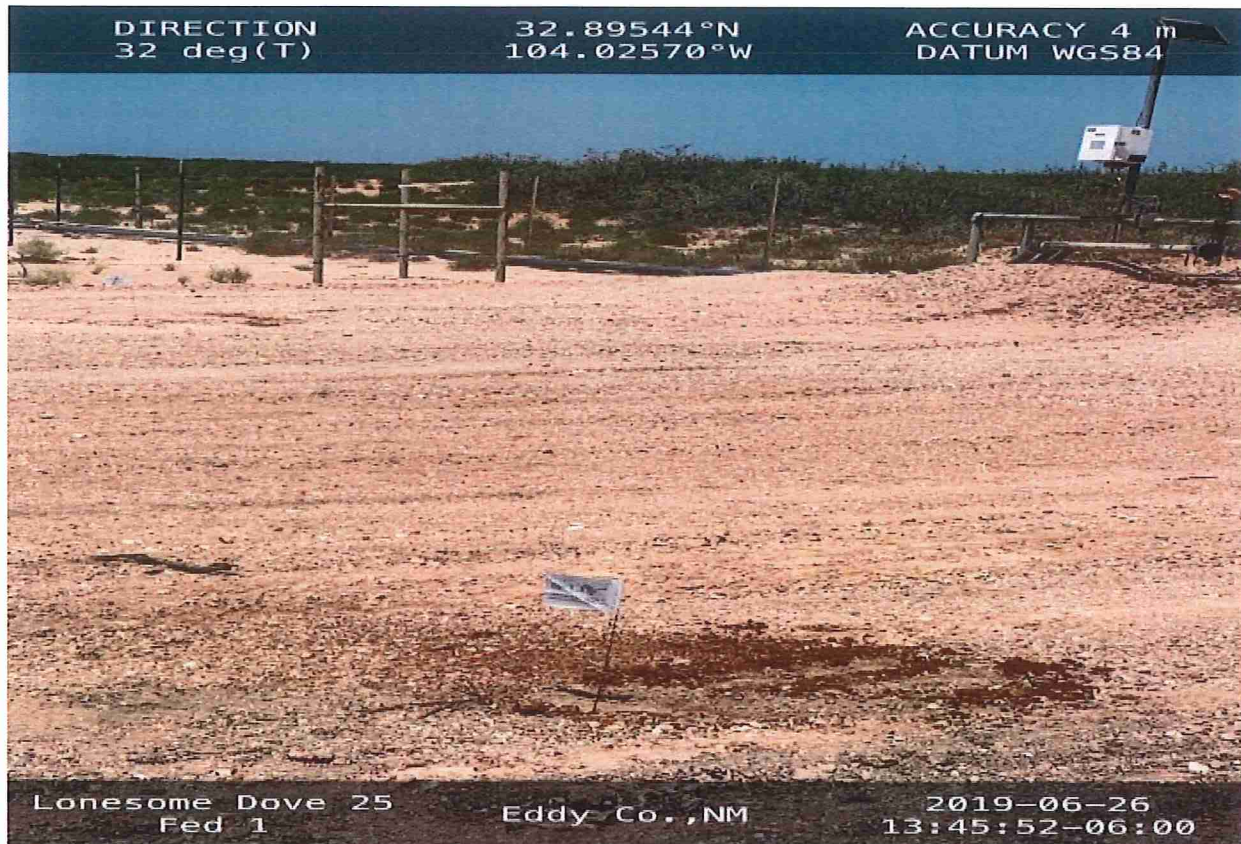
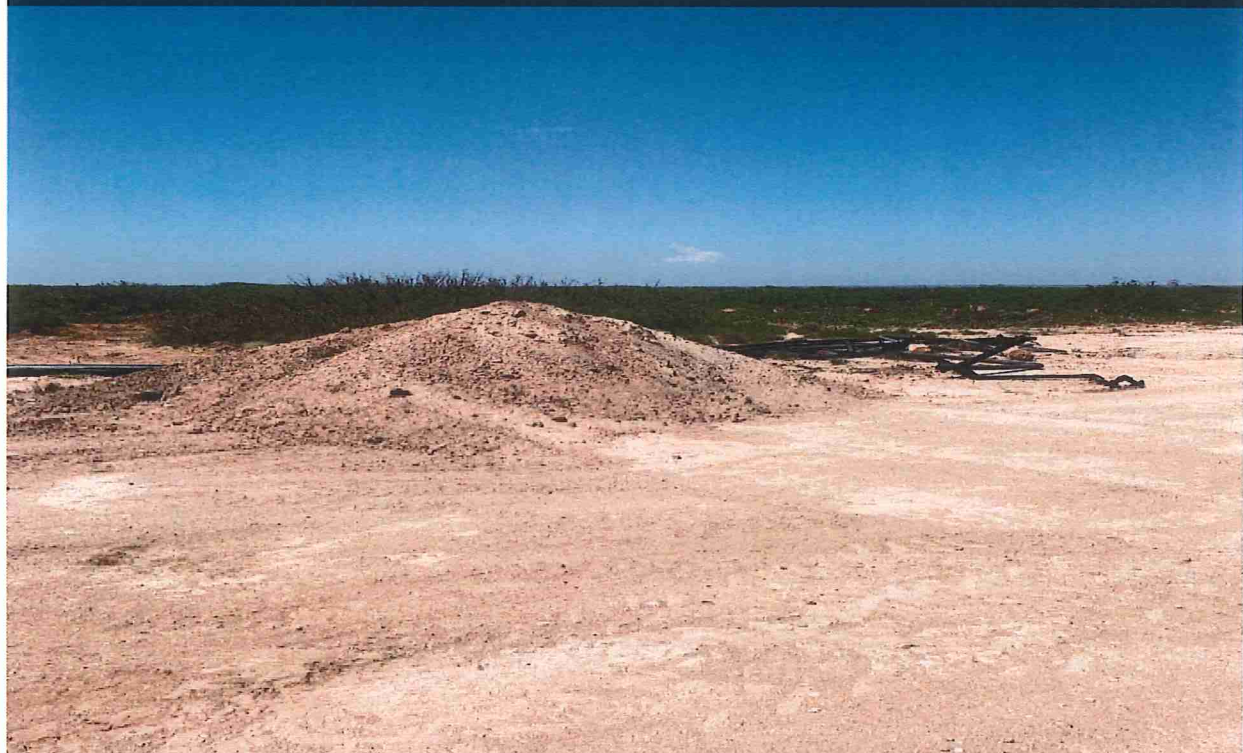
Initial Photos, battery cleared and soil stockpiled

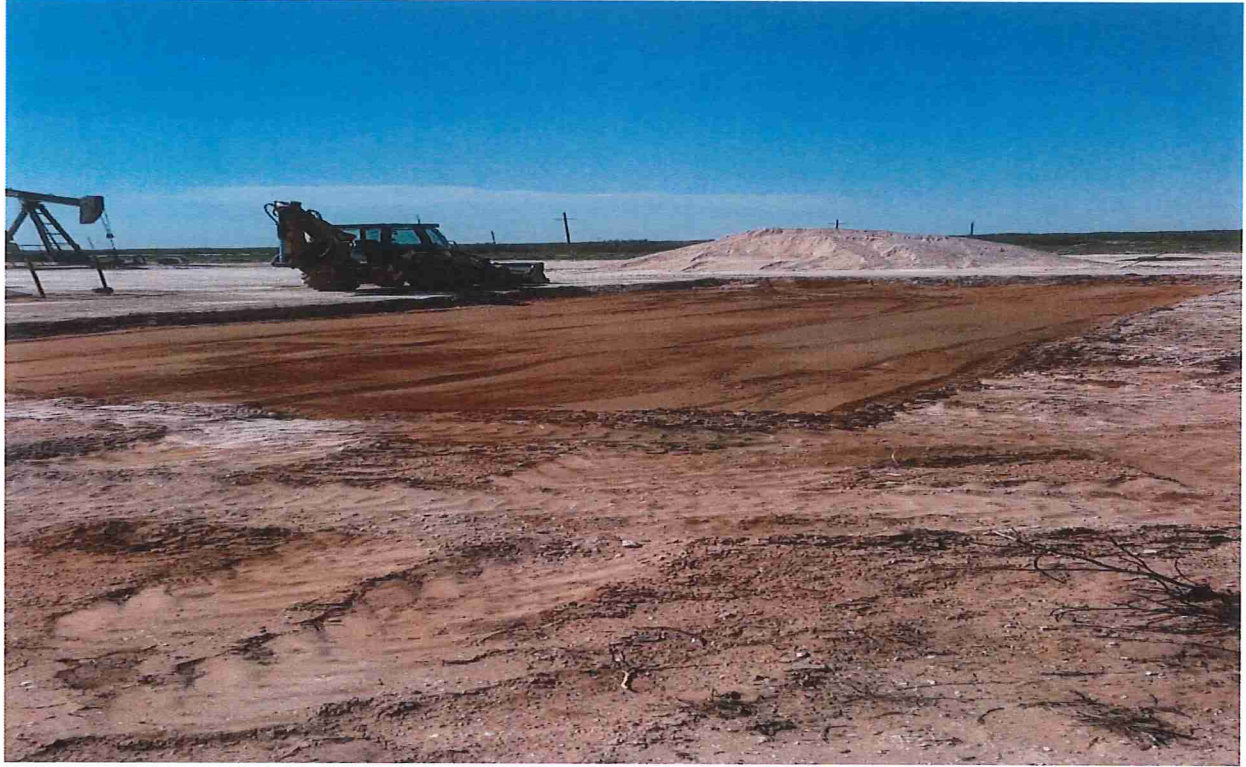
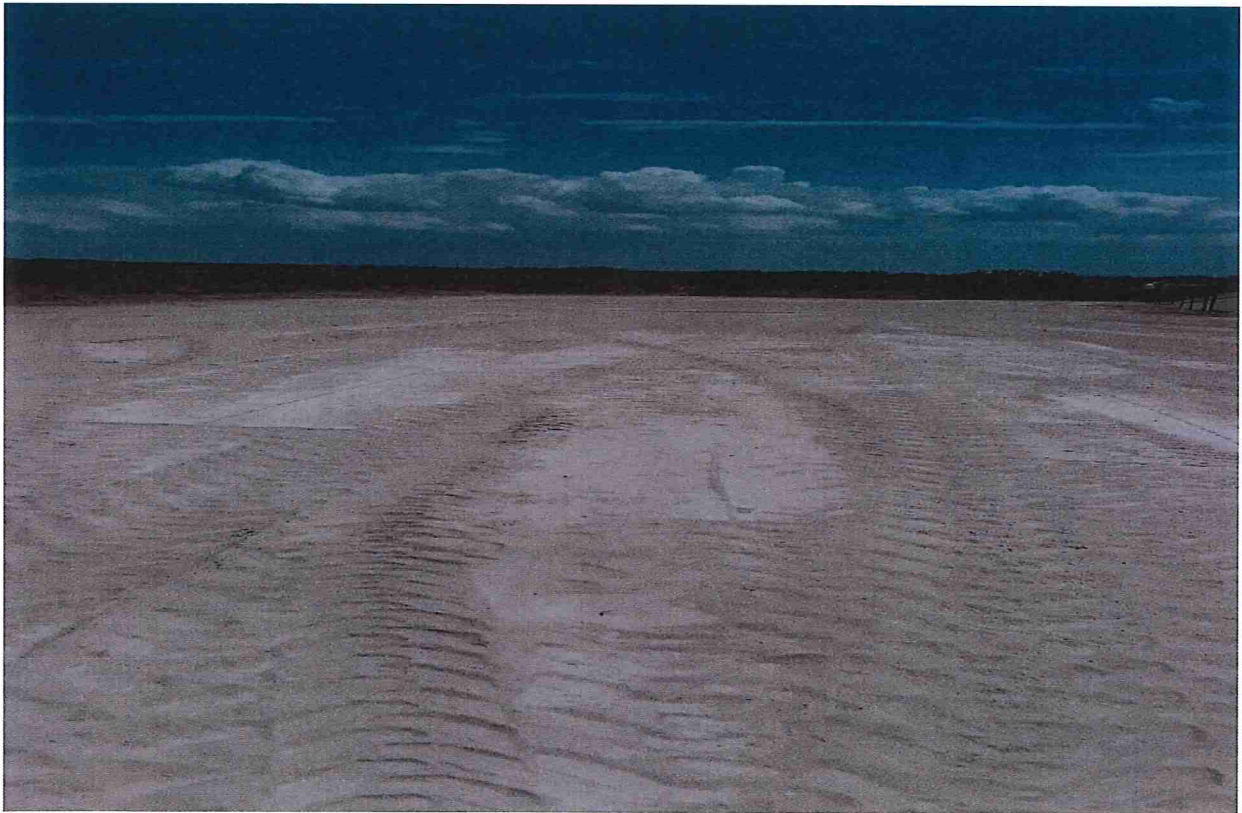
## Excavation and Completion

- The impacted area in the vicinity of sample locations S-5 and S-6 (tank battery area) was excavated to a depth of 1.0-feet BGS.
- The spoil piles initially excavated from the tank battery, denoted SP-1 and SP-2, were removed and disposed of.
- All of the excavated material and stockpiles were hauled to Lea Land, LLC, a NMOCD approved solid waste disposal facility.
- The excavated area was backfilled with new caliche and contoured to match the surrounding location.
- A Final C-141 formally documenting the remedial actions is attached in [Appendix III](#).
