Re: Work Plan
Condor State 1H (5/7/19)
RP#: 1RP-5518
GPS: 32.72958, -103.49786
Unit Letter N, Section 19, Township 18 South, Range 35 East
Lea County, New Mexico

COG Operating, LLC (COG) is pleased to submit the following work plan report in response to a release that occurred at the Condor State 1H flowline located in Unit Letter N, Section 19, Township 18 South and Range 35 East in Lea County, New Mexico.

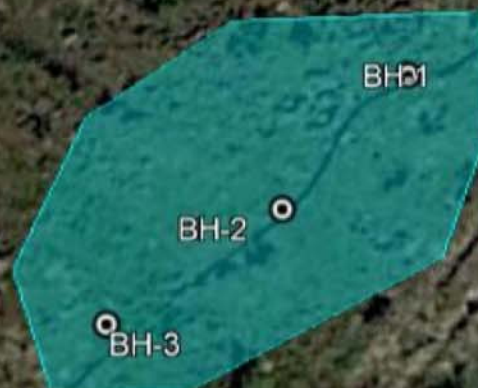
Condor State 1H
Section 19, T18S, R35E, Unit N
Lea County, New Mexico
32.72958, -103.49786

Spill Area
-

Boreholes

Due to the dense formation, a drilling air rotary rig was used to install three (3) boreholes to define the extents. Referring to Table 1, none of the samples exceeded the TPH, Benzene or Total BTEX Remediation Action Levels (RAL's). However, the areas of BH-1 and BH-2 did show a chloride impact to the subsurface soils and vertically defined below 600 mg/kg at 4.0' and 20.0' below surface, respectively. Borehole (BH-3) did not show any chloride impact to the area.

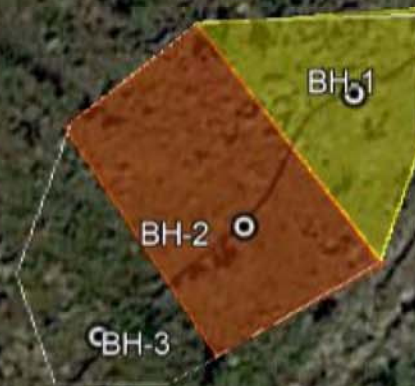
Proposed Removal and Excavation Depths

4.0' Proposed Excavation Depth with Liner
-

4.0' Proposed Excavation Depth
-

Boreholes

Proposed Liner

For the areas of BH-1 and BH-2, COG propose to remove the impacted soil to a depth of 4.0' below surface. Due to the deeper chloride impact, the area of BH-2 will be lined with a 20-mil liner at 4.0' to cap the remaining subsurface impact and backfilled with clean material to grade.
