**Devon Energy Production Company**  
**Snapping 2 State #3H**  
**Delineation Report & Work Plan**

**Section 02, Township 26S, Range 31E**  
**Eddy County, New Mexico**  
**2RP-5122**

**May 24, 2019**

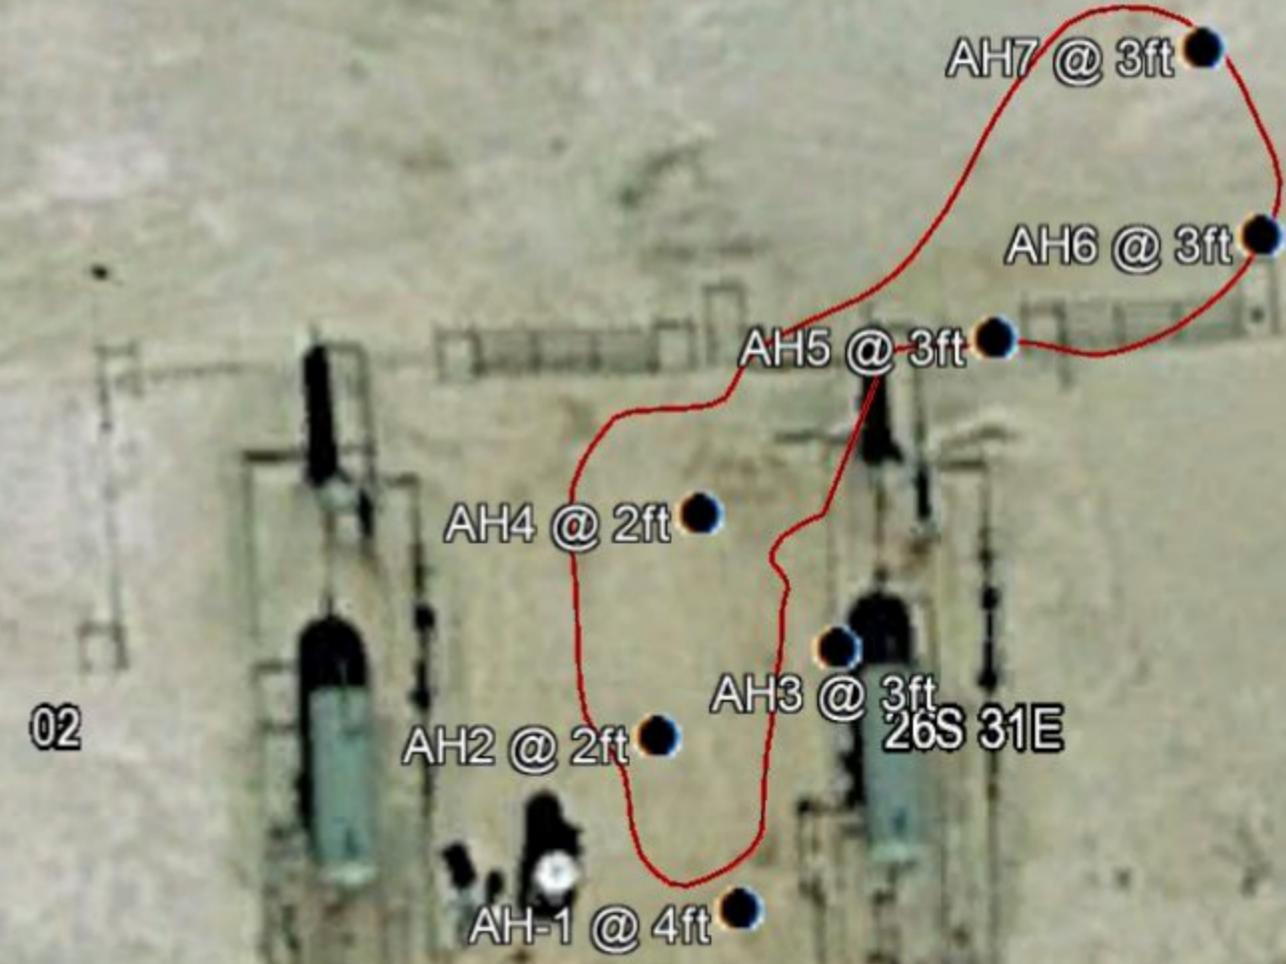
**Figure 2  
Site Plan**

According to the C-141: the cause of release, was due to a bypass line on the 3 phase separator leaking (Figure 2). There was an approximate release of 114 bbls of produced water. Approximately 1, 566 square feet of surface area on the location was impacted.

- Auger Hole Positions
- Spill Area 1

Based on the NMOCD soil screening levels and depth to groundwater for this area: Petroleum Hydrocarbons were not the constituency of concern in this spill. The Chloride levels were < 20, 000 mg/kg. Therefore, SESI is proposing to remove surface impact, and drag location for cosmetic appeal. The pad area will be restored with like material and returned to grade.
