July 22, 2019

Vertex Project #: 19E-00614-008

Spill Closure Report: Queenie 15 Federal #001H (Section 14, Township 20 South, Range 32 East)
API: 30-025-40230
County: Lea
Incident Report: 1RP-5563

Prepared For: **Marathon Oil Permian LLC**
4111 South Tidwell Road
Carlsbad, New Mexico 88220

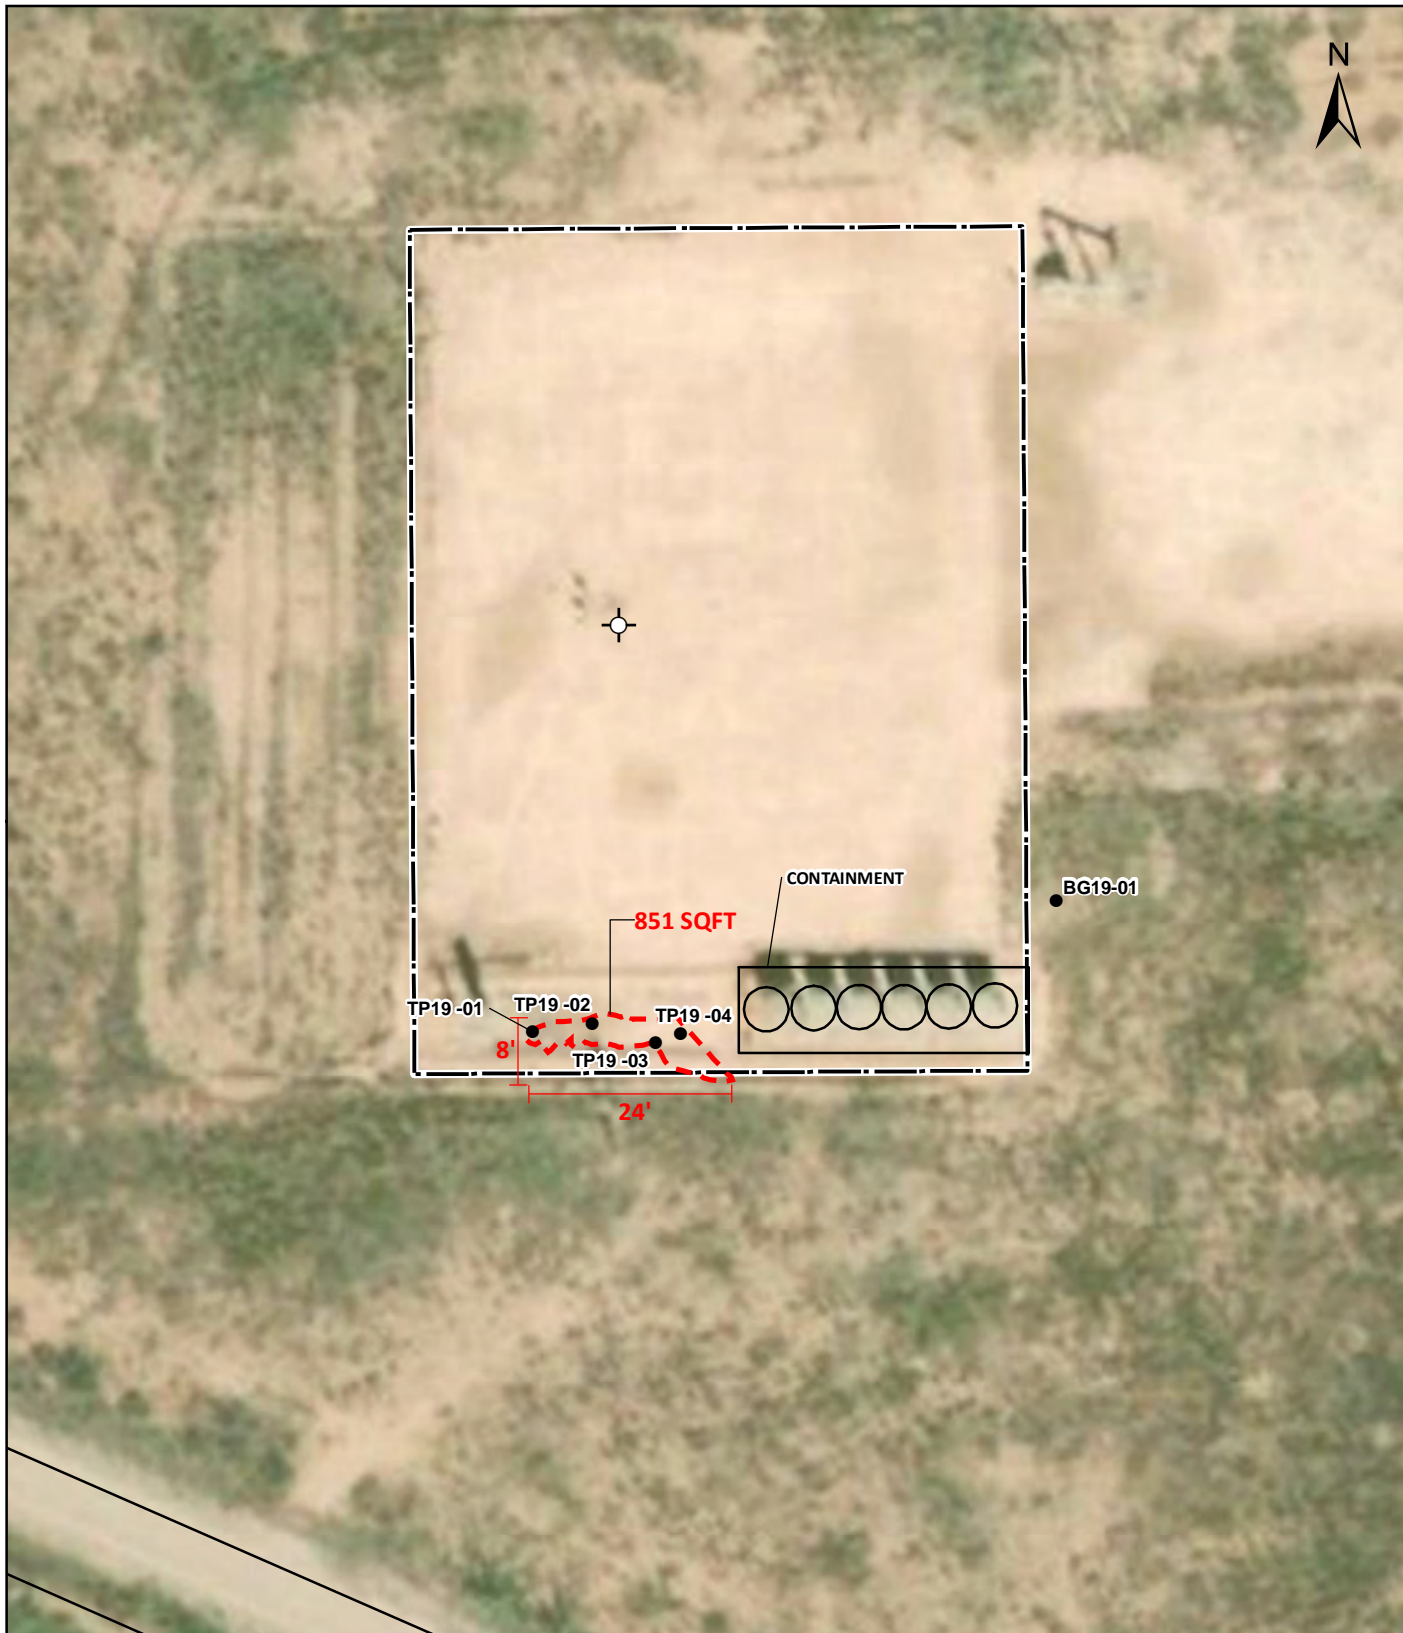
1

Site Schematic Queenie 15 Federal #001H

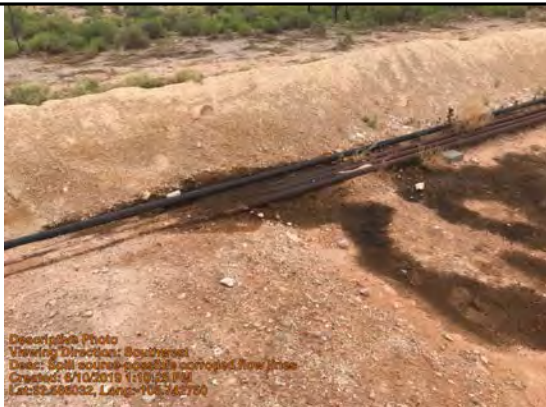
Viewing Direction: Southwest

The spill occurred on June 8, 2019, due to a pin hole on the line going from the oil tanks to the heater treater. The spill was reported June 8, 2019 and involved the release of approximately 7 barrels (bbls) of crude oil on the pad site. Approximately 3 bbls of free fluid was removed during initial spill clean-up. The New Mexico Oil Conservation Division (NMOCD) C-141 Report: 1RP-5563 is included in Attachment 2. The Daily Field Reports (DFRs) and site photographs are included in Attachment 3.

Spill source-possible corroded flow lines

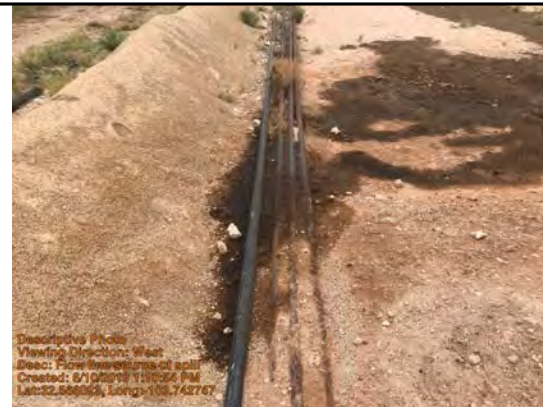
Viewing Direction: West

Flow line source of spill

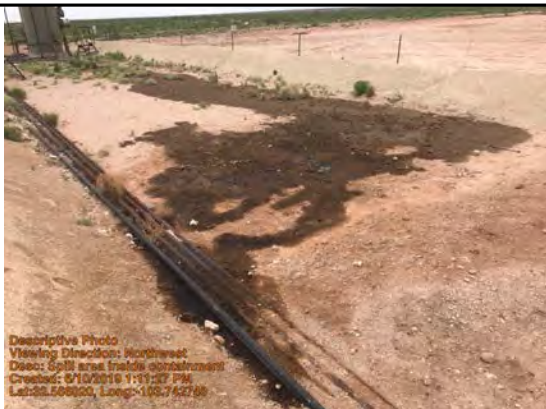
Viewing Direction: Northwest

Spill area inside containment

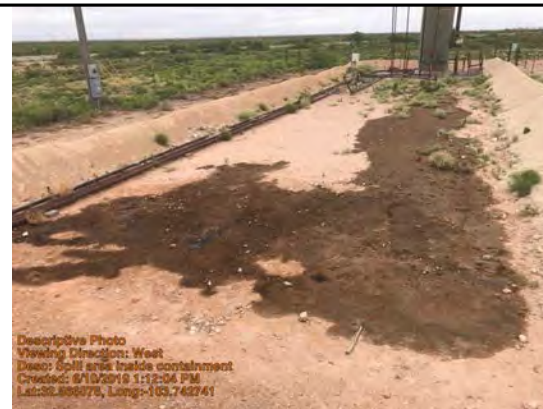
Viewing Direction: West

Spill area inside containment

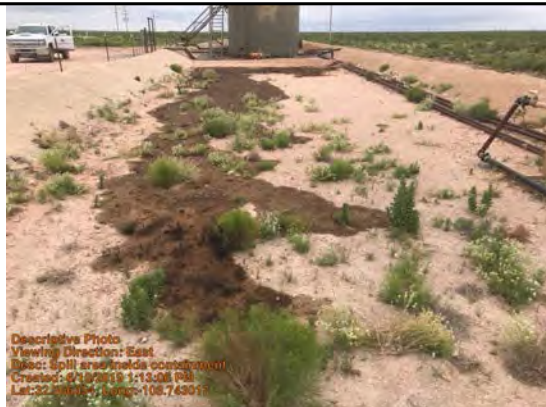
Viewing Direction: East

Spill area inside containment

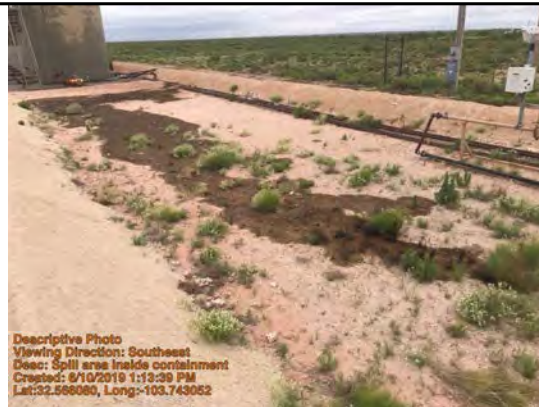
Viewing Direction: Southeast

Spill area inside containment

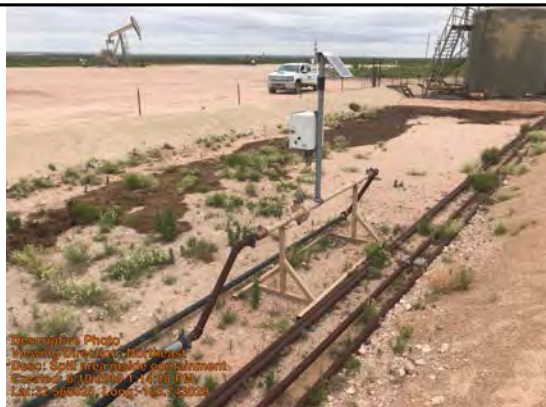
Viewing Direction: Northeast

Spill area inside containment

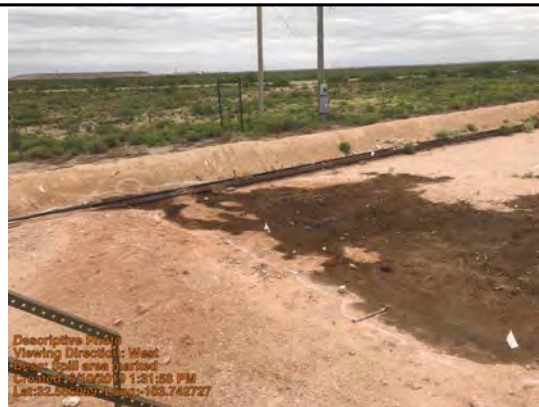
Viewing Direction: Southwest

Spill area marked

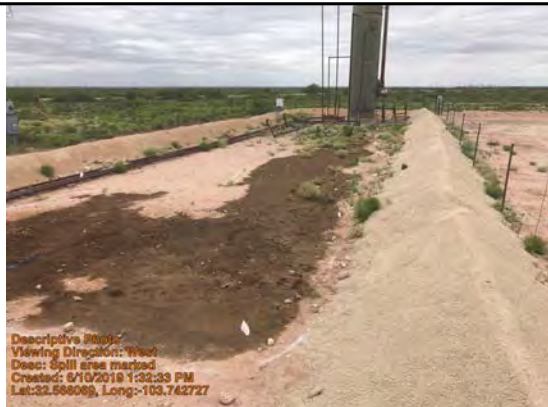
Viewing Direction: West

Spill area marked

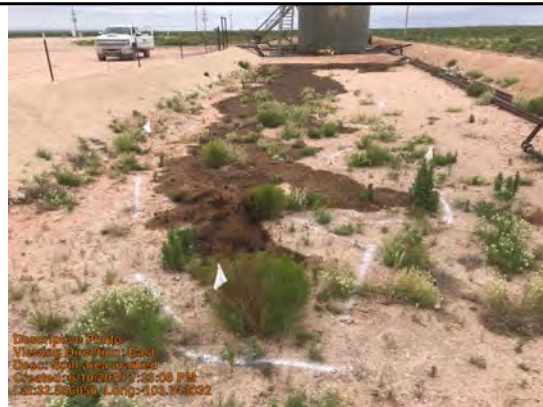
Viewing Direction: East

Spill area marked

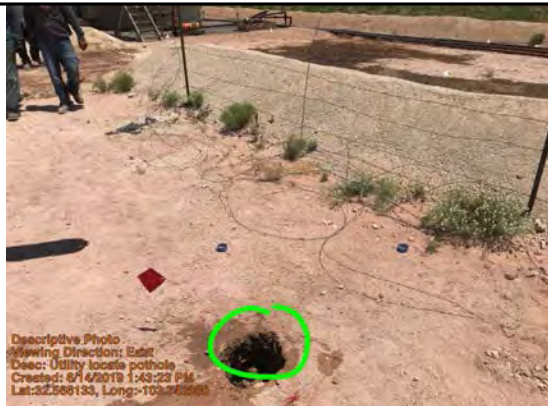
Viewing Direction: East

Utility locate pothole Approximately 1-1.5 feet below surface

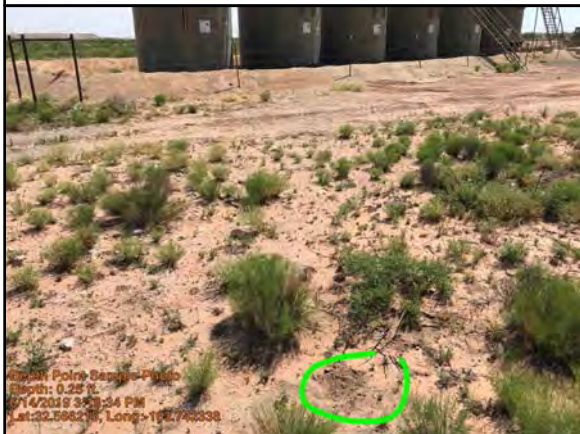
Sample Point ID: BG19-01

Depth: 0.25 ft.

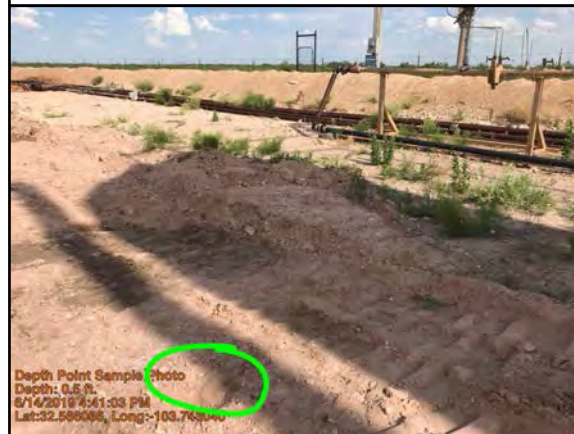
Sample Point ID: TP19-01

Depth: 0.5 ft.

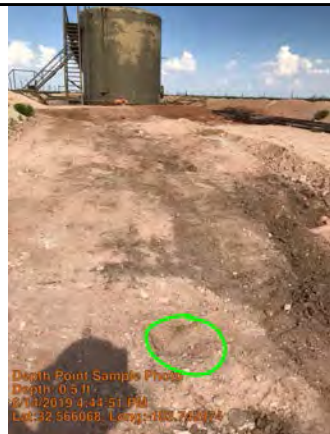
Sample Point ID: TP19-02

Depth: 0.5 ft.

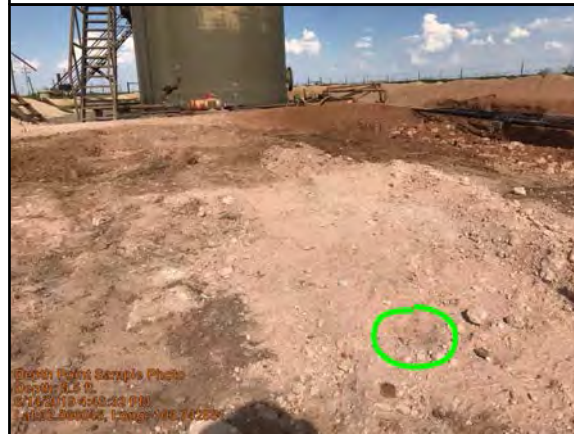
Sample Point ID: TP19-03

Depth: 0.5 ft.

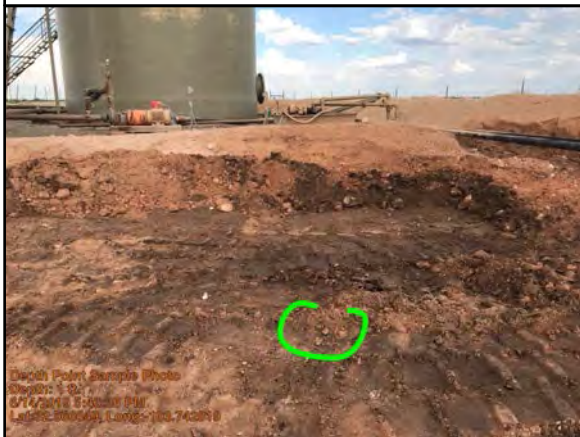
Sample Point ID: TP19-04

Depth: 1 ft.
