Report Type: Closure Report

Site:	Canvasback 13 Federal #002H					
Company:	COG Operating LLC					
Section, Township and Range	Unit A	Sec. 13	T 24S	R 31E		
Lease Number:	API No. 30-015-40538					
County:	Eddy County					
GPS:	32.22300			-103.72300		
Surface Owner:	Federal					
Mineral Owner:						
Directions:	From the intersection of Hwy 128 and Buck Johnson Rd., head Southwest on Buck Johnson Rd for 0.43 miles, turn south onto unnamed lease road and go 0.53 miles and arrive at location.

Re: Closure Report for the COG Operating, LLC, Canvasback 13 Federal #002H, Unit A, Section 13, Township 24 South, Range 31 East, Eddy County, New Mexico. 2RP-5008 and 2RP-5016

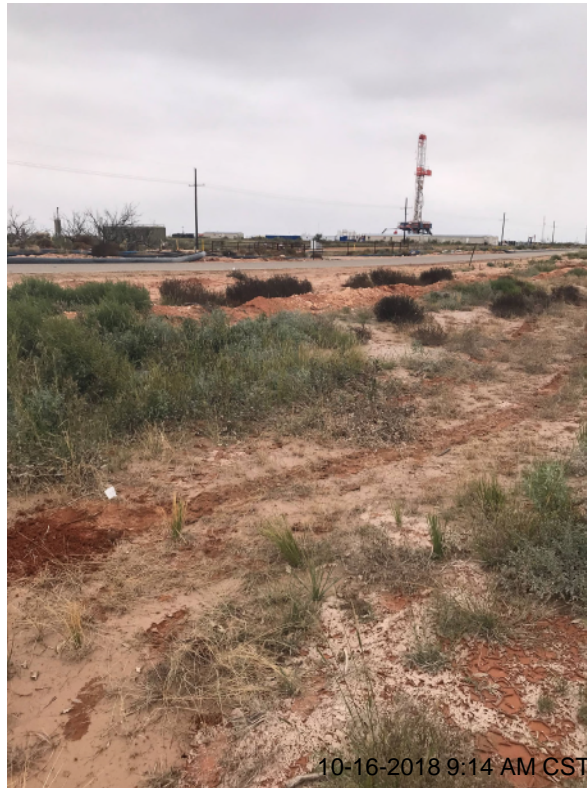
View Northwest – Area of AH-1

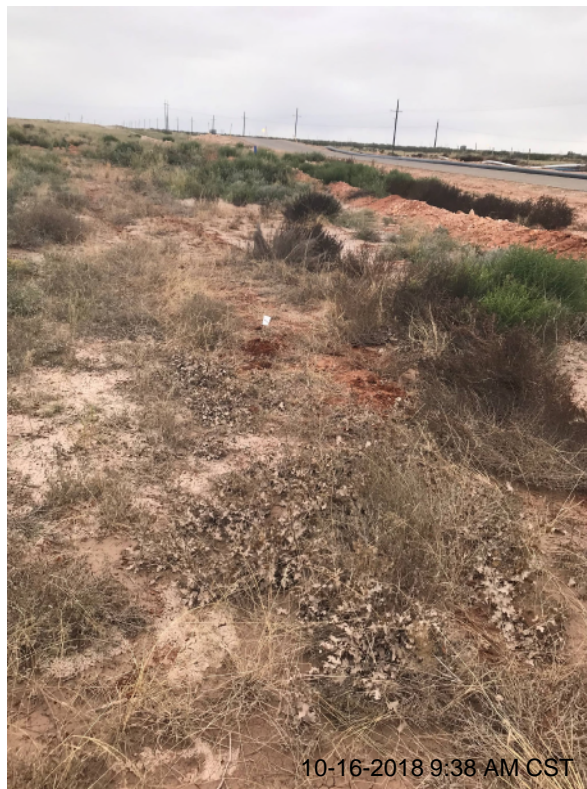
View South – Area of AH-2

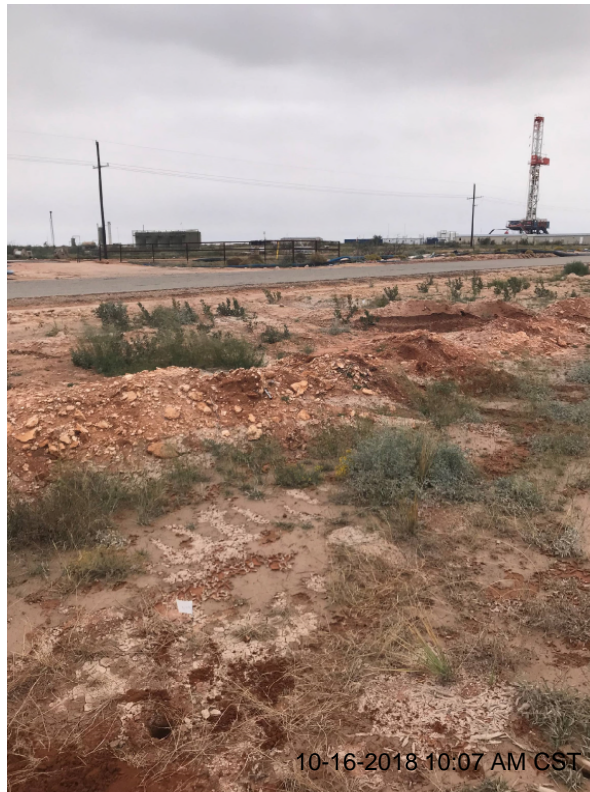
View West-northwest – Area of AH-3

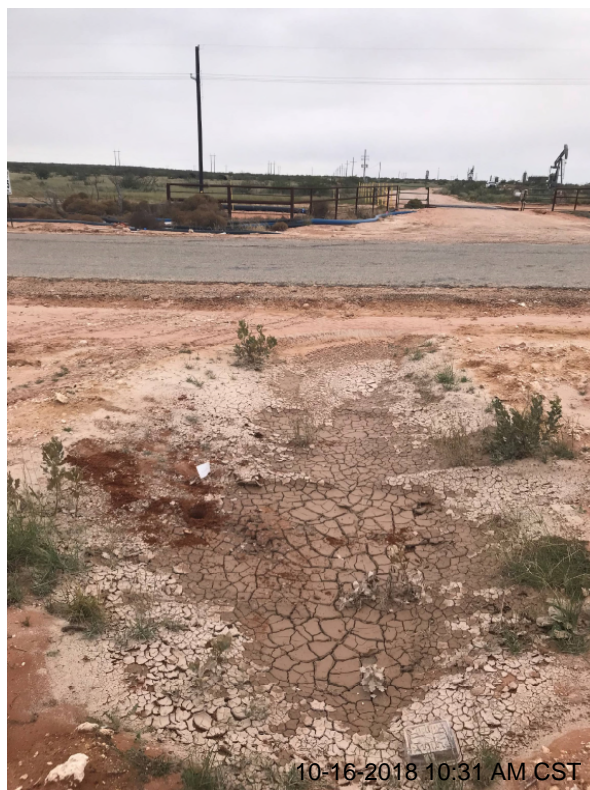
View West – Area of AH-4

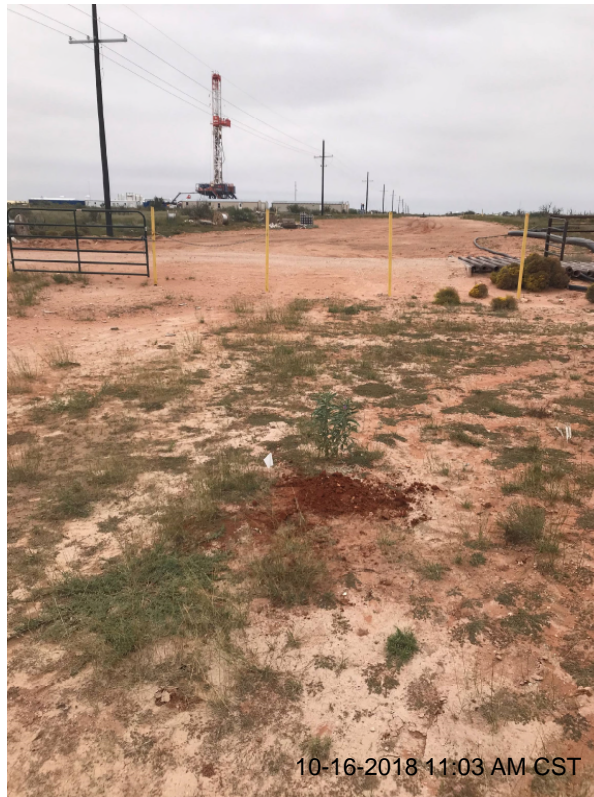
View North – Area of AH-5

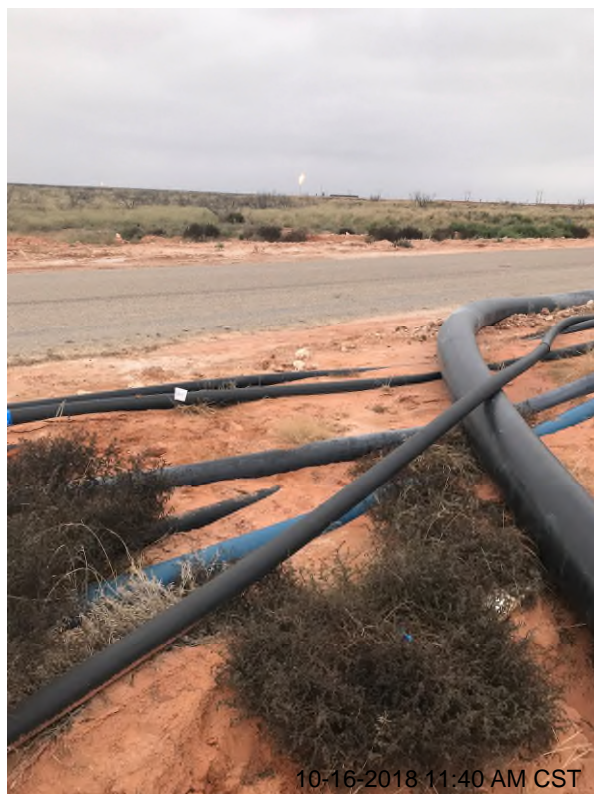
View Southeast – Area of AH-6

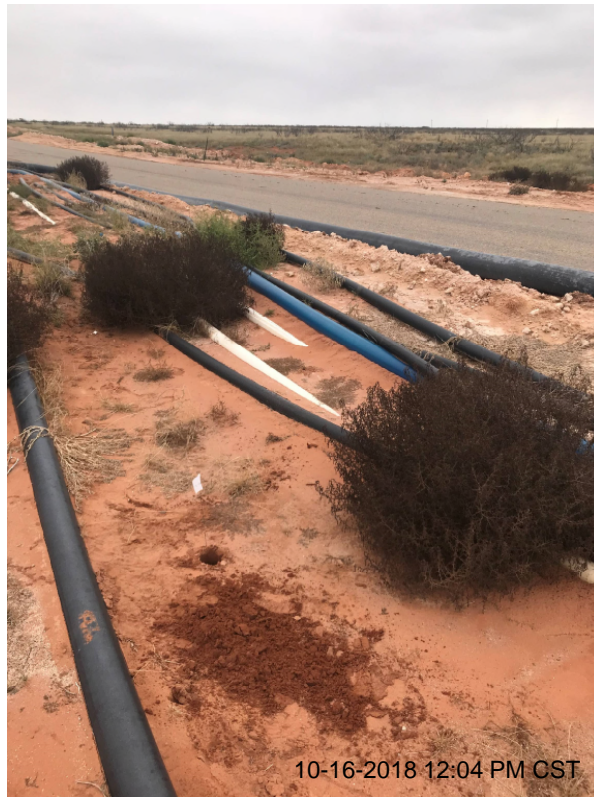
View North-northeast – Area of AH-7

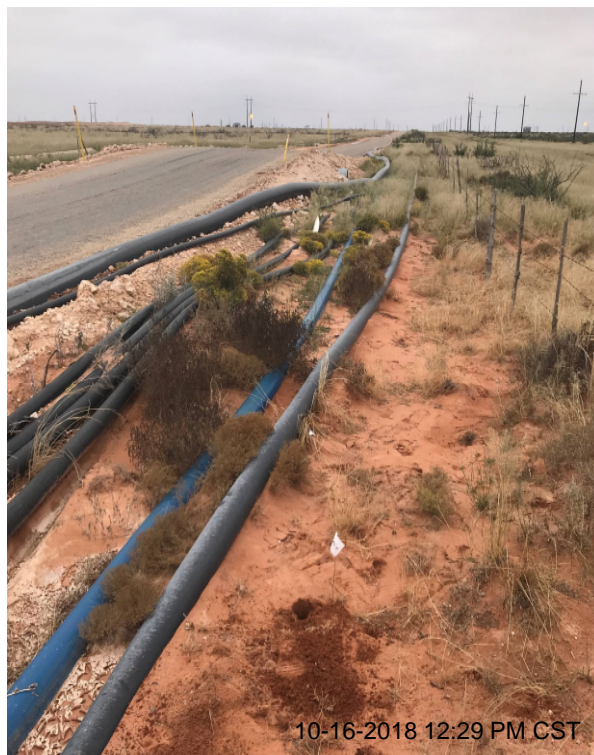
View South – Area of AH-8

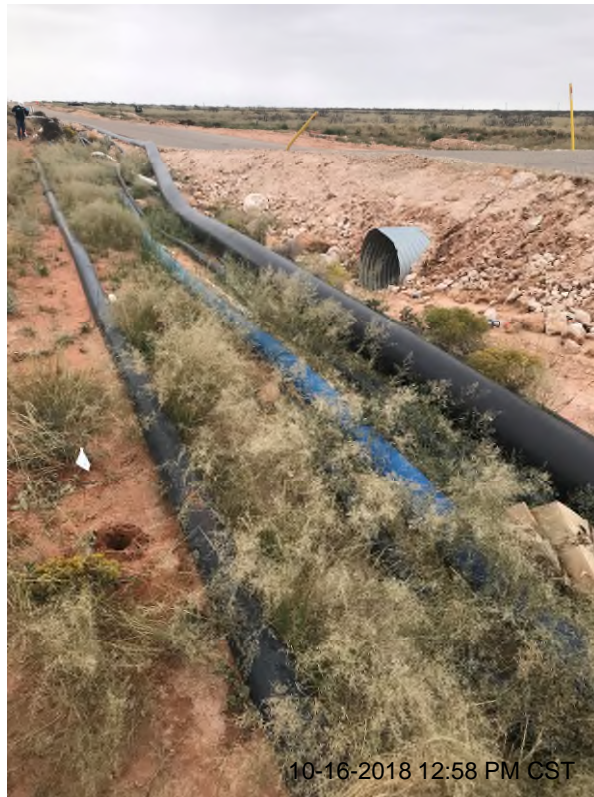
View North – Area of AH-9

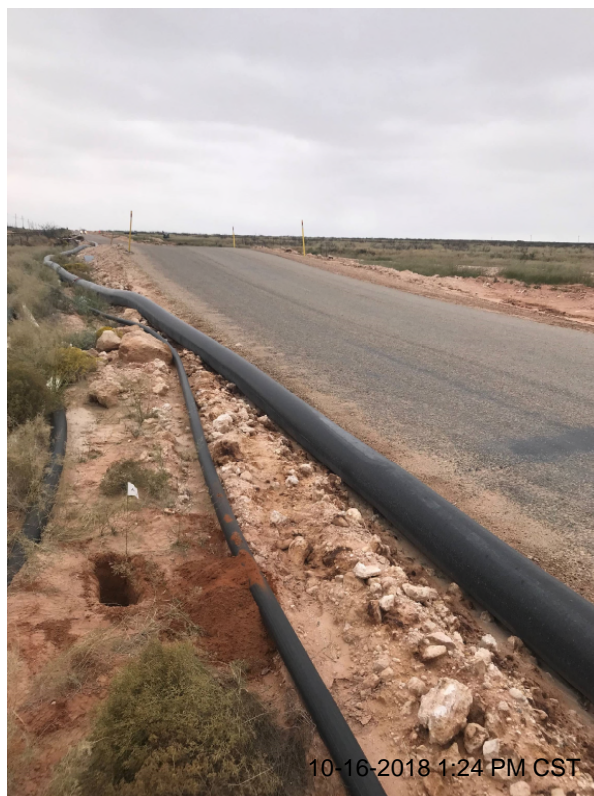
View North – Area of AH-10

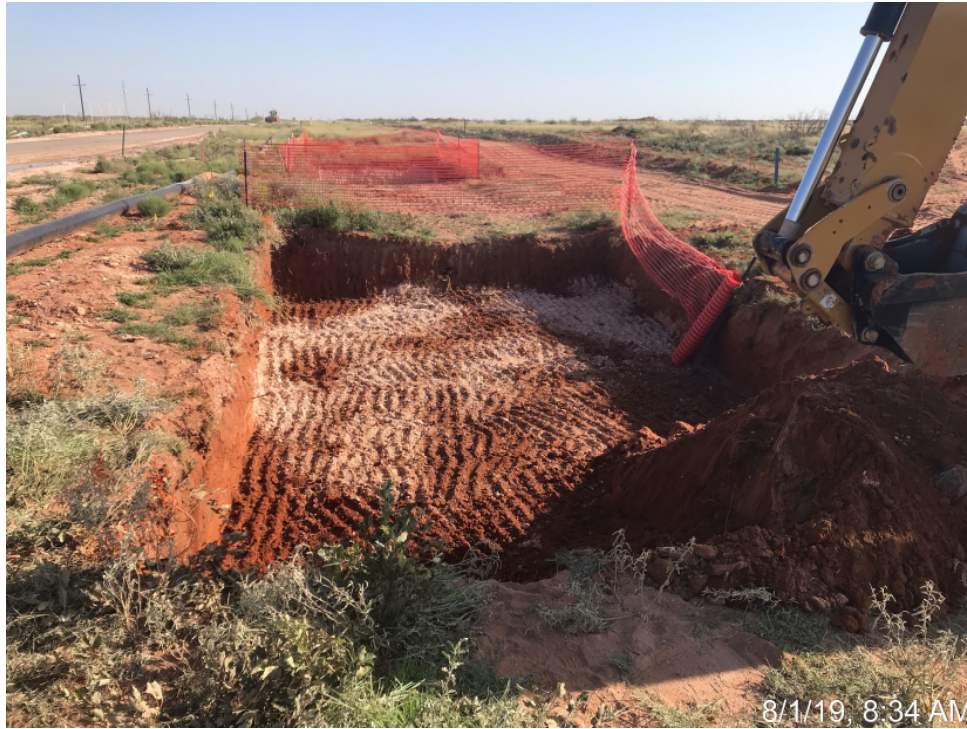
View North – Excavated Area of AH-1

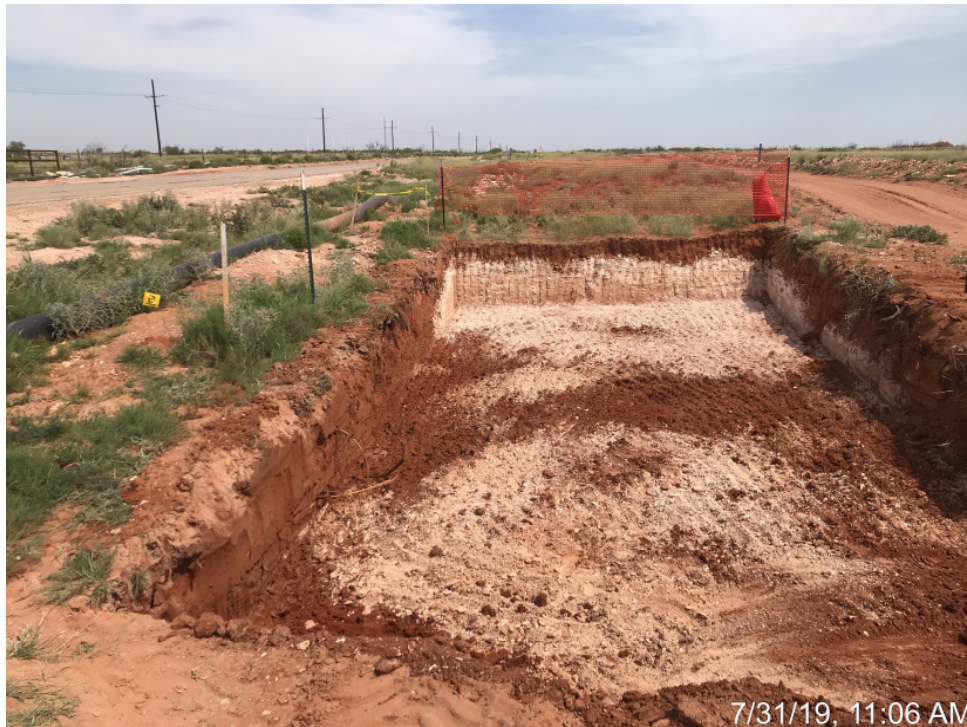
View North – Excavated Area of AH-3

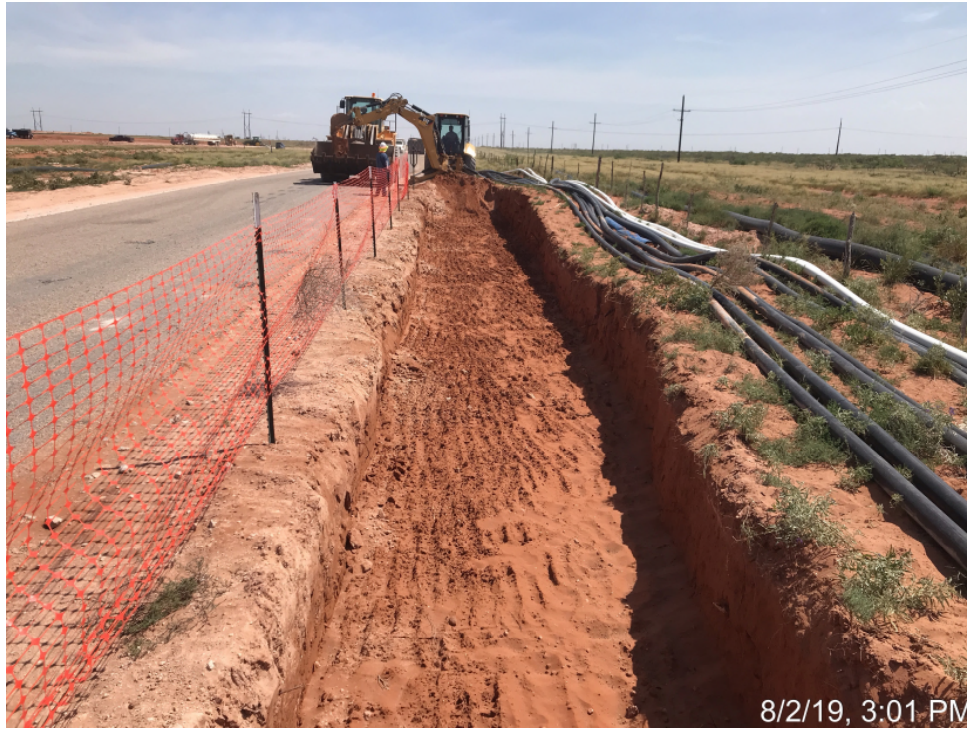
View South – Excavated areas of AH-7 and AH-8
