Report Type: Closure Report 1RP-5526

Site:	Momentum 36 State #1				
Company:	COG Operating LLC				
Section, Township and Range	Unit K	Sec 36	T 25S	R 35E	
Lease Number:	API No. 30-025-37517				
County:	Lea County				
GPS:	32.0838			-103.32229	
Surface Owner:	State				
Directions:	From the intersection of HWY 128 & CR 2, travel east on HWY 128 for 2.90 mi, turn south onto lease road for 3.85 mi, turn east for 0.50 mi, turn south for additional 0.85 mi, turn east for 2.20 miles to location.

Re: Closure Report for the COG Operating, LLC, Momentum 36 State #1, Unit K, Section 36, Township 25 South, Range 35 East, Lea County, New Mexico. 1RP-5526

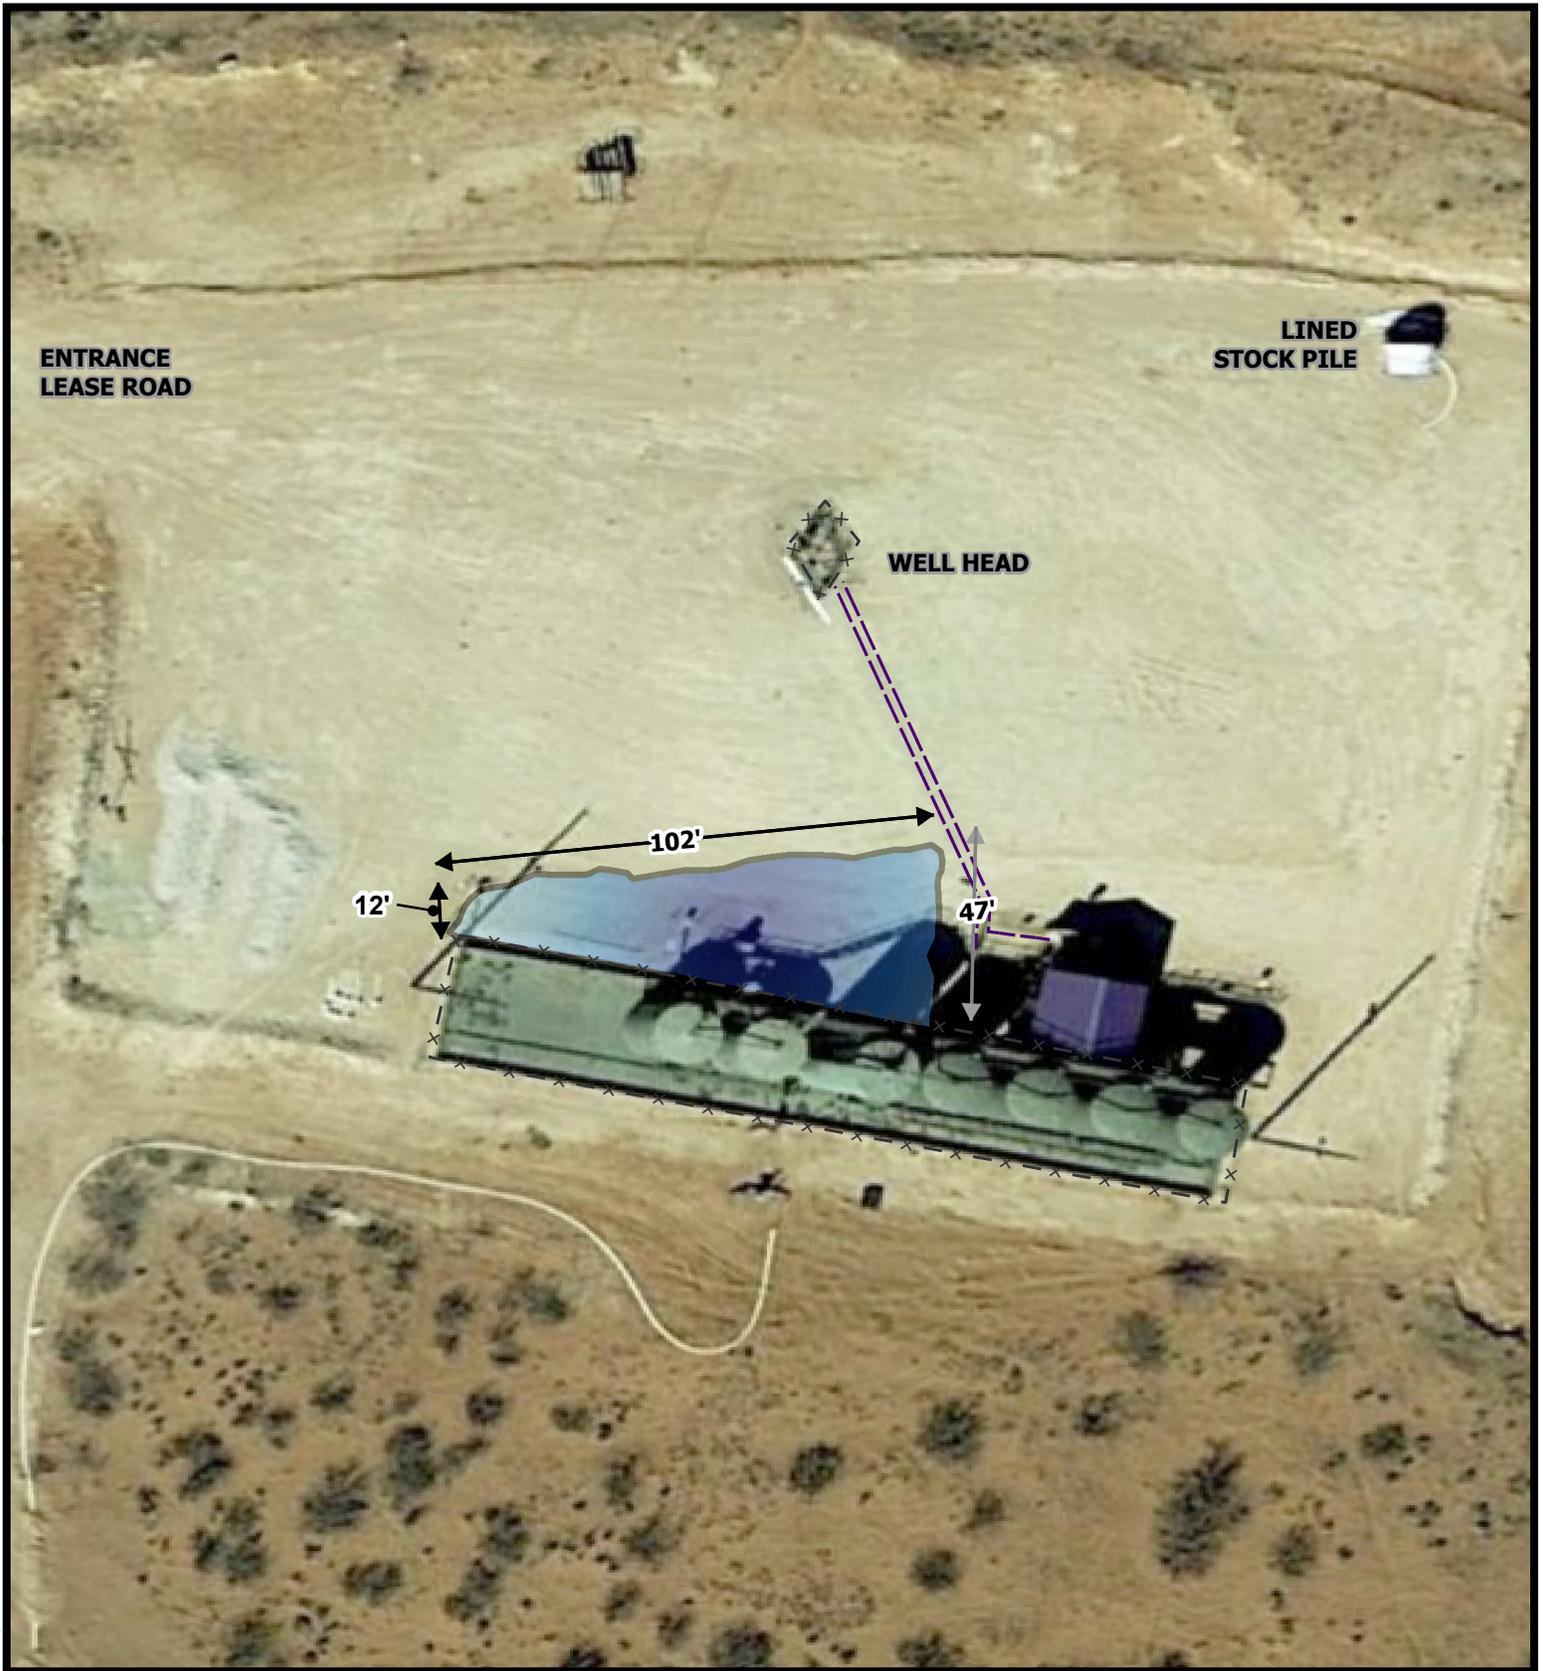
FIGURE
3

According to the State of New Mexico C-14 Report the release was discovered on May 7, 2019 due to a gun barrel malfunction resulting in a tank overflow. Approximately 9 barrels of oil and 51 barrels of produced water was released into the lined facility. A vacuum truck was dispatched to remove all freestanding fluids and recovered 8 barrels of oil and 50 barrels of produced water. The release occurred inside the lined facility and had some overspray onto the pad. The impacted area on the pad measures approximately 47' x 102'. The C-141 Form is included in Appendix A.

SPILL ASSESSMENT MAP
MOMENTUM 36 STATE #001
PROPERTY LOCATED AT 32.08378, -103.32229
LEA COUNTY, NEW MEXICO

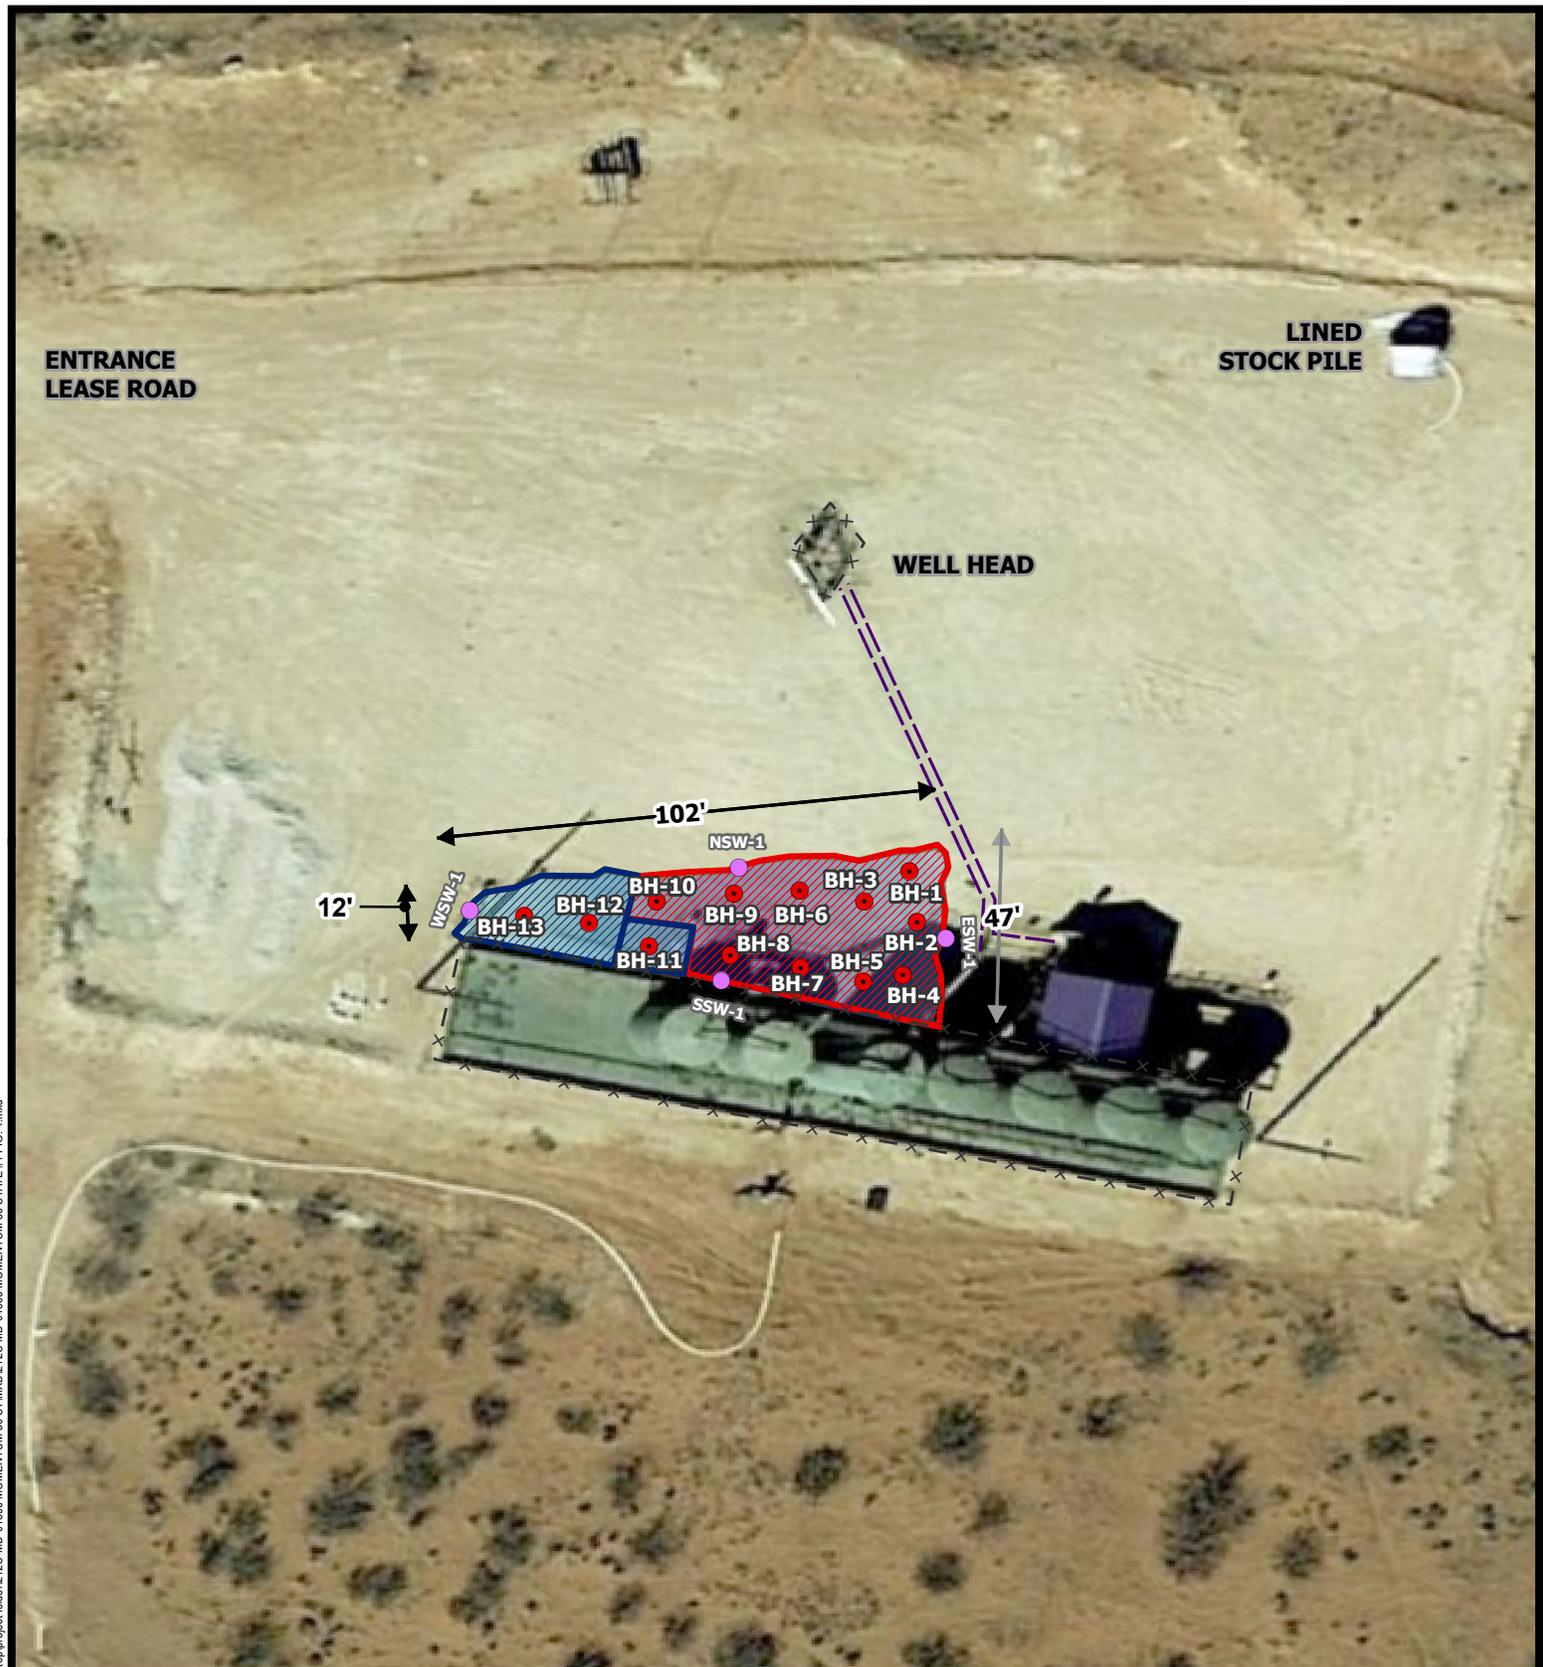
FIGURE 4

Tetra Tech personnel were onsite on June 19th, June 20th, and July 23rd, 2019, to perform and supervise the remediation activities at risk. The release area was excavated to total depths between 0.5' to 1.0' below surface. Thirteen (13) bottom holes (Bottom Hole 1 through Bottom Hole 13) and four (4) sidewall composite samples (North Sidewall 1, South Sidewall 1, East Sidewall 1, and West Sidewall 1) were collected every 200 square feet to ensure proper removal of the impacted soils. The samples were submitted to the laboratory to be analyzed for TPH method 8015 extended, BTEX method 8021B, and Chloride by EPA Method 300.0. The sampling results are summarized in Table 1. The release area is shown on Figure 3. The excavation depths and sample locations are shown in Figure 4.

EXCAVATION AREA & DEPTH MAP MAP
MOMENTUM 36 STATE #001
PROPERTY LOCATED AT 32.08378, -103.32229
LEA COUNTY, NEW MEXICO

Referring to Table 1, all final confirmation samples showed benzene, total BTEX, TPH, and chloride concentrations below the RRAL's.

Approximately 115 cubic yards of material was excavated and transported offsite for proper disposal. The area was then backfilled with clean material to surface grade.

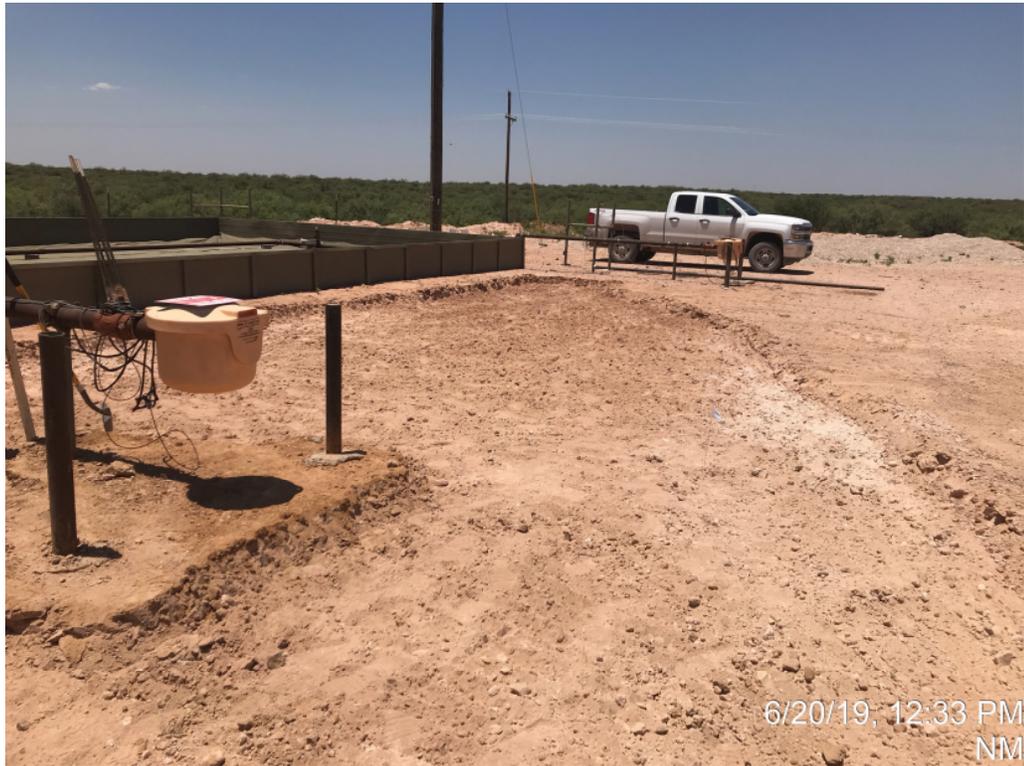
View South – Excavation Area

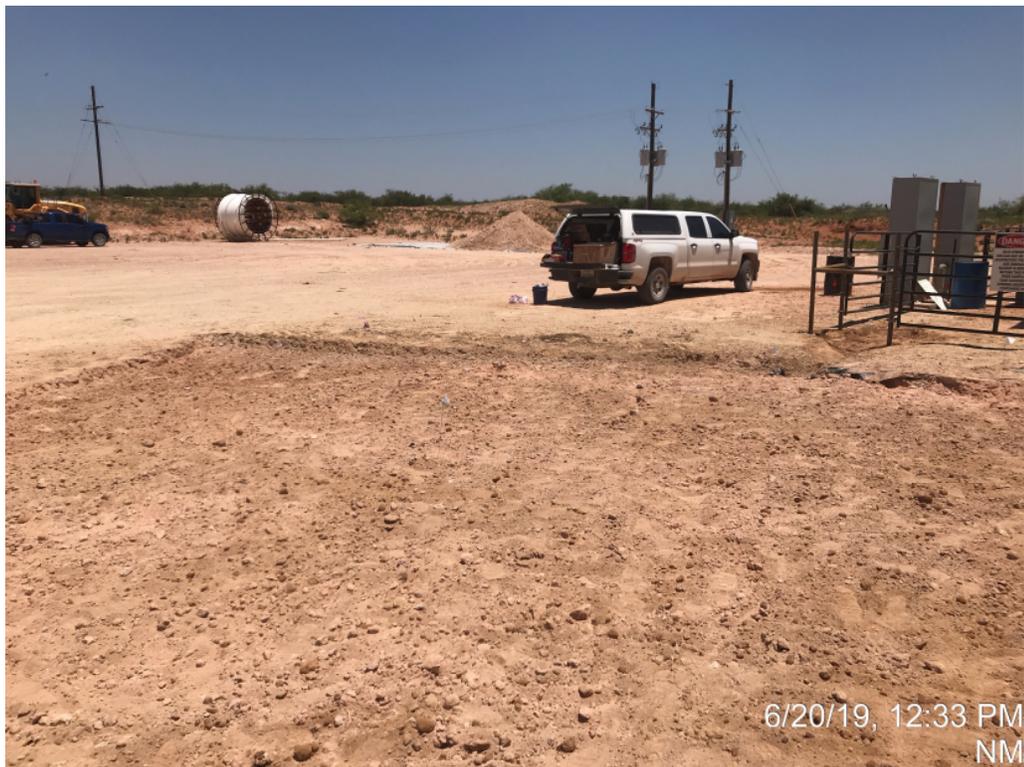
View North – Excavation Area

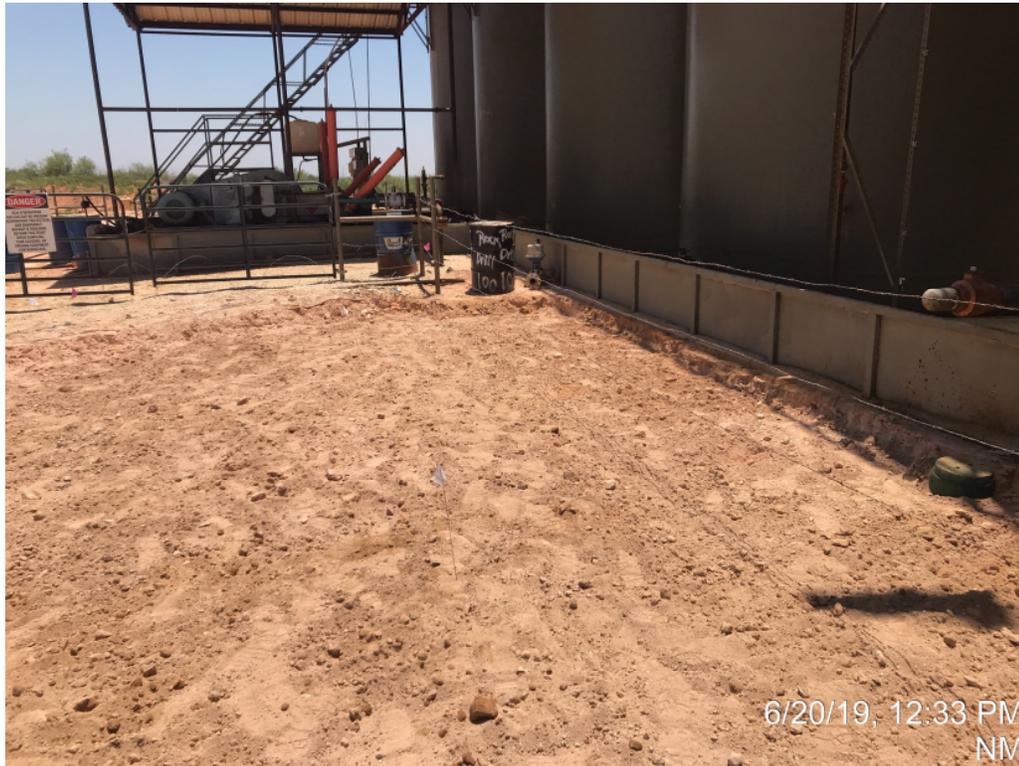
View North – Excavation Area

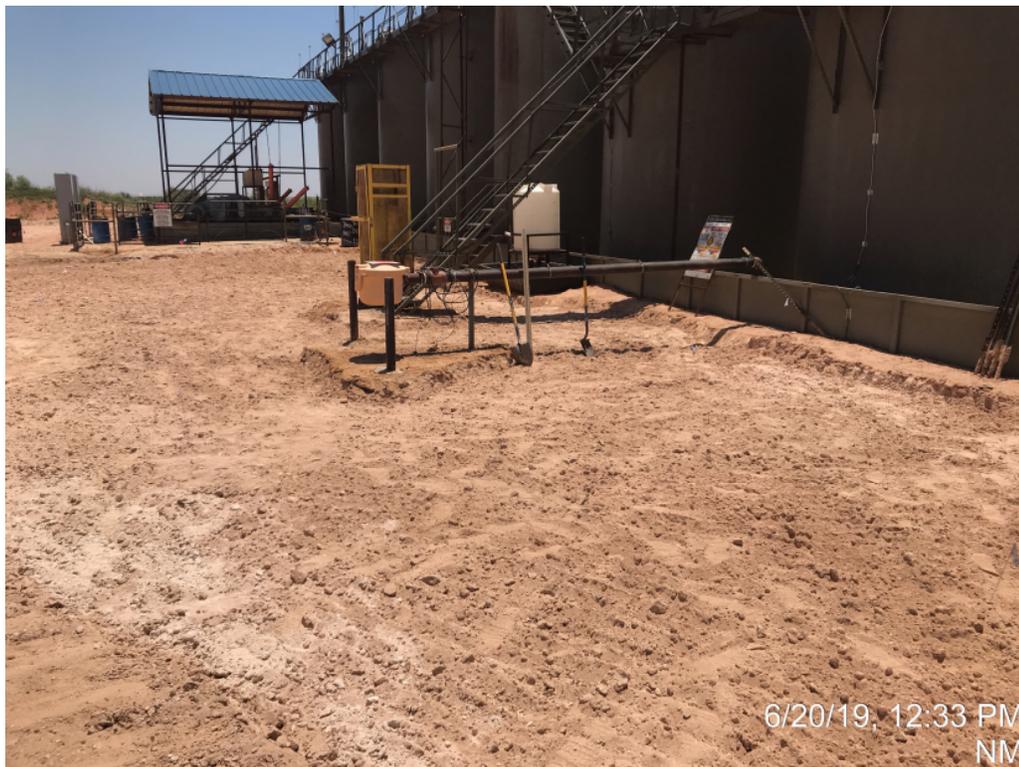
View North – Excavation Area

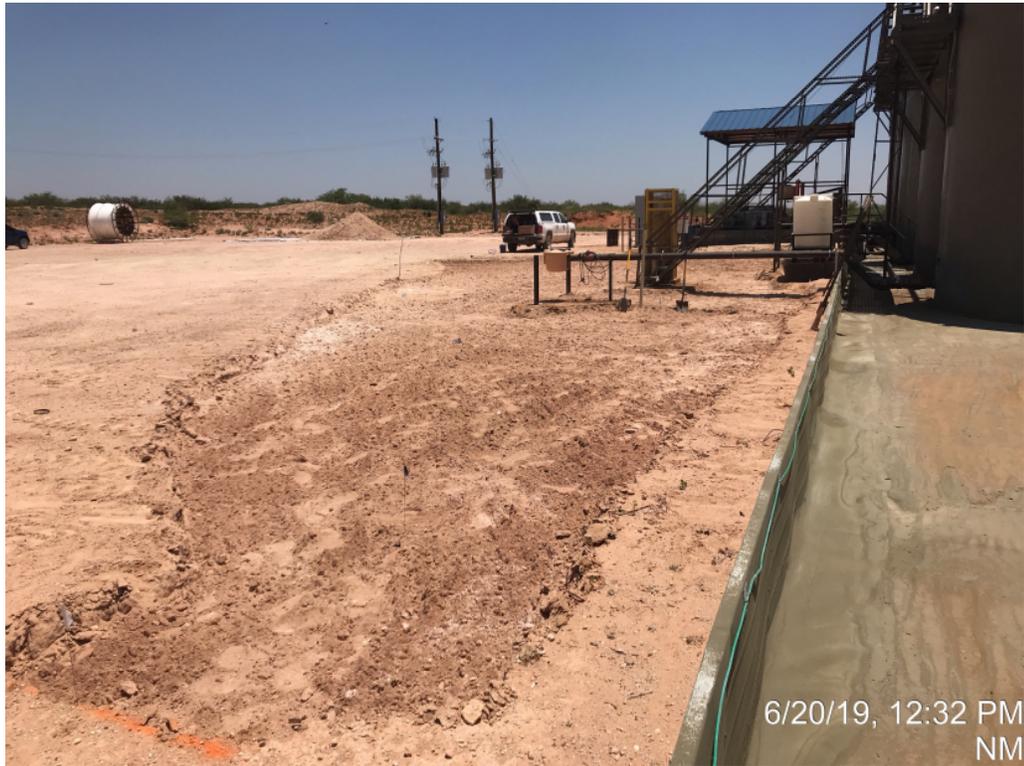
View North – Excavation Area
