Re: Site Assessment Report and Proposed Remediation Plan
Site Name: 2B Pipeline
GPS: Latitude: 32.16947 Longitude: -103.20493
Legals: UL "N", Sec. 31, T24S, R37E
Lea County, New Mexico
NMOCD Ref. No. 1RP-5265

Lowry Environmental & Associates, LLC (LEA), on behalf of ETC Texas Pipeline, Ltd., has prepared this Site Assessment Report and Proposed Remediation Plan for the Release Site known as the 2B Pipeline. Details of the release are summarized on the table below:

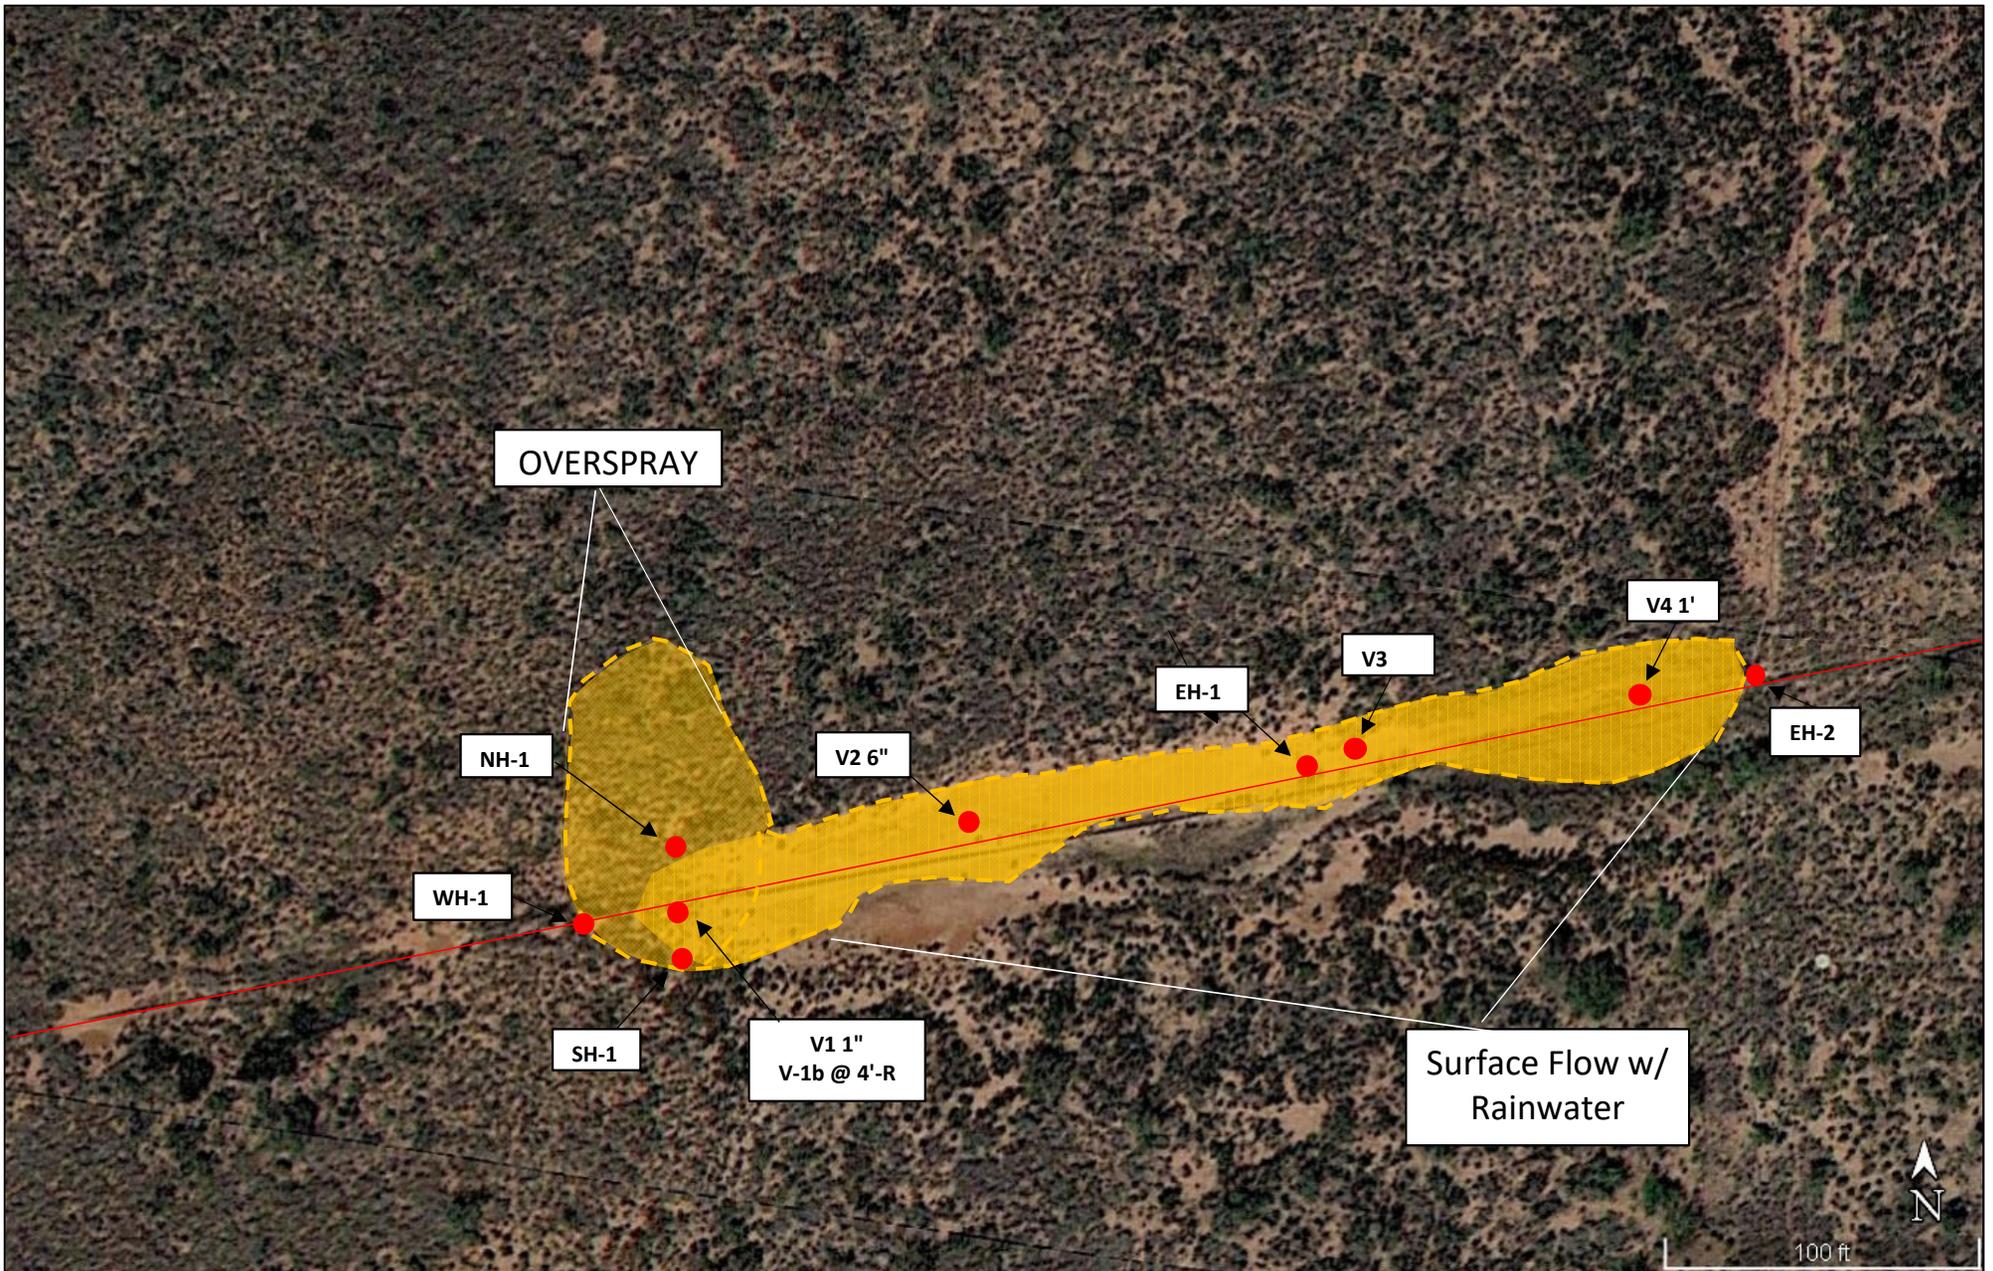
Figure 3 - Site & Sample Location Map

Figure 3
 Site & Sample Location Map
 ETC Texas Pipeline, Ltd.
 2B Pipeline
 GPS: 32.16947, -103.20493
 Lea County, New Mexico

A "Site & Sample Location Map" is provided as Attachment #3. Field Data, if applicable, is provided as Attachment #9. Soil profile observations are provided on Attachment #5. Laboratory analytical reports are provided as Attachment #6.

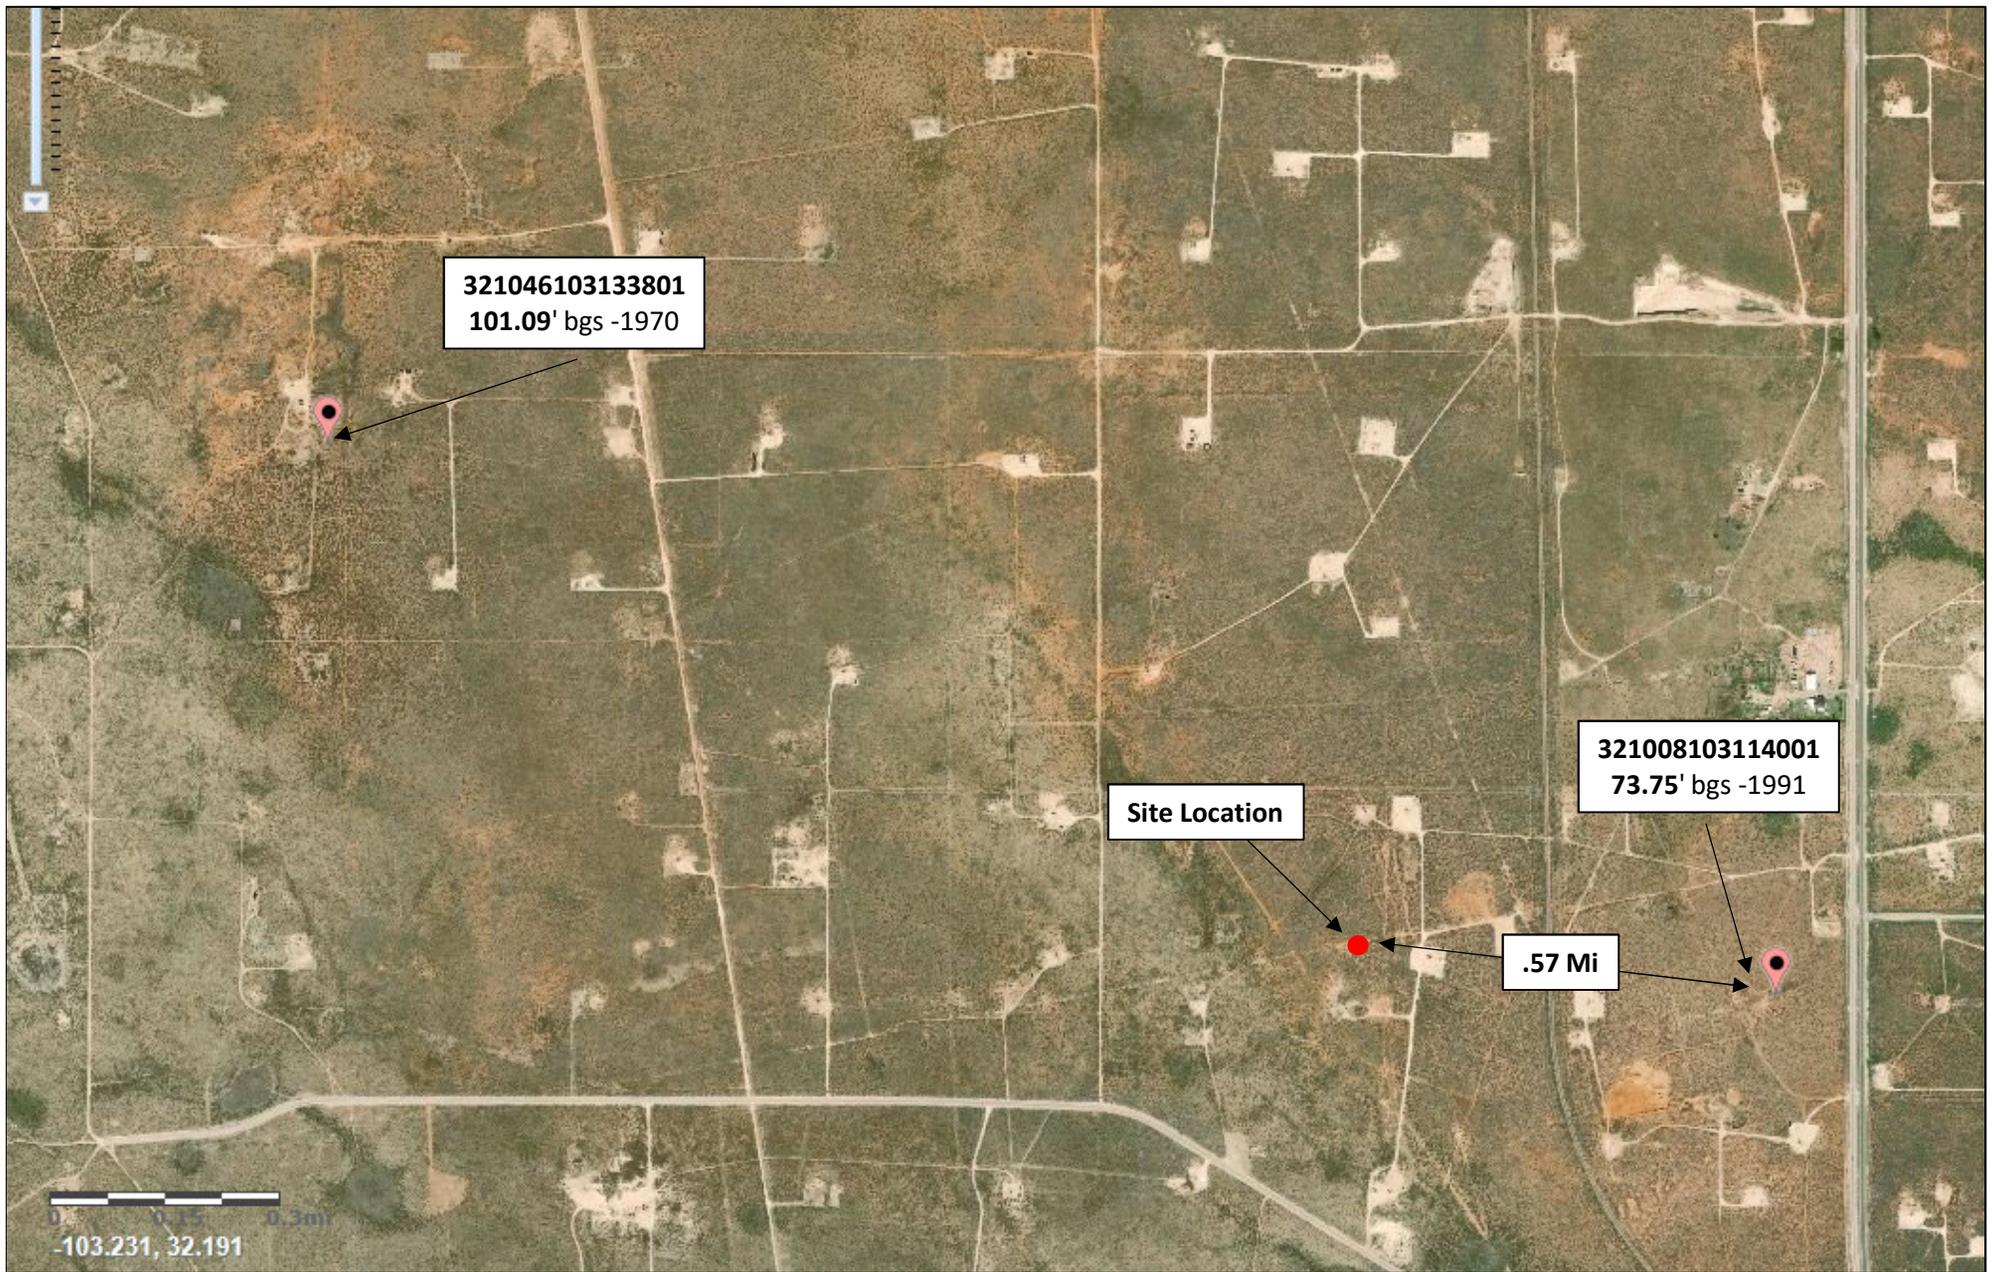
Figure 4

USGS Well Proximity Map
ETC Texas Pipeline, Ltd.
2B Pipeline
GPS: 32.16947, -103.20493
Lea County, New Mexico

A search of groundwater databases maintained by the New Mexico Office of the State Engineer (NMOSE) and United States Geological Survey was conducted in an effort to determine the average depth to groundwater within a 1 Mile radius of the Site and identify any registered water wells within a 1/2 Mile radius of the Site. A search of the NMOSE database suggested the presence of 1 water well (CP00549) within 1,000 ft. of the site. A field survey indicated available geographic information for CP00549 is outdated and/or incorrect; there is no water well in that vicinity. A search of the USGS database did not identify any water wells within a 1/2 Mile radius.

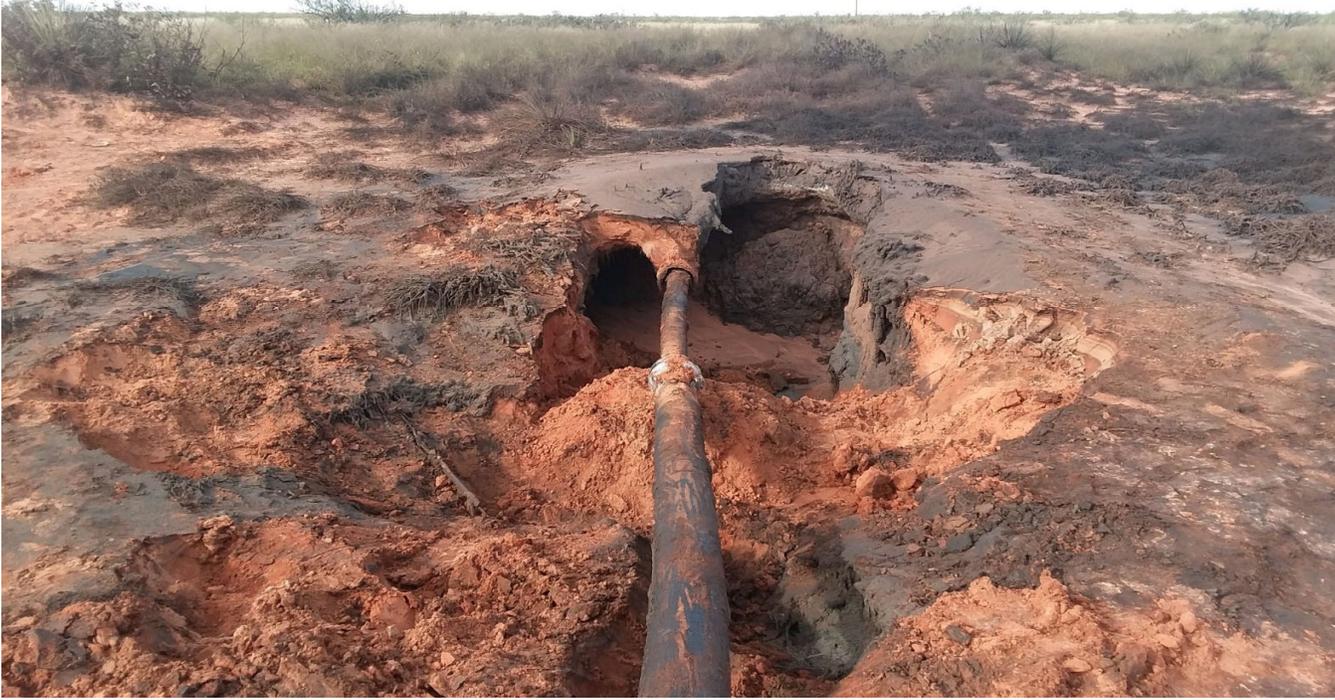
Figure 1 View of surface staining from the initial release, facing Southwest.

- Utilizing mechanical equipment, excavate impacted soil within the release margins affected above the NMOCD Closure Criteria.
- The floor of the excavation will be advanced to a depth of approximately 4 ft. bgs in the area characterized by sample points V1 and V-1b, 6 in. bgs in the area characterized by sample point V2, 8 in. bgs in the area characterized by sample point V3 or until laboratory analytical results from confirmation soil samples indicate concentrations of BTEX, TPH and chloride are below the NMOCD Closure Criteria.

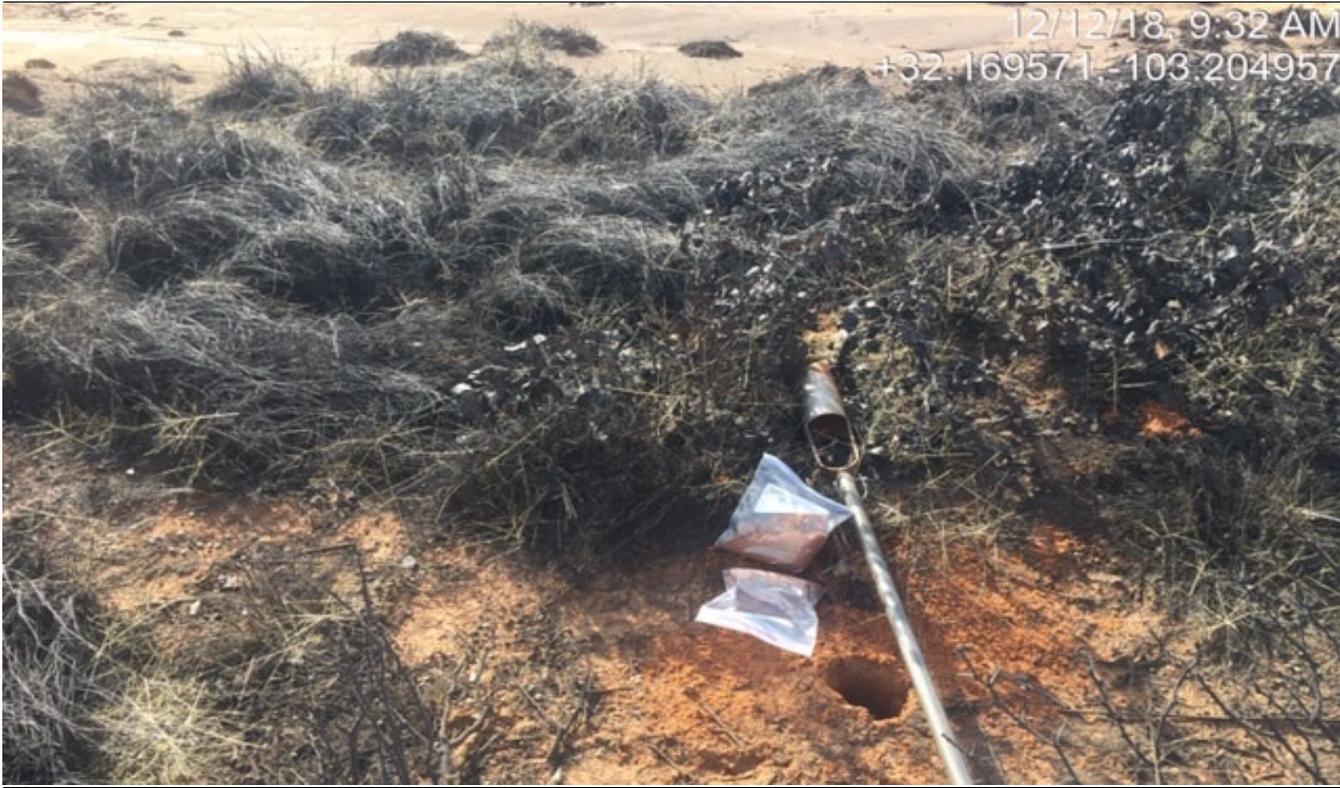
Figure 2 View of sample location, facing North.

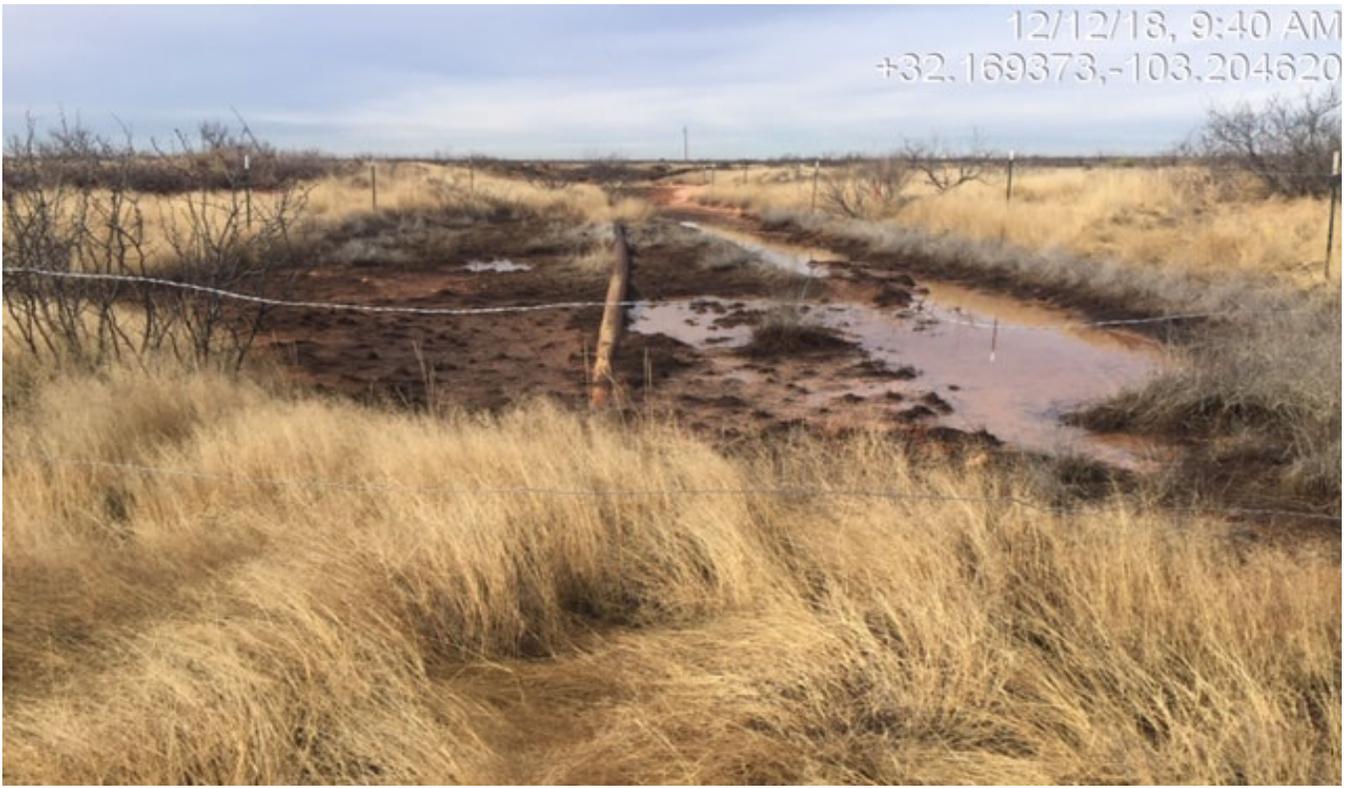
Figure 3 View of surface staining from the initial release, facing Southwest.

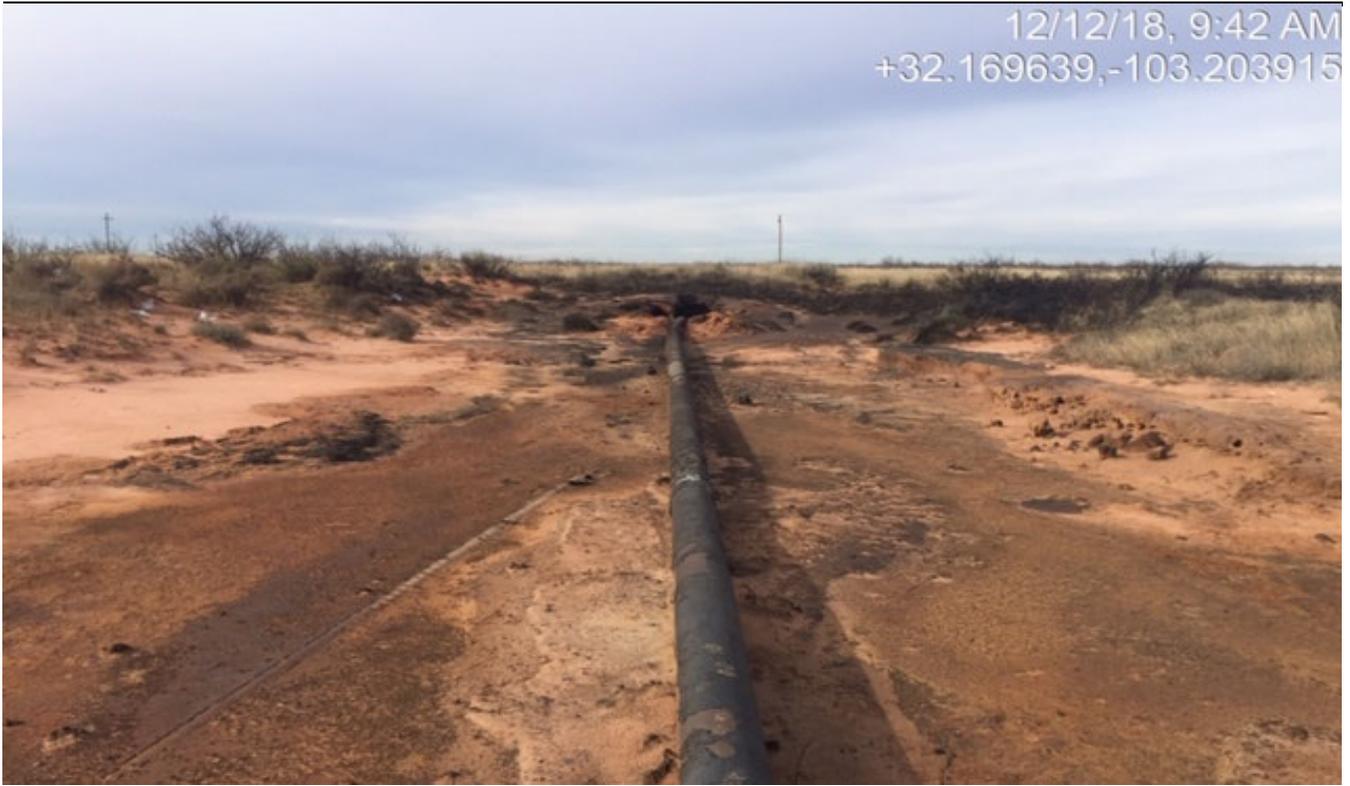
Figure 4 View of surface staining from the initial release, facing Southwest.

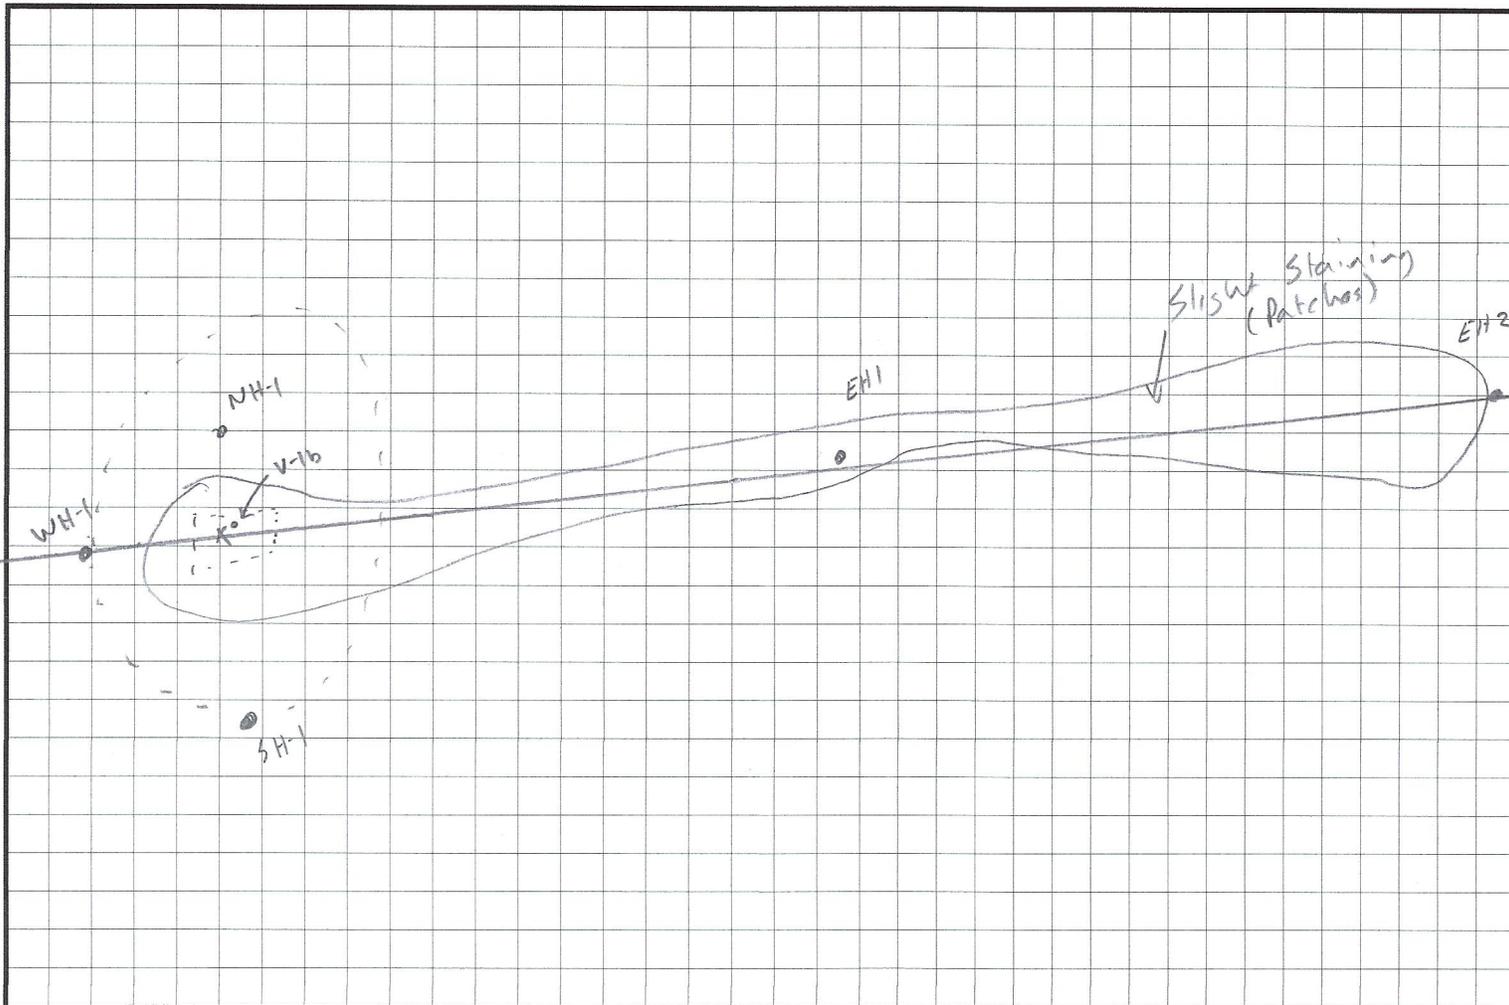
Impacts appear to be limit to surface in overspray area : Flow path
 (Historical impacts from crude release (unrehab) present.
 Hit Rock @ 4' bgs @ release point.

Field ID	Odor/PID	Chloride
V-1 @ 4'	Light	<120
