**SUBJECT:** Remediation Closure Report for the 1009 Pipeline Release (1RP-5596), Lea County, New Mexico

Regional Vicinity & Wellhead Protection Map  
 1009 Pipeline Release (IRP-5596) - Enterprise  
 Sec 36 T21S R32E, Lea County, New Mexico

**Site and Sample Location Map**  
**1009 Line Release - Enterprise**  
**Sec 36 T21S R32E, Lea County, New Mexico**

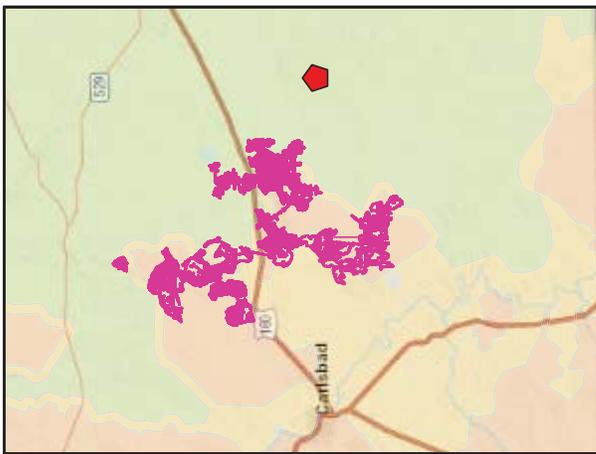
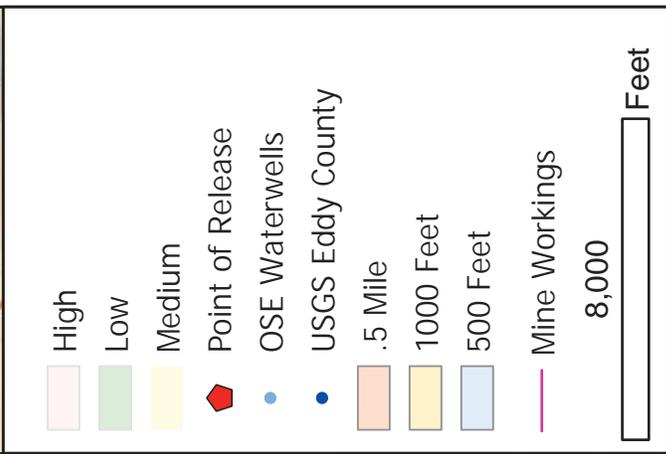
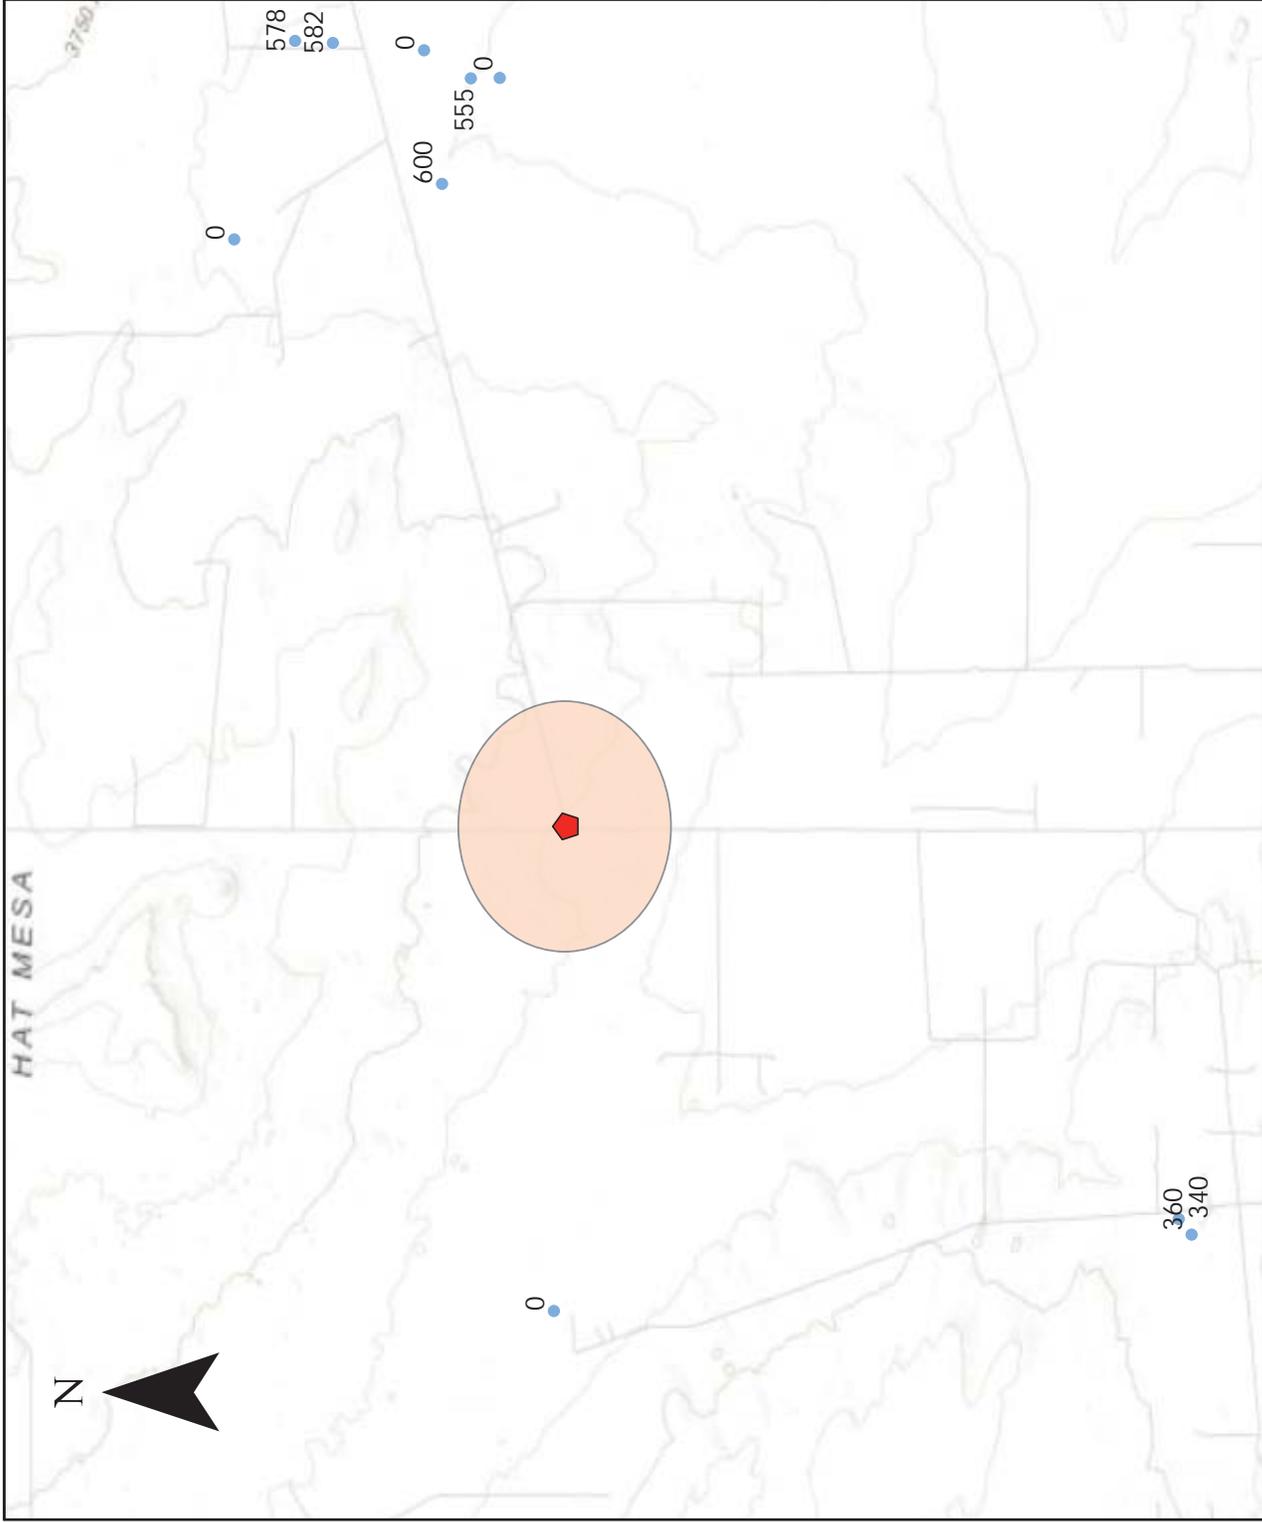
Figure 1

Based upon New Mexico Office of the State Engineer (NMOSE) and United States Geological Survey (USGS) well data, depth to groundwater in the area is estimated to be between 200 and 330 feet below grade surface (bgs). There are no known water sources within ½-mile of the location, according to the NMOSE online water well database ([https://gis.ose.state.nm.us/gisapps/ose\\_pod\\_locations/](https://gis.ose.state.nm.us/gisapps/ose_pod_locations/); accessed June 18, 2019; Appendix B). The nearest significant watercourse is an unnamed intermittent stream, located approximately 5,480 feet to the south. Figure 2 illustrates the site with 200 and 300-foot radii to indicate that it does not lie within a sensitive area as described in 19.15.29.12.C(4) NMAC.

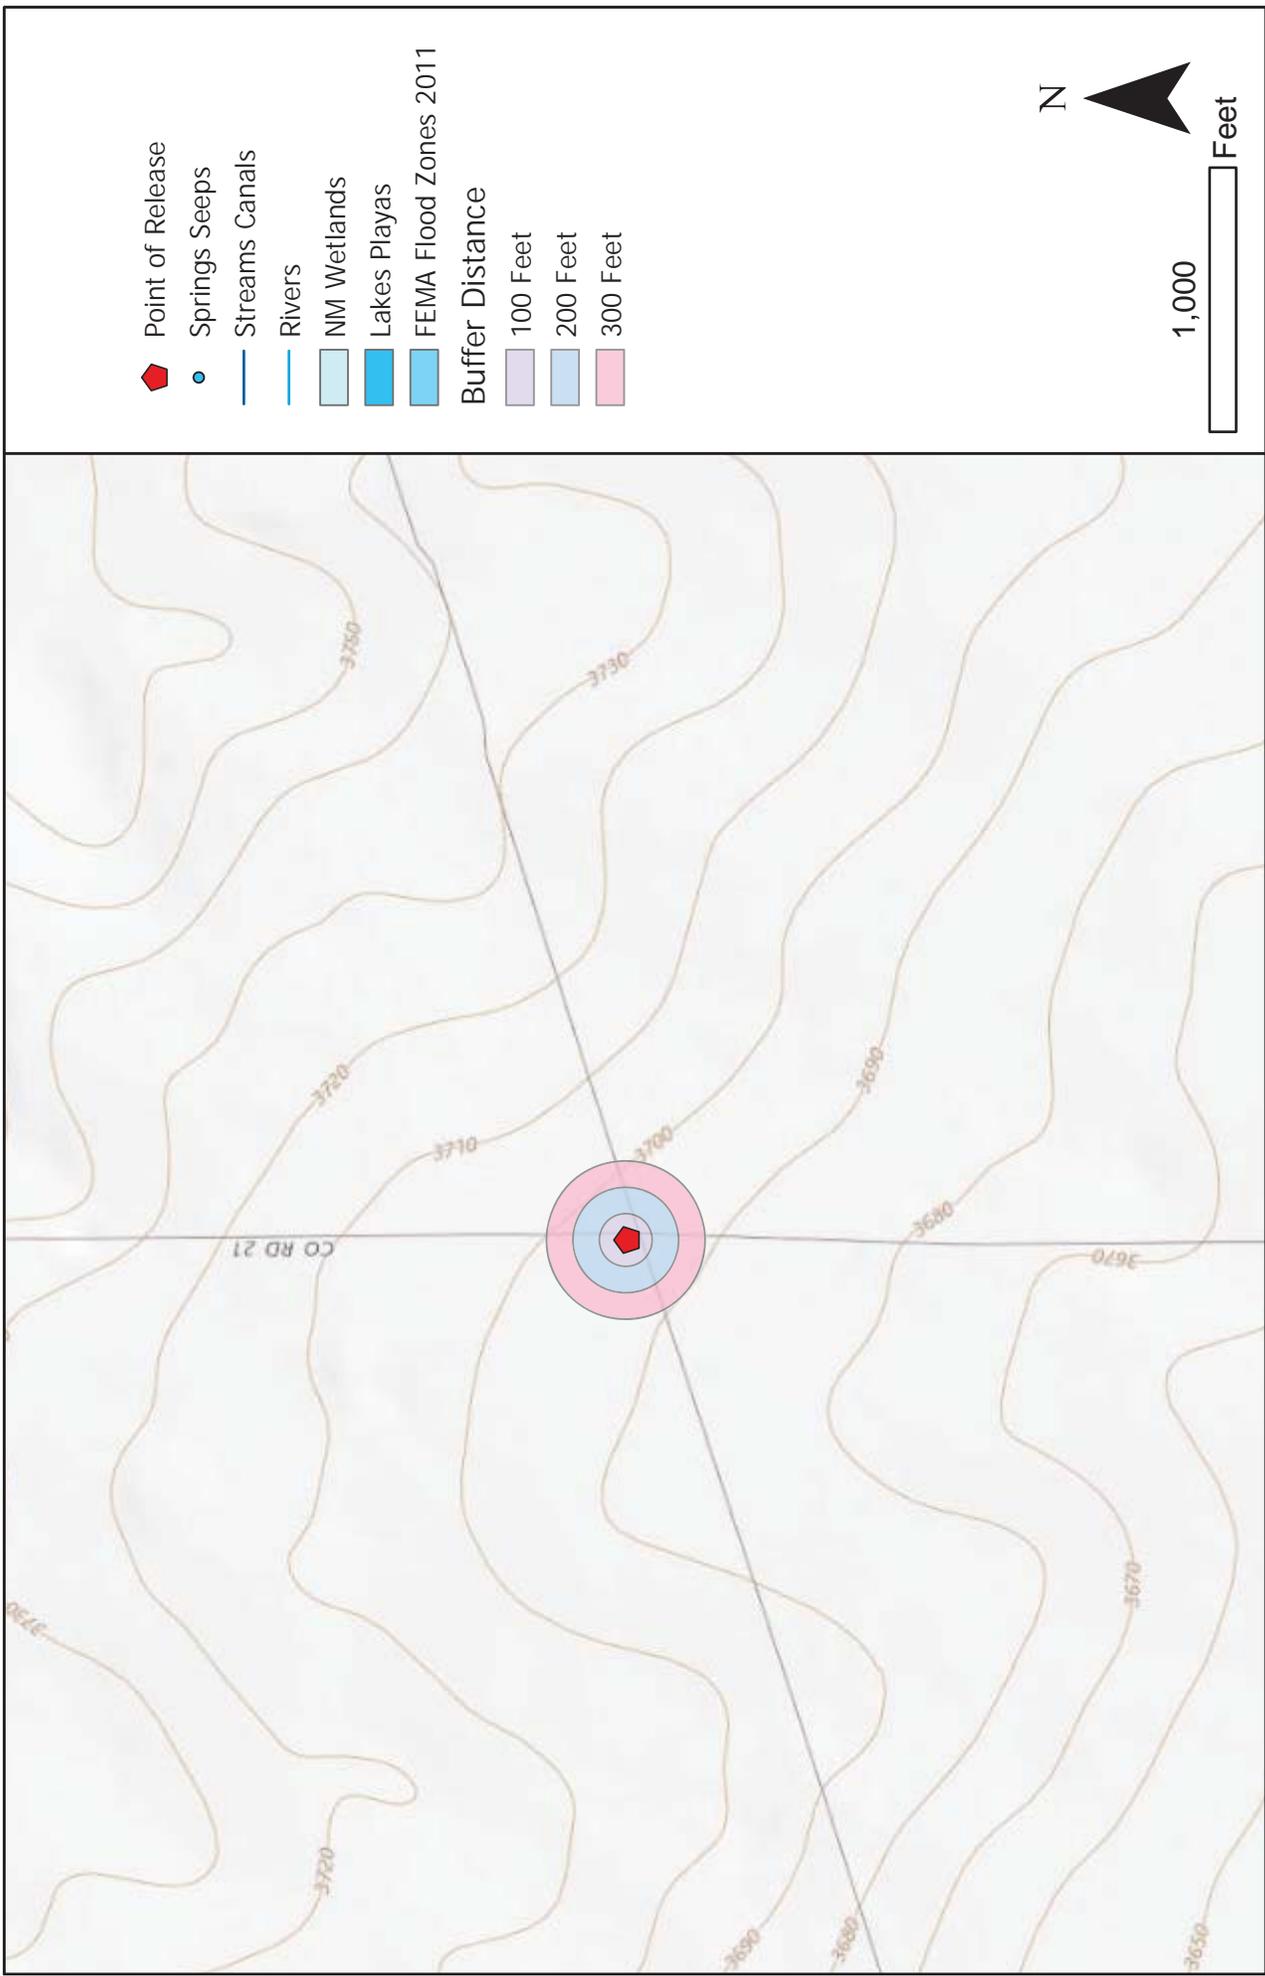
Surface Water Protection Map  
 1009 Pipeline Release (IRP-5596) - Enterprise  
 Sec 36 T21S R32E, Lea County, New Mexico

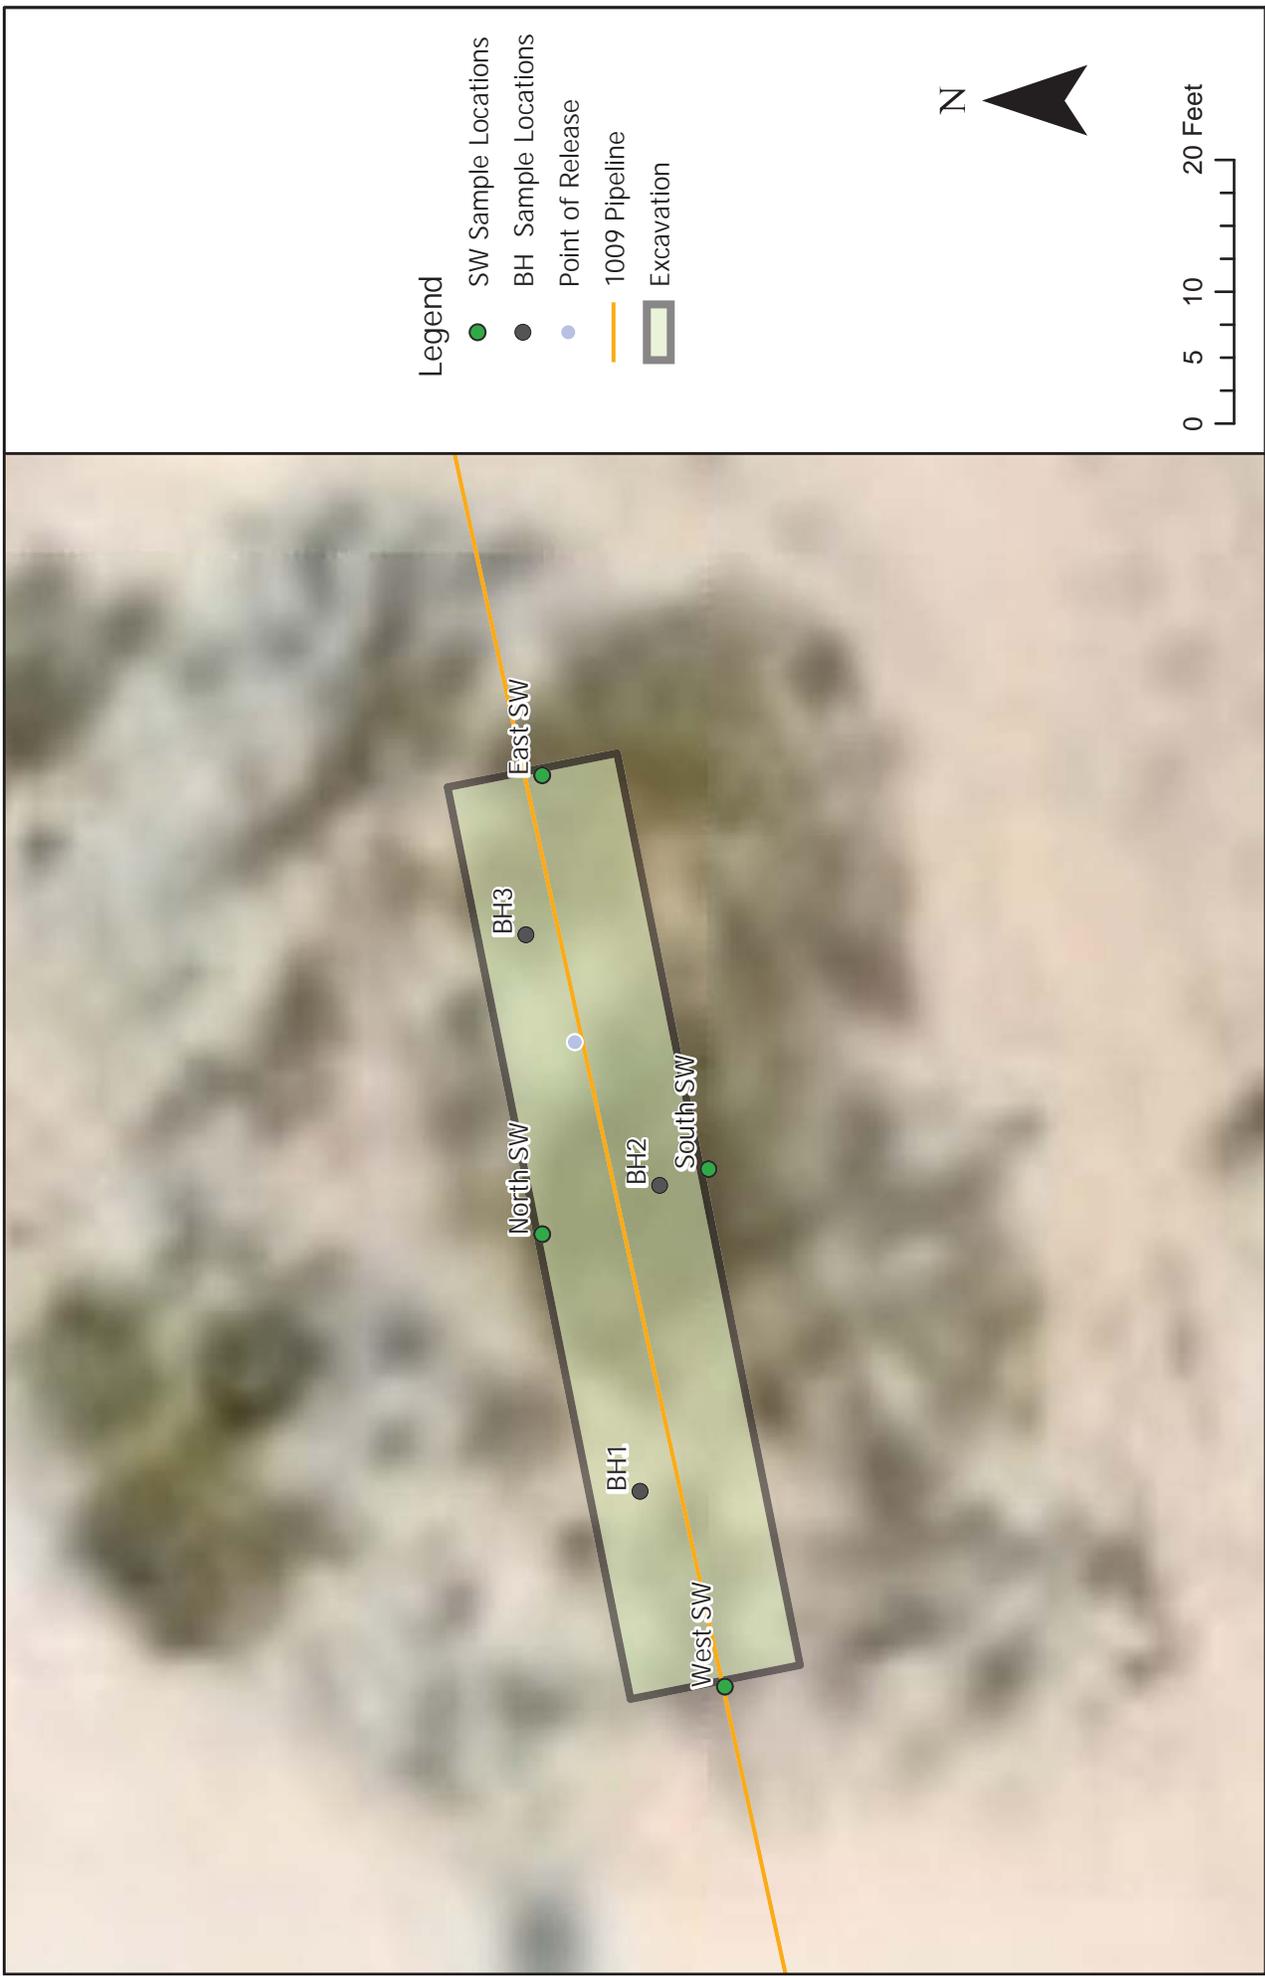
201 South Halaquena Street Centisbad, New Mexico 88221 (575) 689-7040 Serving the Southwest & Rocky Mountains
	<b>Figure 3</b>

At the request of Enterprise, on June 13, 2019, SMA collected composite soil samples from the excavated area exposed for pipeline repair activities to ensure that the release was properly remediated. The excavation measured approximately 10 feet by 50 feet by 5 feet deep. Three samples (BH1-BH3) were collected from beneath the exposed pipeline at depths from 4 to 5 feet below grade surface (bgs). In addition, four (4), five-point composite sidewall samples (North SW, South SW, East SW and West SW) were collected.

Figure 3 shows the extent of the excavation and sample locations. All laboratory results are summarized in Table 3. Laboratory reports are included in Appendix D.

In addition to meeting the Closure Criteria, the top four (4) feet of impacted areas meet the Reclamation requirements of 19.15.29.13(D)(1). Contaminated soils were removed and replaced with clean backfill material to return the surface to previous contours. The contaminated soil was transported and disposed of at an NMOCD permitted disposal facility.

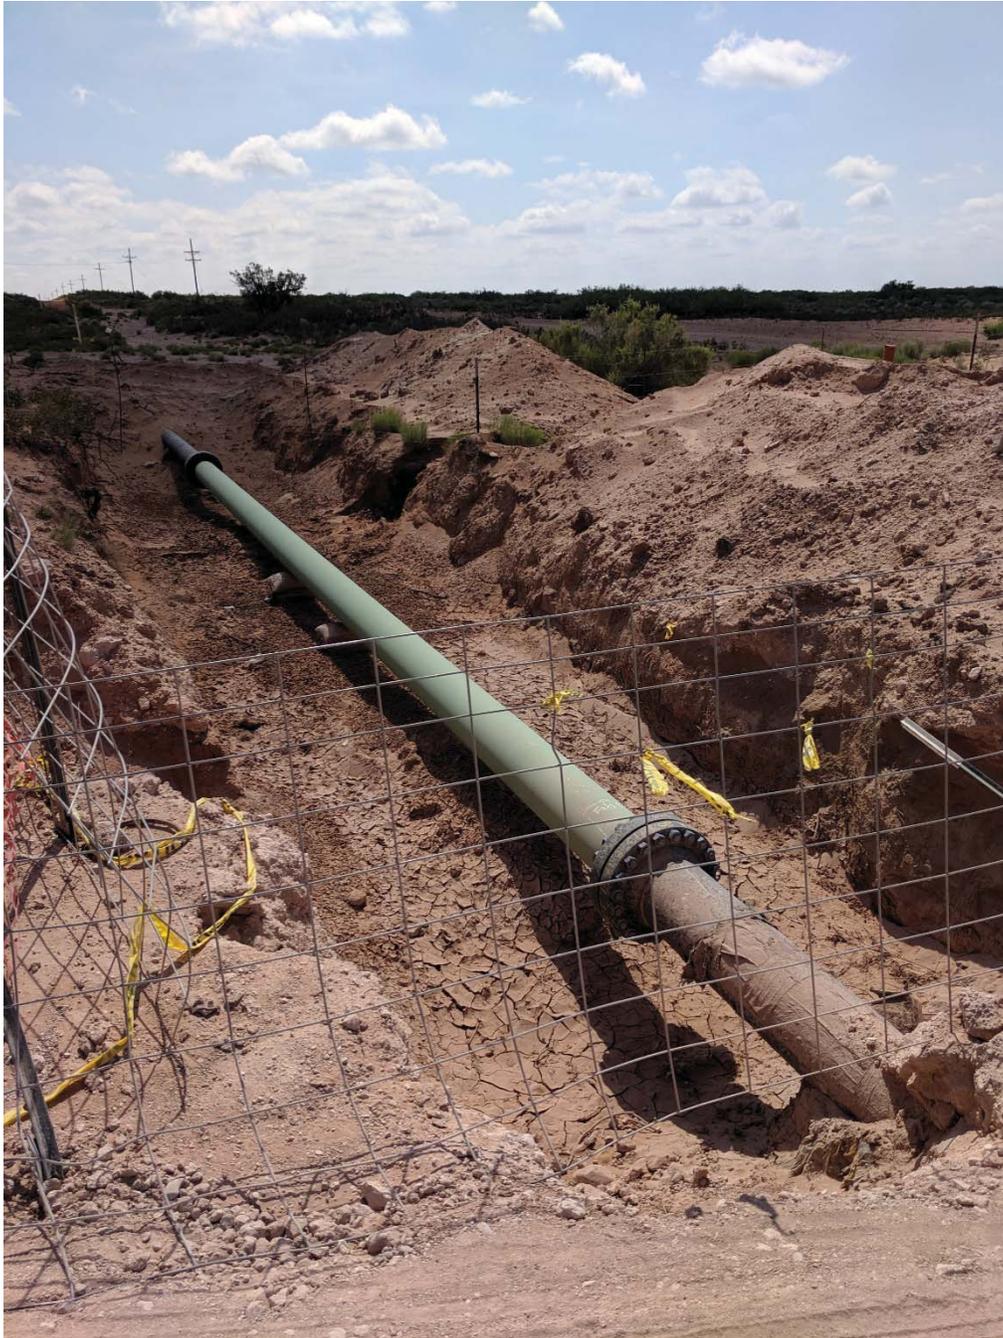
Photo Taken June 13,2019

As summarized in Table 3, results indicated all samples met NMOCD Closure Criteria. The required photo of the excavation is included in Appendix C.

Facing West
