June 10, 2019

#5E27950-BG2

SUBJECT: Remediation Closure Report for the Flowmaster 24 34 15 SB #4H Release (1RP-5431), Lea County, New Mexico

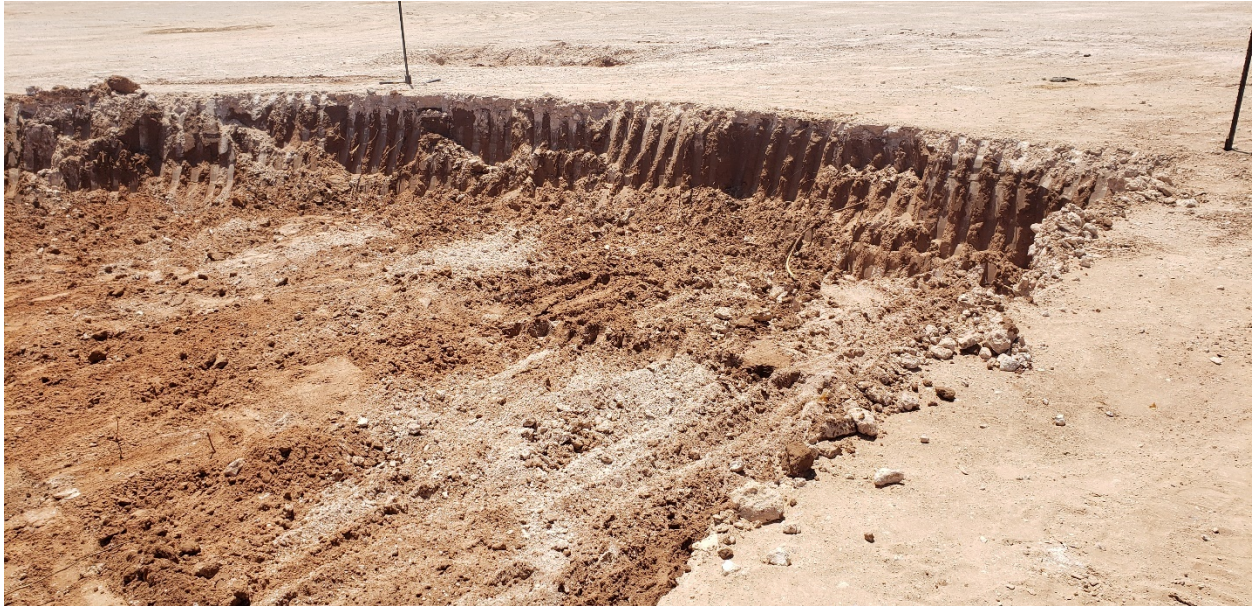
Facing south

32.22405, -103.46317

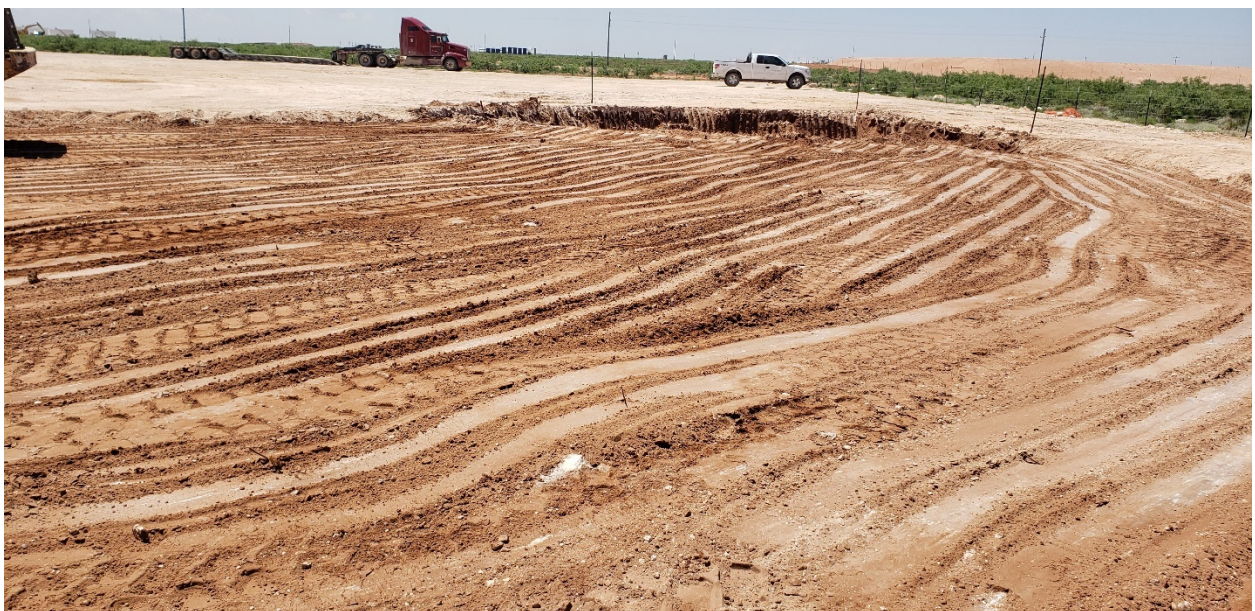
Photo Taken May 29, 2019

Facing North

32.22380, -103.46319
