### **Closure Report**

Re: Geronimo 28 State # 2 SWD  
API# 30-015-40876  
Case # 2RP-4977

On 9/10/2018 a release occurred due to a hole developed on a 4 inch transition. An initial C-141 was submitted to NMOCD and approved on 9/20/2018. The release is located east of Artesia New Mexico (GPS Coordinates 32.80423 -104.17411) in unit letter I section 28 township 17S range 28E. A groundwater survey was conducted utilizing USGS and NMOSE well search in the area which indicates an average depth of groundwater below the release at 157 feet. In the remediation plan submitted to NMOCD Apache Corporation stated in error that the release was in an area of high karst. Attached is the release on the BLM Karst map demonstrating the release is in an area of low karst. Apache Corporation request with this new data that the closure requirements be adjusted from table one standards of less than 50 feet to the closure requirements for releases over 100 feet to ground water.

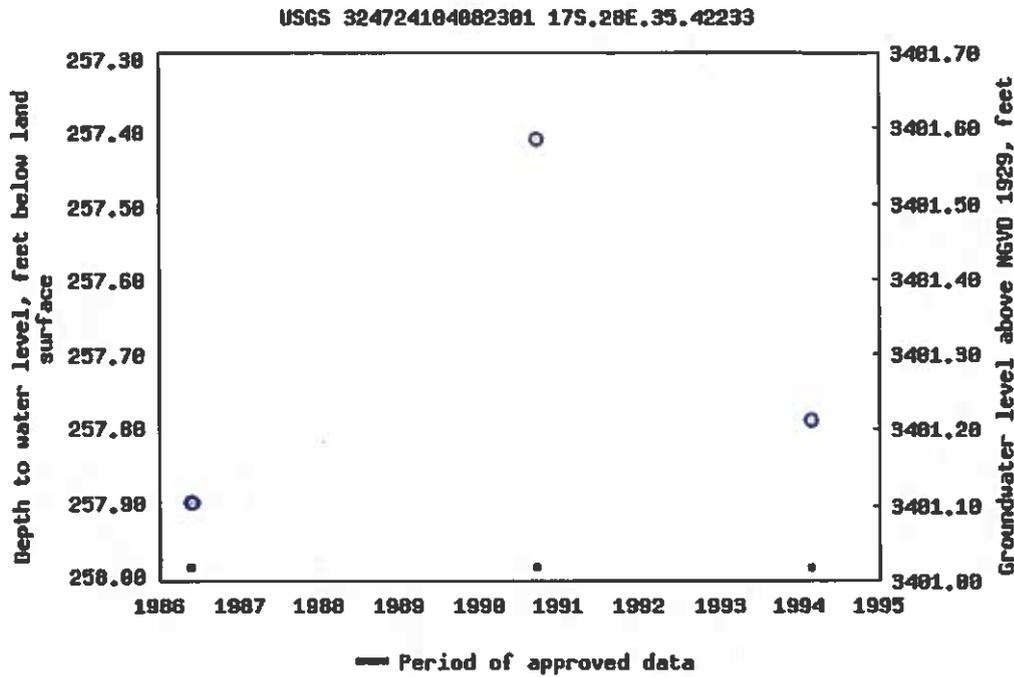
### USGS 324724104082301 17S.28E.35.42233

The depth of the well is 280.00 feet below land surface.

This well is completed in the Rustler Formation (312RSLR) local aquifer.

Breaks in the plot represent a gap of at least one year between field measurements.

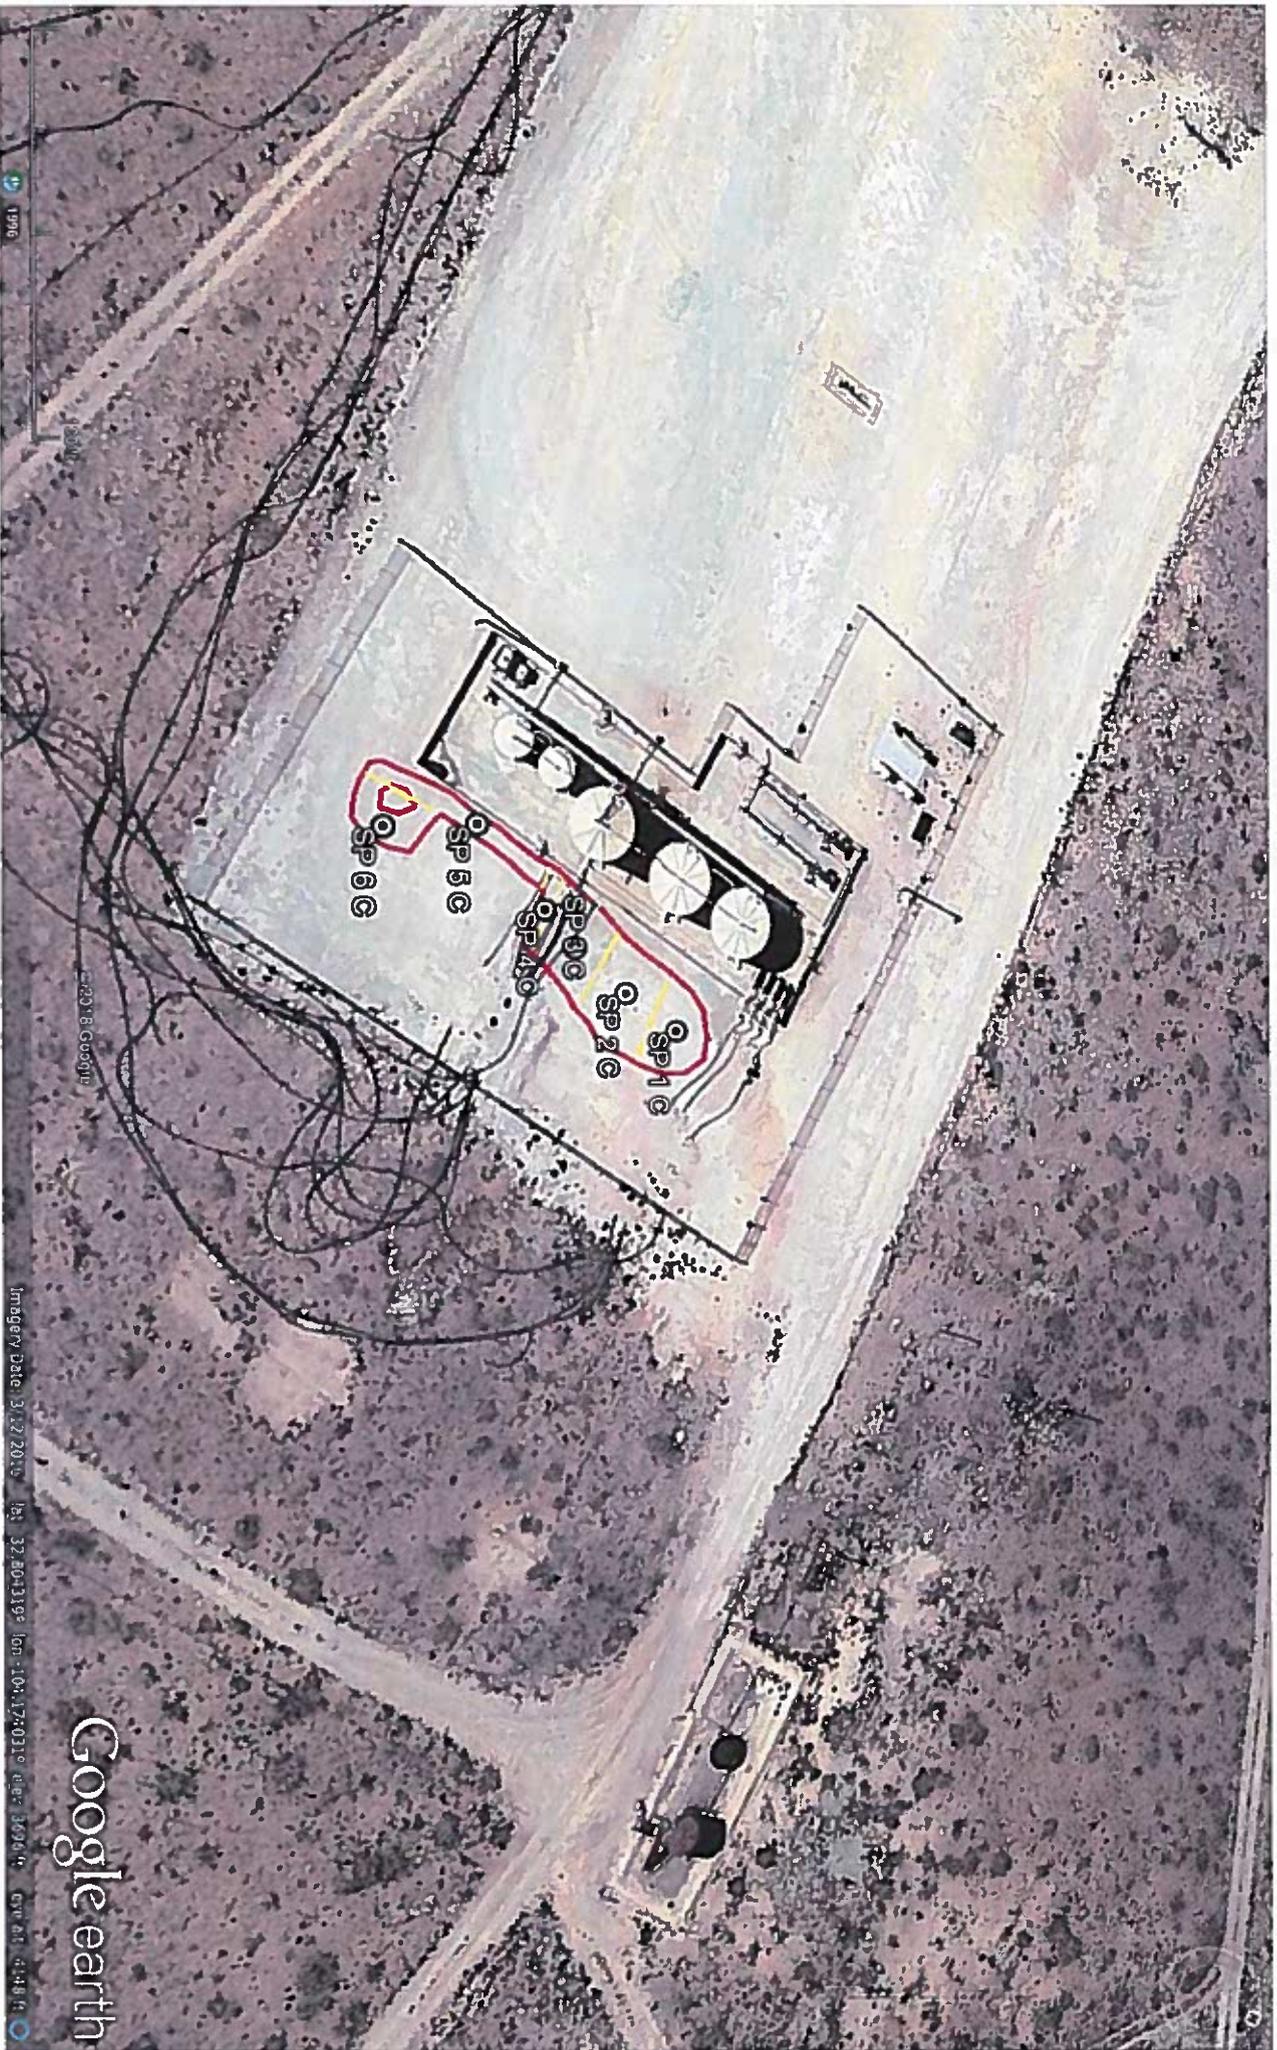
Bottom Final Samples

Sample Pt.	Depth	Chloride	Benzene	Toluene	Ethybenzene	Total Xylenes	Total BTEX	GRO	DRO	EXT DRO	GPS
SP 1 C	Surface	96	<0.050	<0.050	<0.050	<0.150	<0.300	<10	<10	<10	32.804352 -104.174046
SP 2 C	Surface	2280	<0.050	<0.050	<0.050	<0.150	<0.300	<10	<10	<10	32.804298 -104.174049
SP 3 C	Surface	928	<0.050	<0.050	<0.050	<0.150	<0.300	<10	<10	<10	32.804238 -104.174062
SP 4 C	Surface	2000	<0.050	<0.050	<0.050	<0.150	<0.300	<10	<10	<10	32.804203 -104.174081
SP 5 C	Surface	3120	<0.050	<0.050	<0.050	<0.150	<0.300	<10	<10	<10	32.804122-104.174118
SP 6 C	Surface	3640	<0.050	<0.050	<0.050	<0.150	<0.300	<10	<10	<10	32.804056 -104.174071

On 6/3/2019 final 5 point bottom composite samples were collected and submitted to a commercial laboratory for analysis of chloride, TPH, and BTEX. All laboratory results are below table one standards for sites over 100 feet to ground water. Apache Corporation respectfully request that 2RP-4977 be closed.
