## Release Notification **SO90U-190802-C-1410**

Site Name Goldenchild Central Tank Battery	Site Type Bulk Storage and Separation Facility
Date Release Discovered 7/21/2019	API# (if applicable) 30-015-41846 (Goldenchild 6 St SWD)

**RE: Closure Request  
Goldenchild Central Tank Battery  
Remediation Permit Number 2RP-5590  
Eddy County, New Mexico**

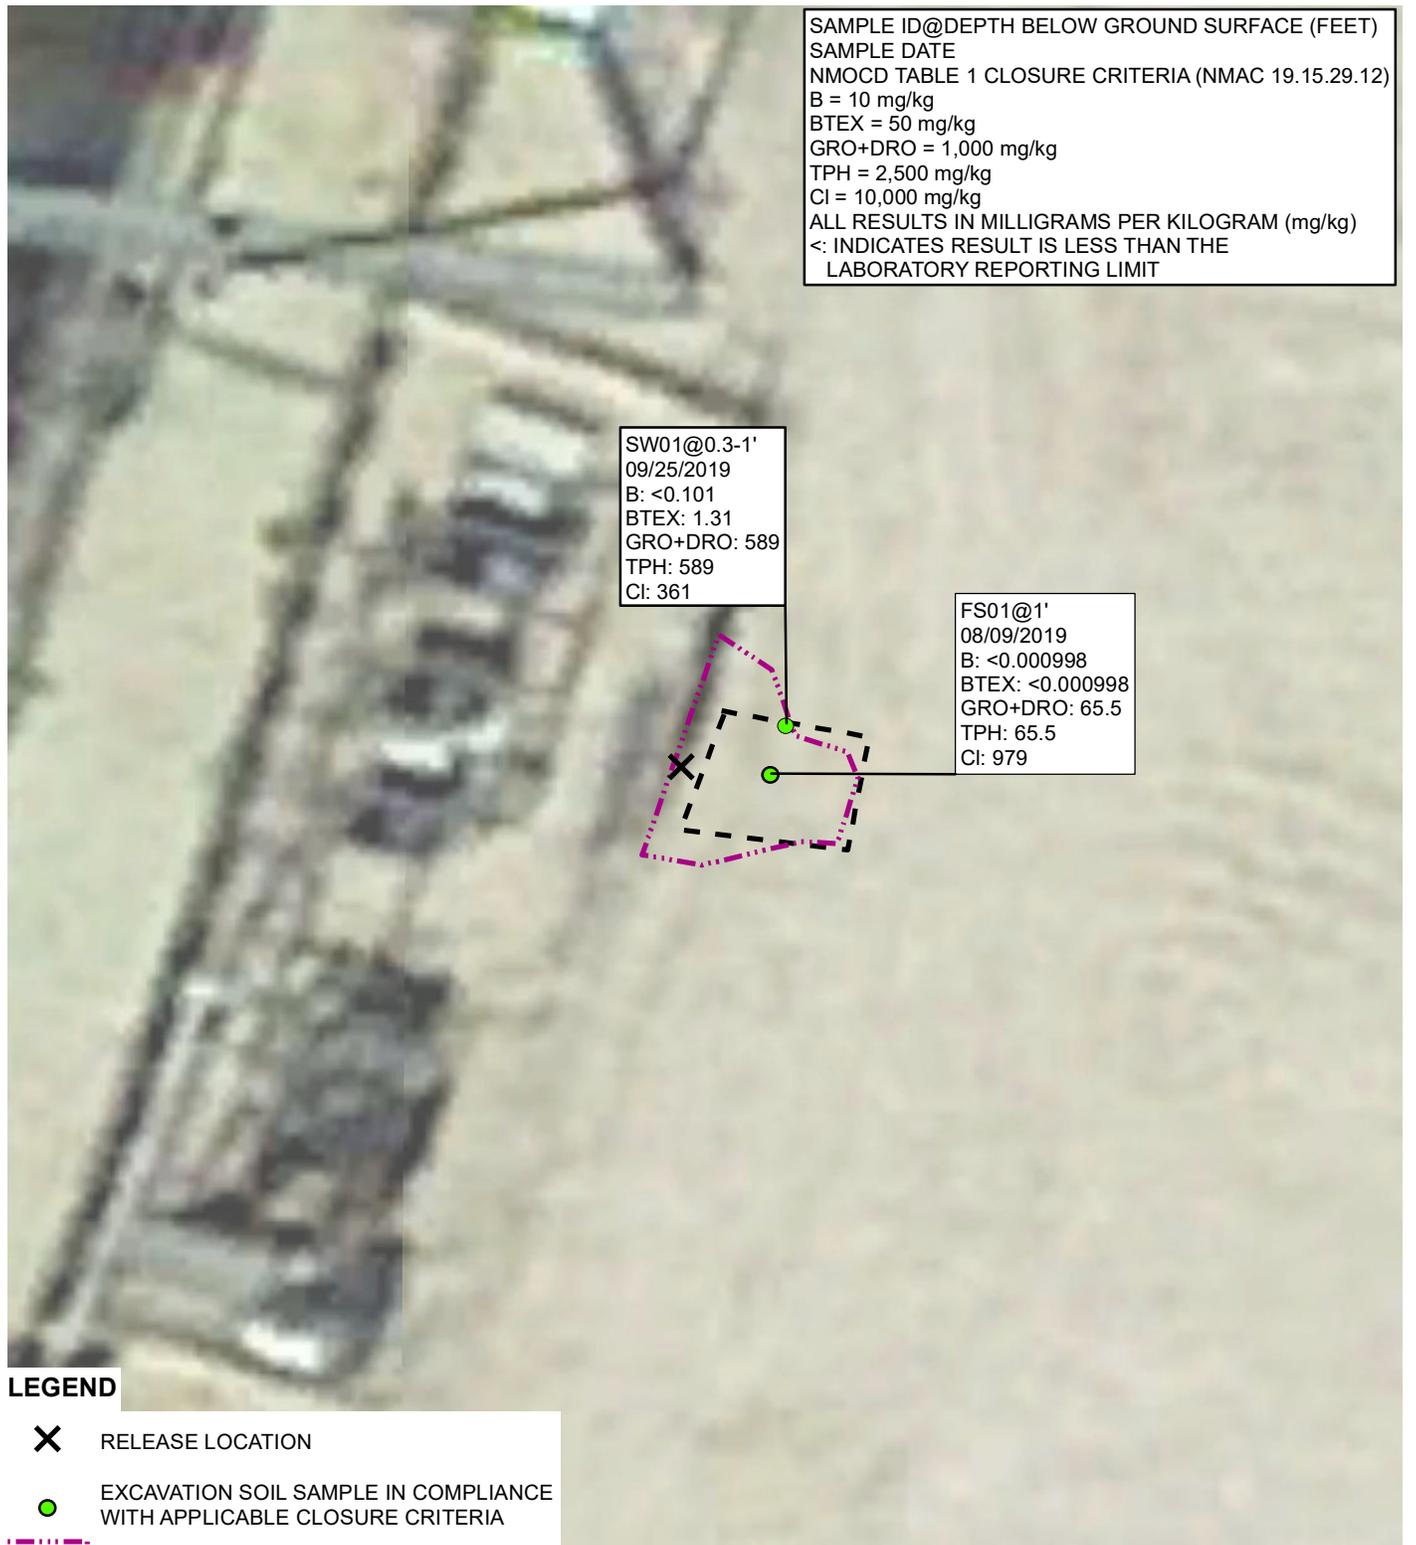
**FIGURE 2**  
 EXCAVATION SOIL SAMPLE LOCATIONS  
 GOLDENCHILD CENTRAL TANK BATTERY  
 UNIT P SEC 6 T25S R29E  
 EDDY COUNTY, NEW MEXICO  
 XTO ENERGY, INC.

SW01@0.3-1'  
 09/25/2019  
 B: <0.101  
 BTEX: 1.31  
 GRO+DRO: 589  
 TPH: 589  
 Cl: 361

FS01@1'  
 08/09/2019  
 B: <0.000998  
 BTEX: <0.000998  
 GRO+DRO: 65.5  
 TPH: 65.5  
 Cl: 979

The final excavation extent measured approximately 50 square feet in area. A total of approximately 2 cubic yards of impacted soil were removed from the excavation. The impacted soil was transported and properly disposed of at the R360 landfill facility located in Hobbs, New Mexico.

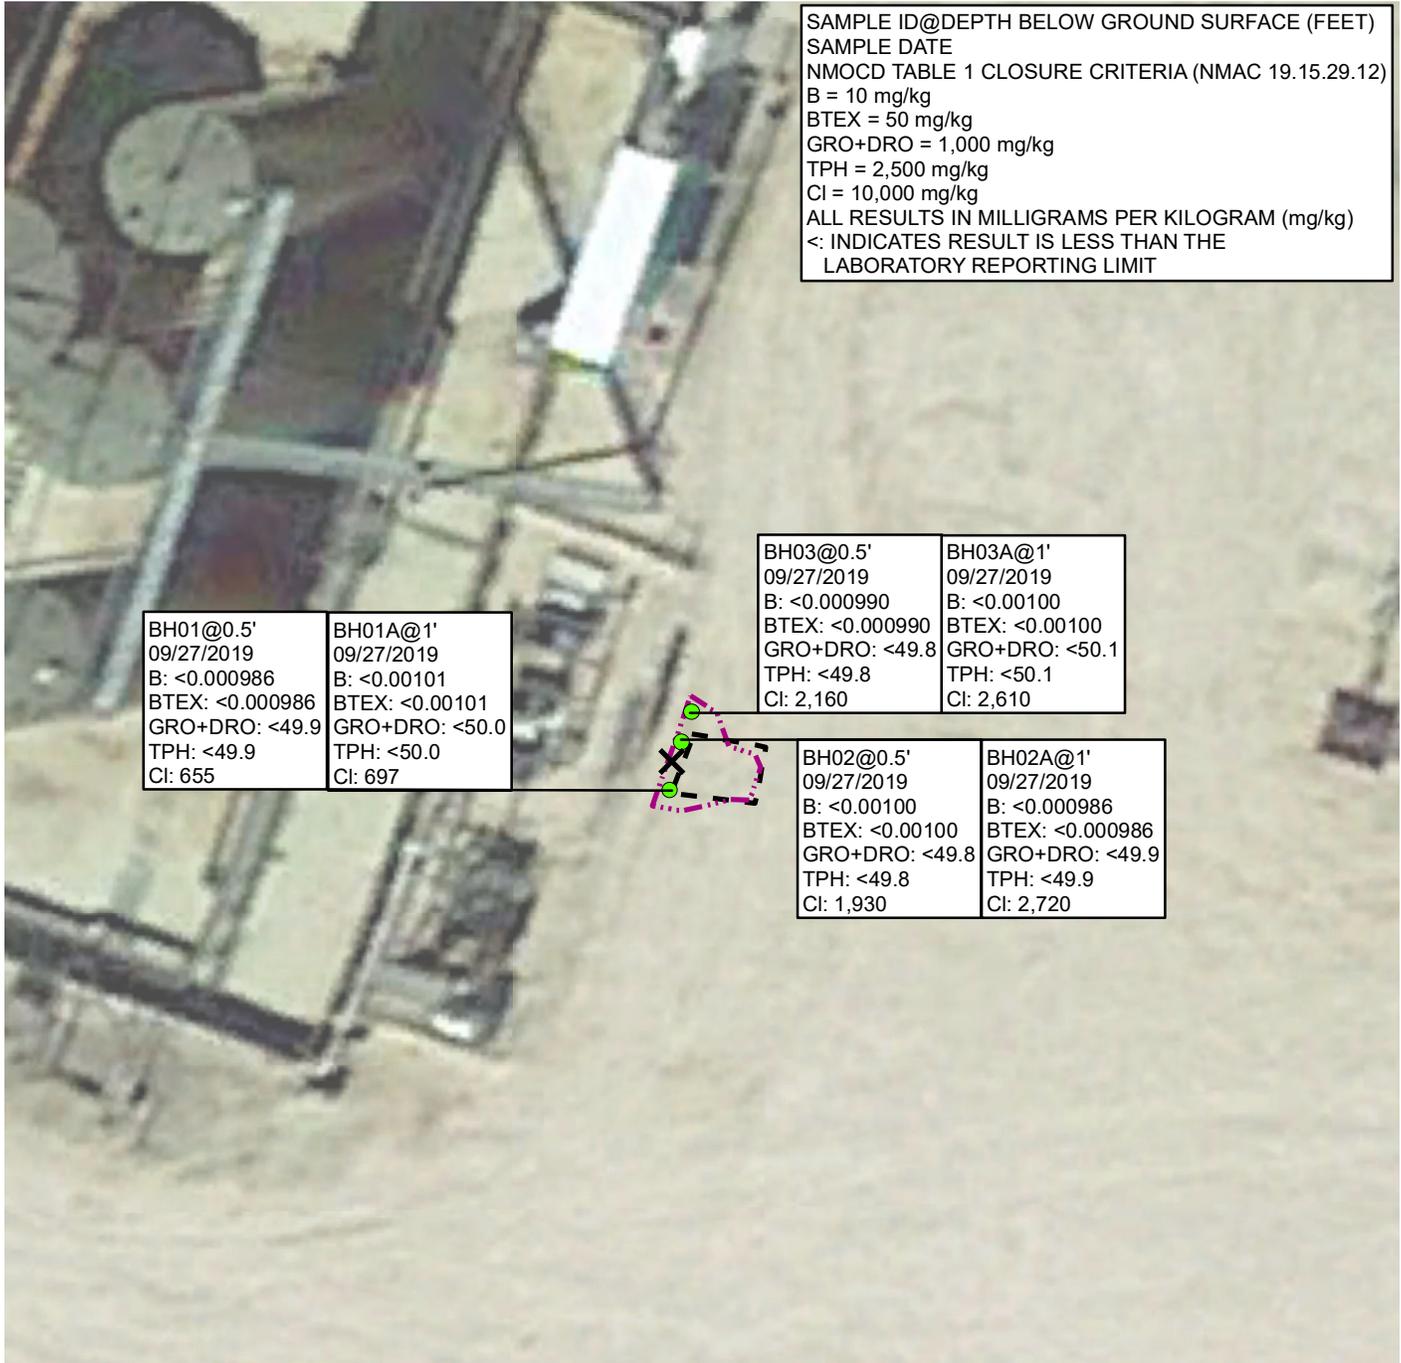
BH01@0.5' 09/27/2019 B: <0.000986 BTEX: <0.000986 GRO+DRO: <49.9 TPH: <49.9 Cl: 655	BH01A@1' 09/27/2019 B: <0.00101 BTEX: <0.00101 GRO+DRO: <50.0 TPH: <50.0 Cl: 697
---	--

On September 27, 2019, LTE personnel returned to the Site to oversee soil assessment activities in the area of the release extent that was not excavated. Boreholes were advanced via hand auger at three locations (BH01 through BH03), immediately surrounding the point of release. Boreholes BH01 through BH03 were advanced to a depth of approximately 1 foot bgs. Two soil samples were collected from each borehole at depths of approximately 0.5 feet and 1 foot bgs. Soil from the boreholes was field screened for volatile aromatic hydrocarbons and chloride. Field screening results and observations for each borehole were logged on lithologic/soil sampling logs, which are included in Attachment 3. The delineation soil samples were collected, handled, and analyzed as described above. The boreholes were backfilled with the soil removed. The release extent and the borehole and delineation soil sample locations are depicted on Figure 3.

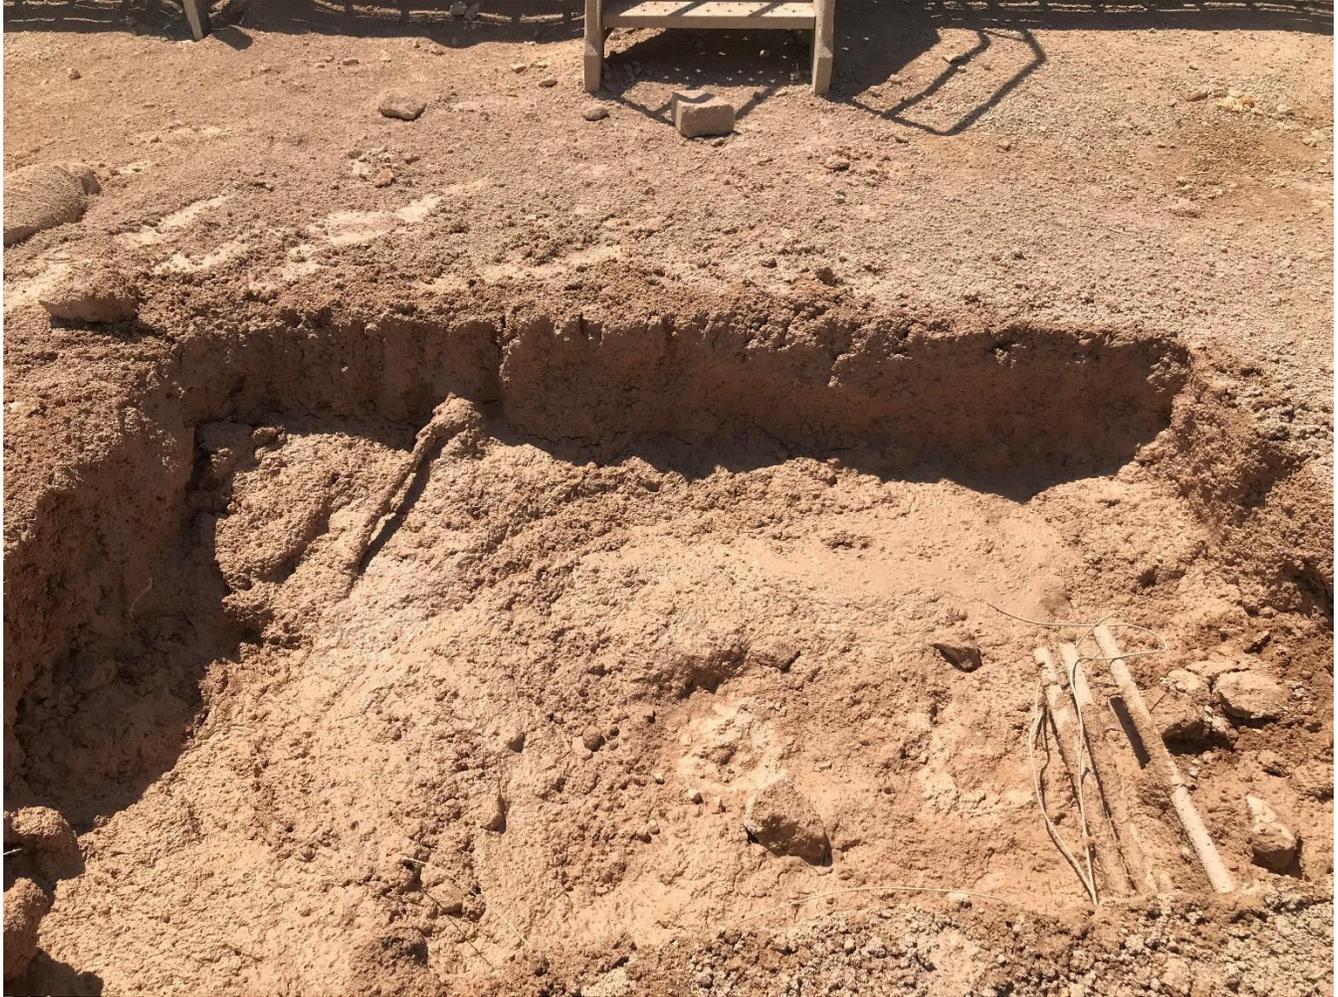
**Western view of excavation extent during confirmation soil sampling activities.**

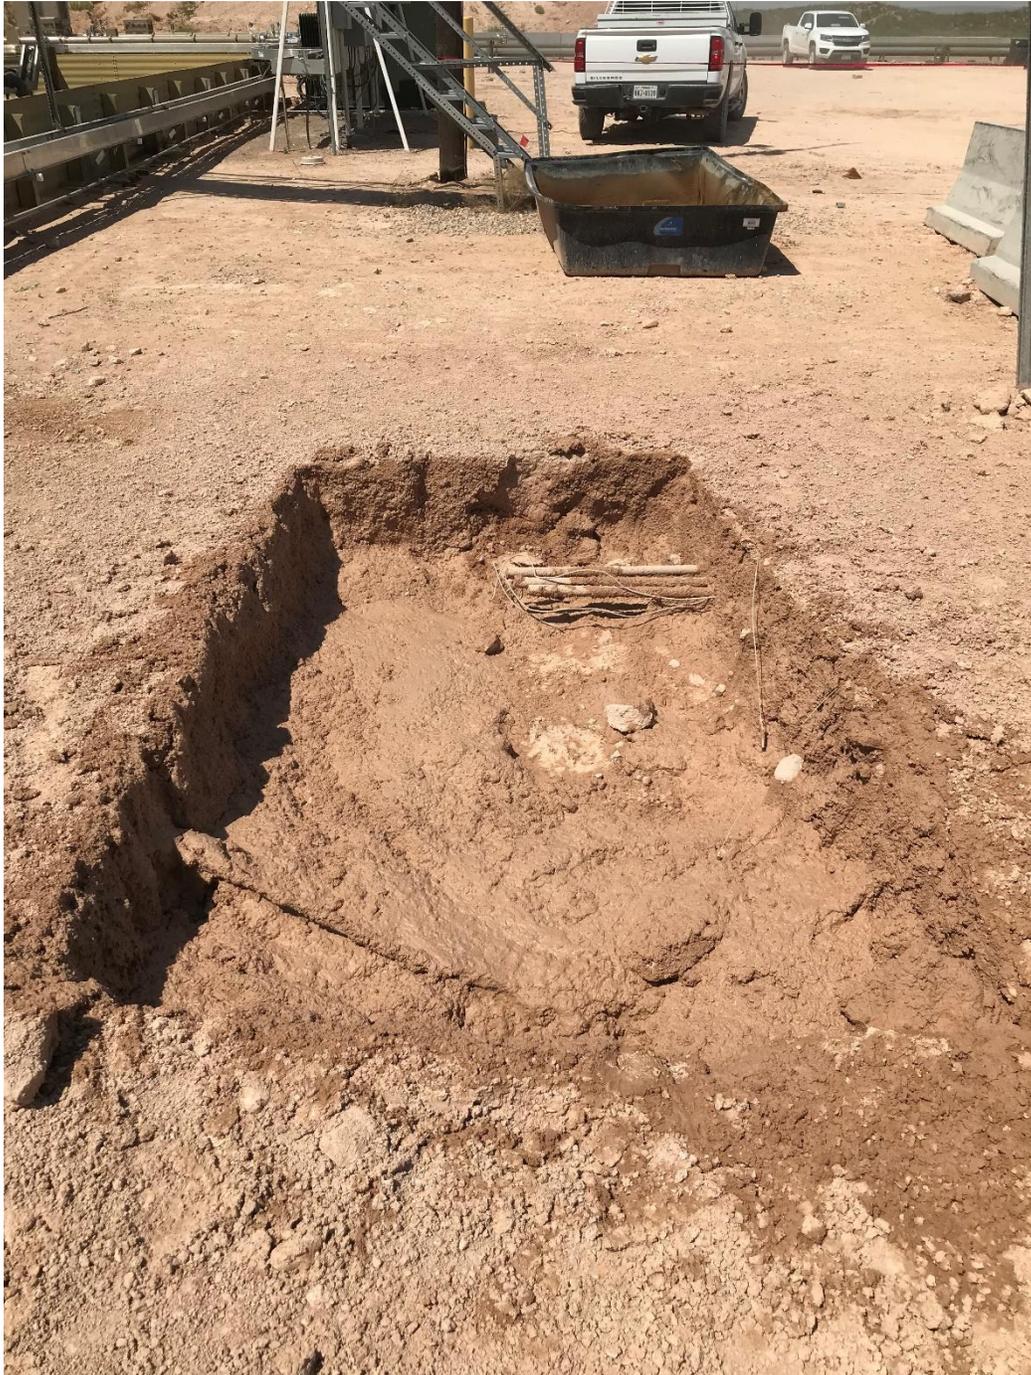
**Northern view of excavation extent during confirmation soil sampling activities.**
