October 16, 2019

#5E27950-BG11

SUBJECT: Remediation Closure Report for the State AA #001 SWD Release (1RP-5257), Lea County,  
 New Mexico

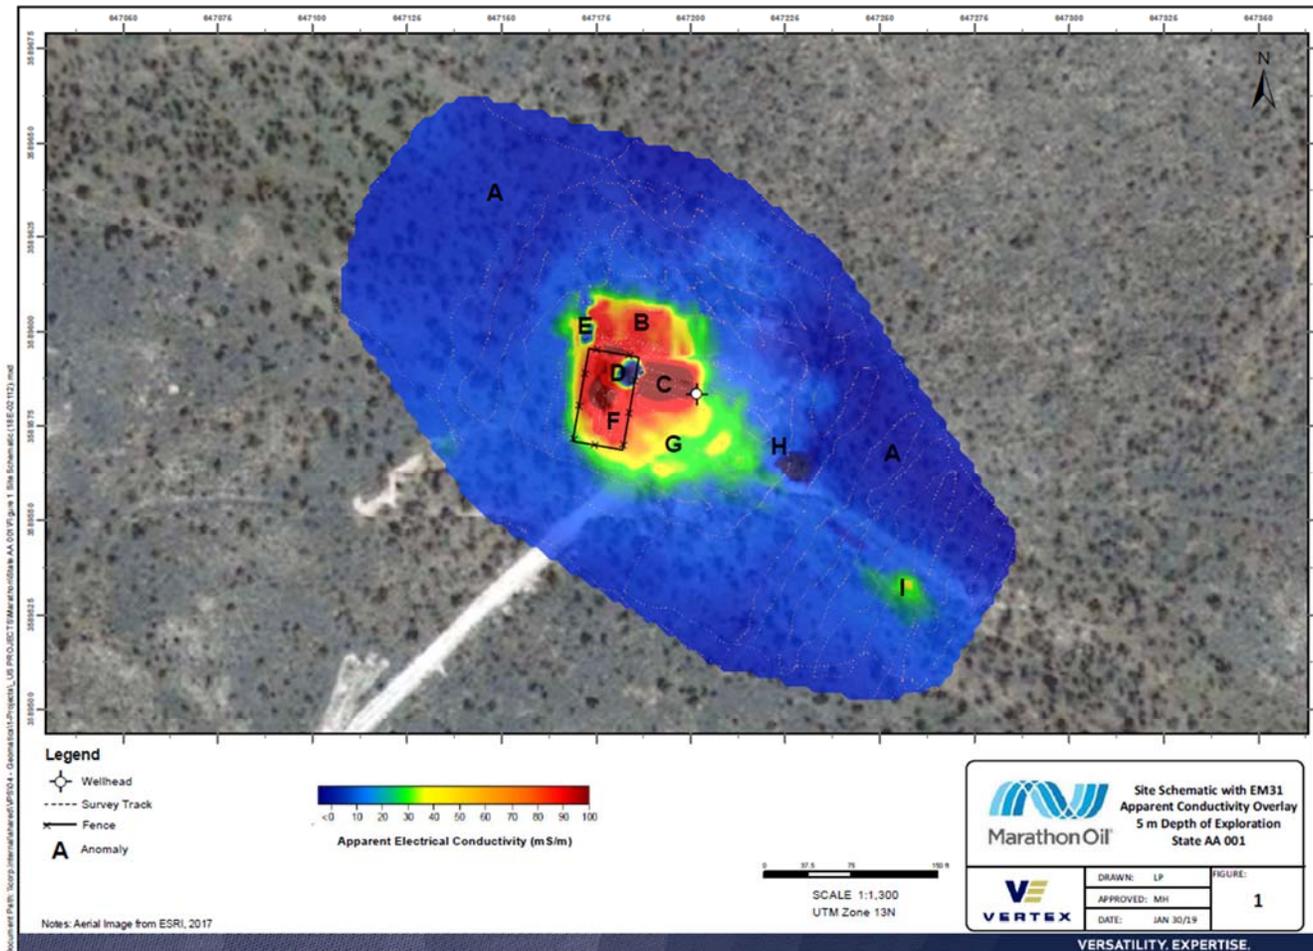
Image 1. Vertex EM Survey Results

Results of the survey indicated elevated conductivity levels, relative to background, on the well pad, particularly in the areas of the tank battery, north of the tank battery, and northeast of the tank battery, as shown in Image 1, below. The highest conductivity readings (>100 – 200 milli-Siemen/meter (mS/M)) were reported inside the tank battery where the release occurred, and along the pipe that runs from the

pump to the injection wellhead. The specific depth of the elevated conductivity could not be determined using the EM survey method; however, the effective measurement depth of the instrument is approximately 16 feet and readings are a weighted average. Note that a small hotspot occurred southeast of the tank battery (denoted as "I" in Image 1); this hotspot was a result of two partially buried metal stakes and not due to contamination.

On January 9, 2019, Vertex Resource Services Inc. (Vertex) conducted an electromagnetic (EM) survey of the entire wellsite and extending off the wellsite. The purpose of the EM survey was to map variations in ground conductivity that may identify the location of and extent of a produced water release, which are typically high in chlorides and exhibit high conductivity readings. The survey was performed using a Geonics EM31 Terrain Conductivity Meter at 10-yard spaced transects across the site.

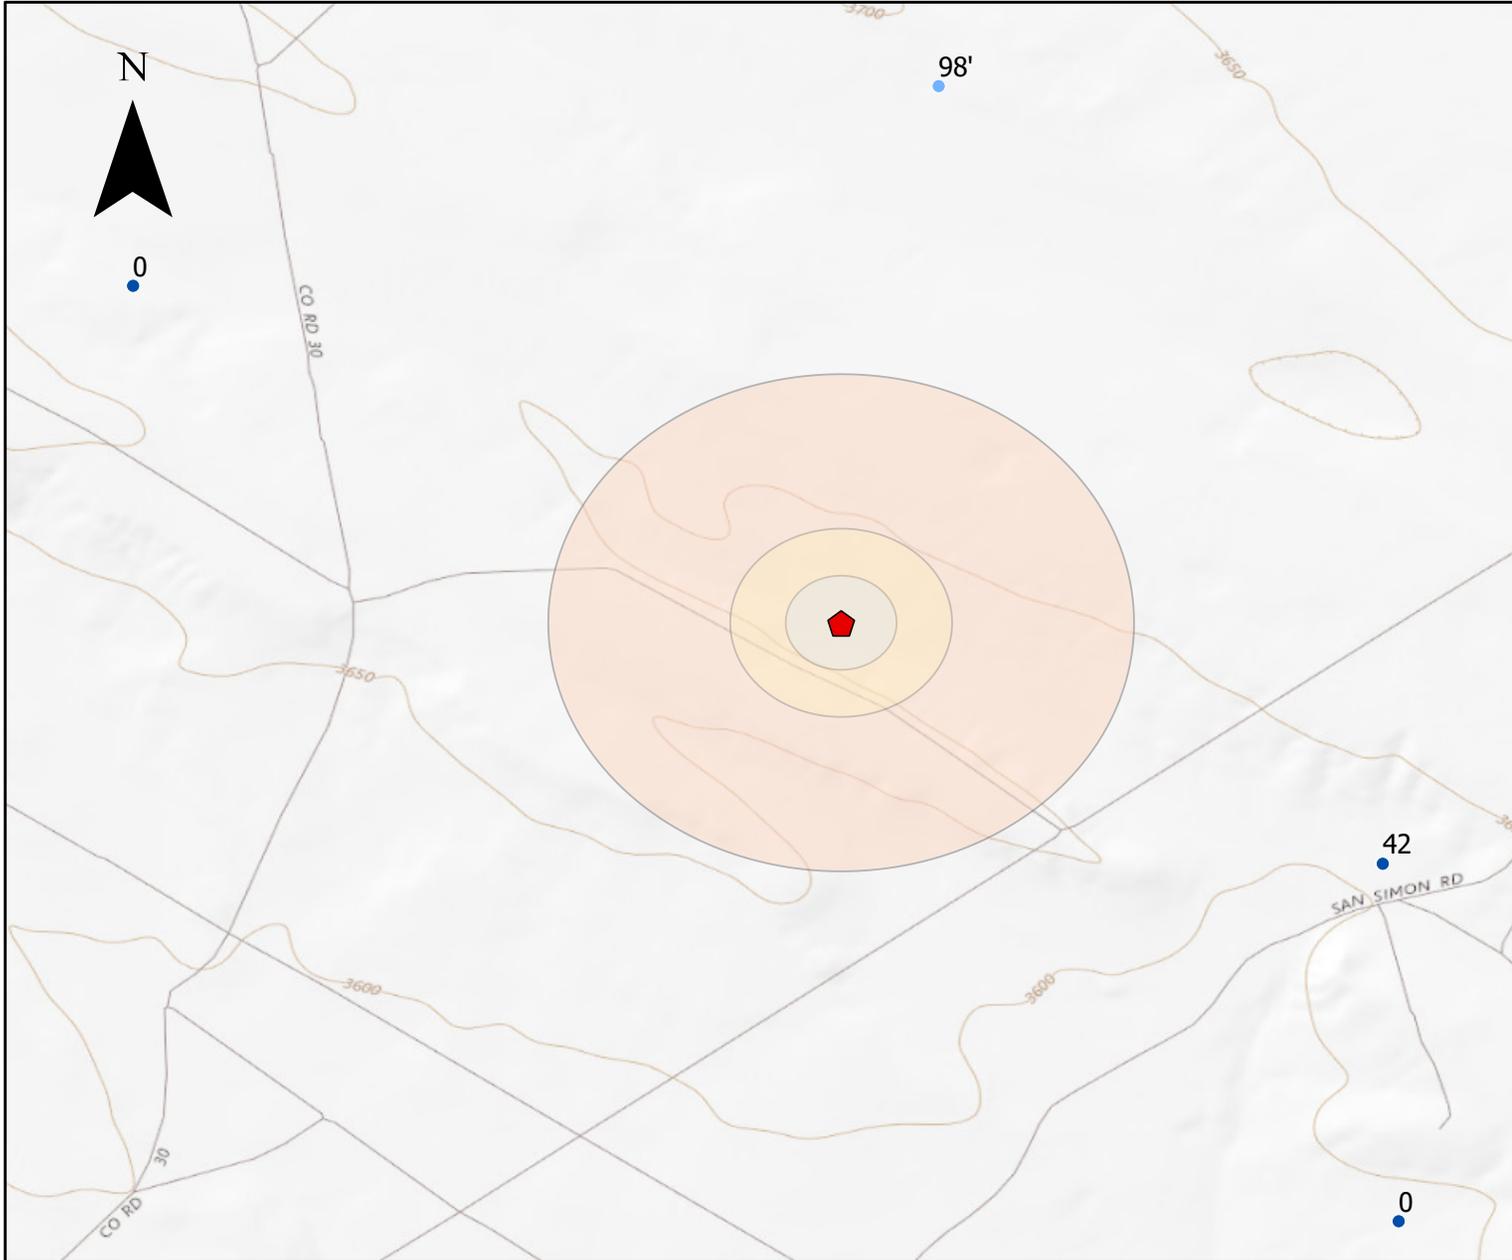
*Figure 1*

*Regional Vicinity & Wellhead Protection Map  
State AA #1- Marathon  
Sec 35 T21S R34E, NM*

Figure 1 illustrates the vicinity and site location, Figures 2 and 3 illustrate the release location. The C-141 form is included in Appendix A.

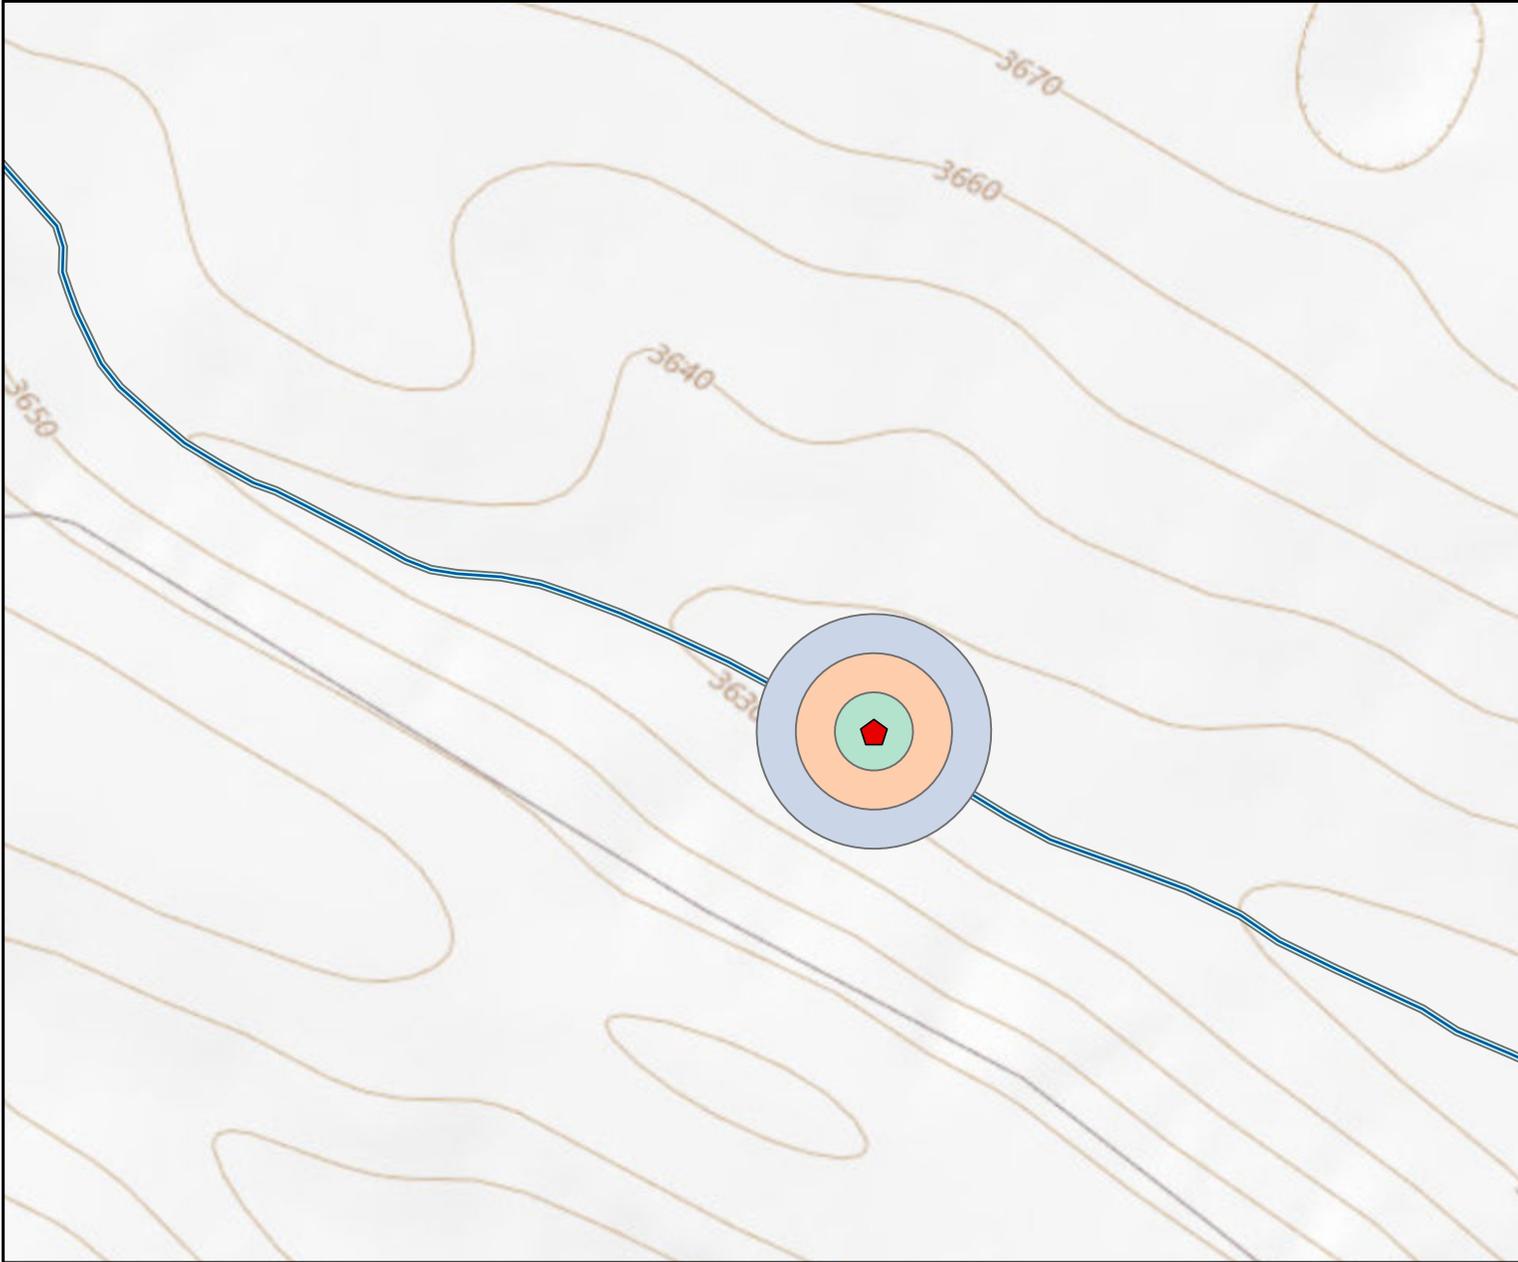
The site is located within a depression along the path of an unnamed arroyo, according to the San Simon Ranch Quad 7.5-min USGS topographic map. Figure 2 illustrates the site with 200 and 300-foot radii to indicate that it does lie within a sensitive area (unnamed arroyo) as described in 19.15.29.12.C(4) NMAC.

Surface Water Protection Map  
 State AA #1- Marathon  
 Sec 35 T21S R34E, NM

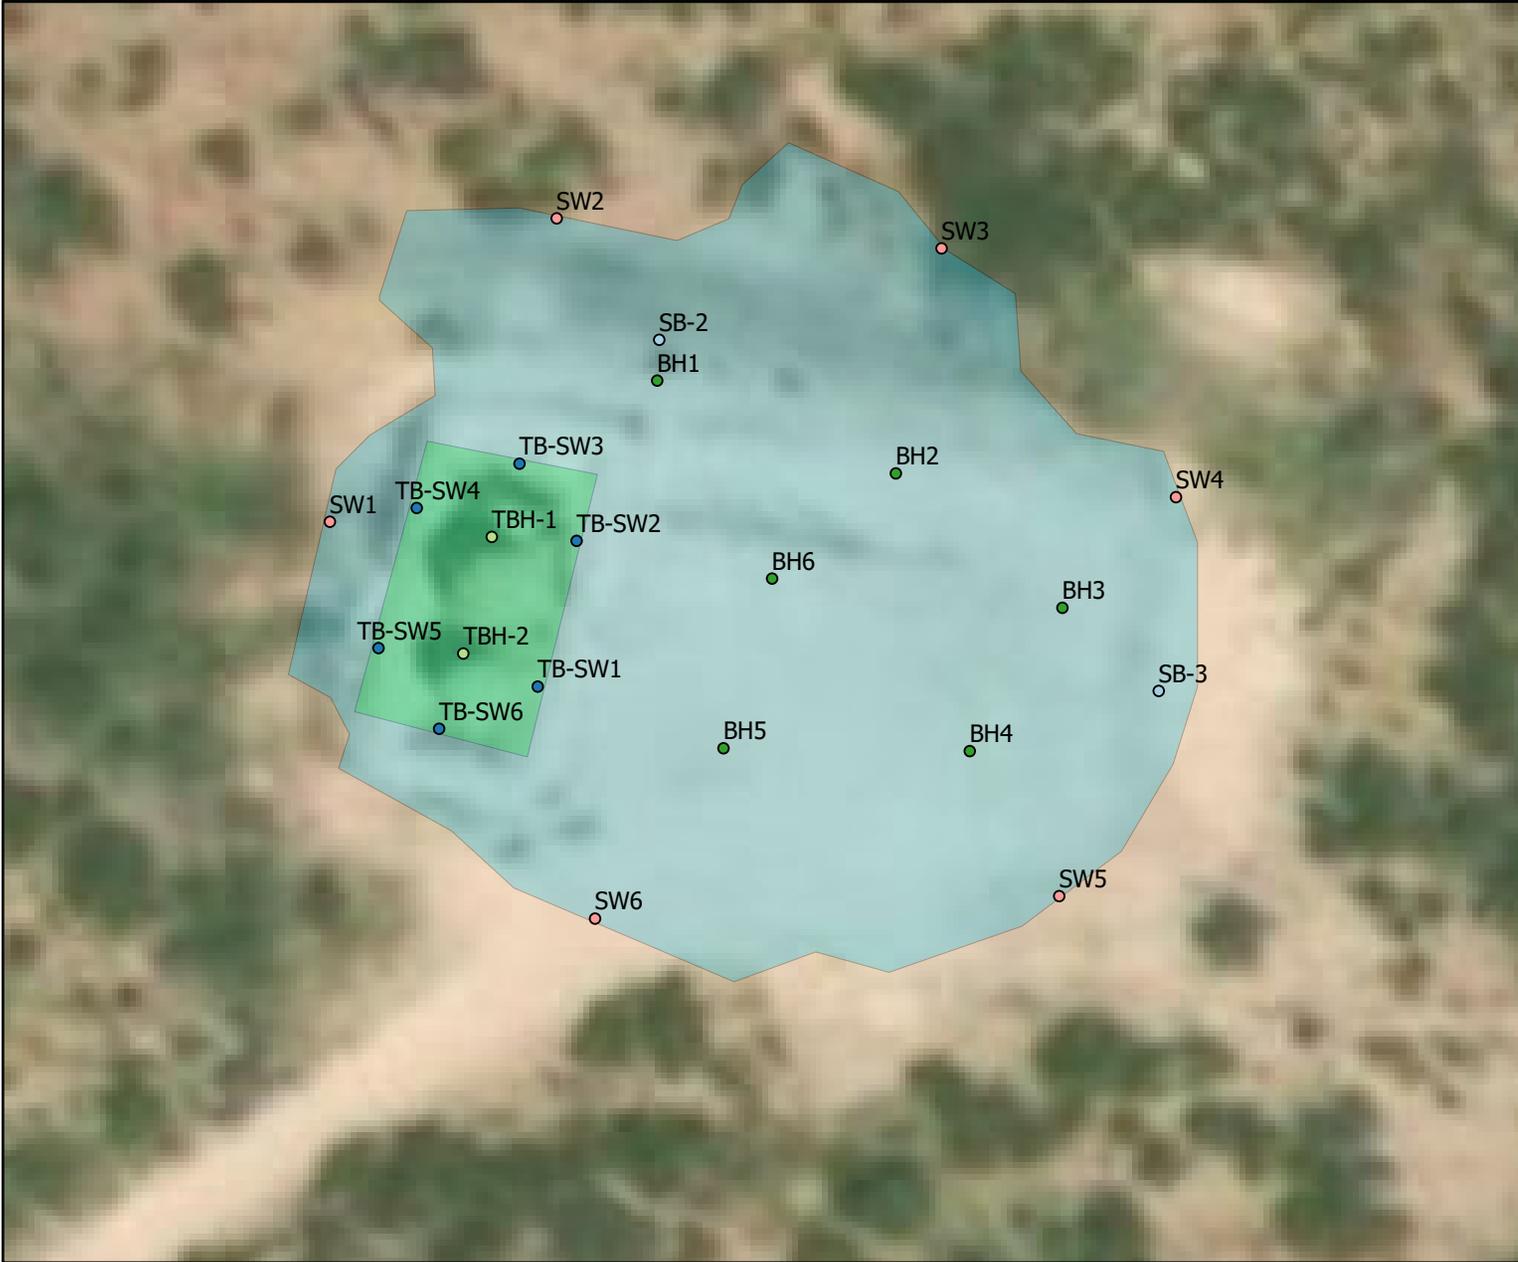
Figure 3 shows the extent of the excavation and sample locations. All confirmation laboratory results are summarized in Table 3. Laboratory reports are included in Appendix D.

Site and Sample Location Map  
 State AA #001 SWD - Marathon Oil LLC  
 Sec35 T21S R34E, Lea County, New Mexico

The tank battery area was excavated 10 feet bgs. Confirmation samples were comprised of five-point composites of the base (TBH-1 and TBH-2) and walls (TB-SW1 through TB-SW6). A total of eight (8) confirmation samples were collected within the tank battery and a bentonite liner was installed at the base of the excavation. Tank battery samples were analyzed for total chloride using EPA Method 300.0 and MRO, DRO, and GRO by EPA Method 8015D.

The area outside the tank battery and on the well pad was excavated to four (4) feet bgs, with the sidewalls extended until chloride levels were below 600 ppm. Confirmation samples were comprised of five-point composites of the base (BH1-BH6) and walls (SW1-SW6). A total of 12 confirmation samples were collected on the well pad and a bentonite liner was installed at the base of the excavation. Well pad base samples were analyzed for total chloride using EPA Method 300.0 and MRO, DRO, and GRO by EPA Method 8015D. Well pad sidewall samples were analyzed for total chloride using EPA Method 300.0 only.

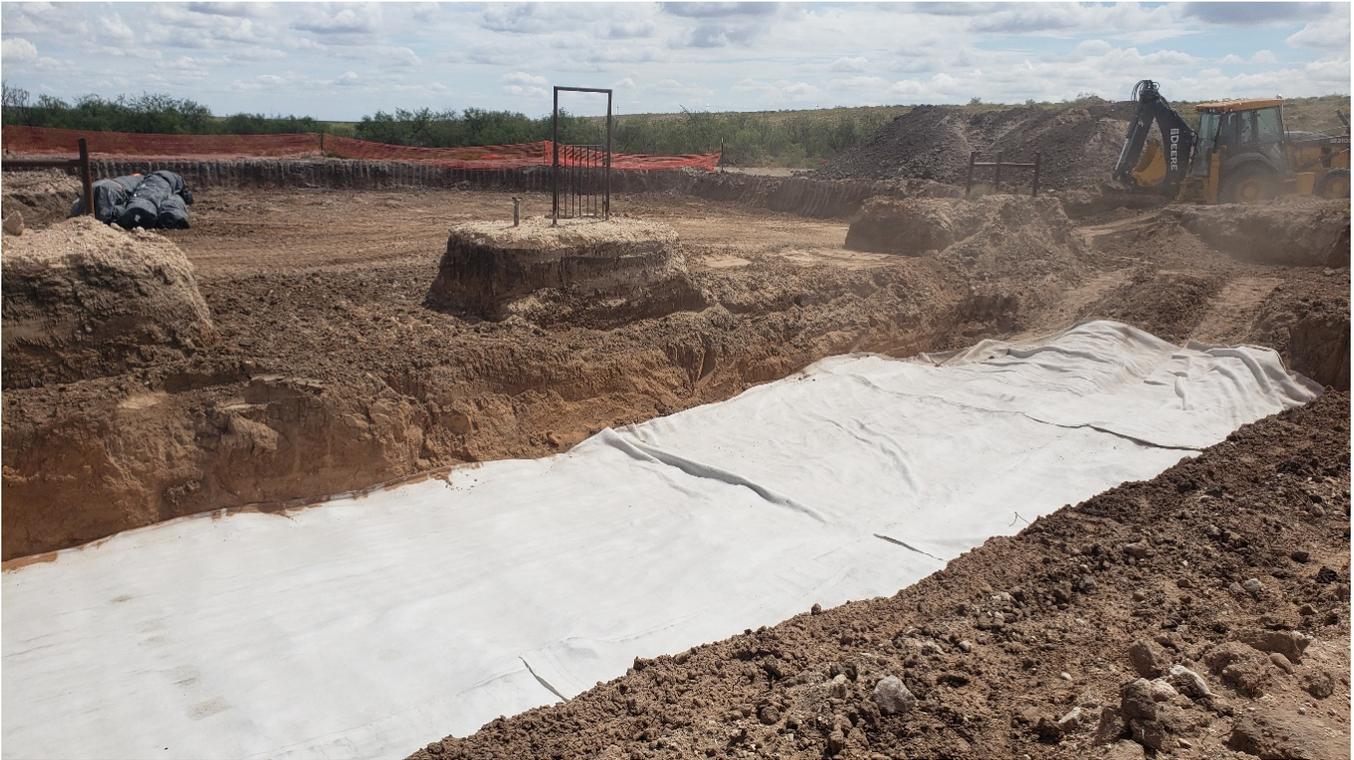
September 13, 2019

Tank Battery with bentonite liner Facing Southeast

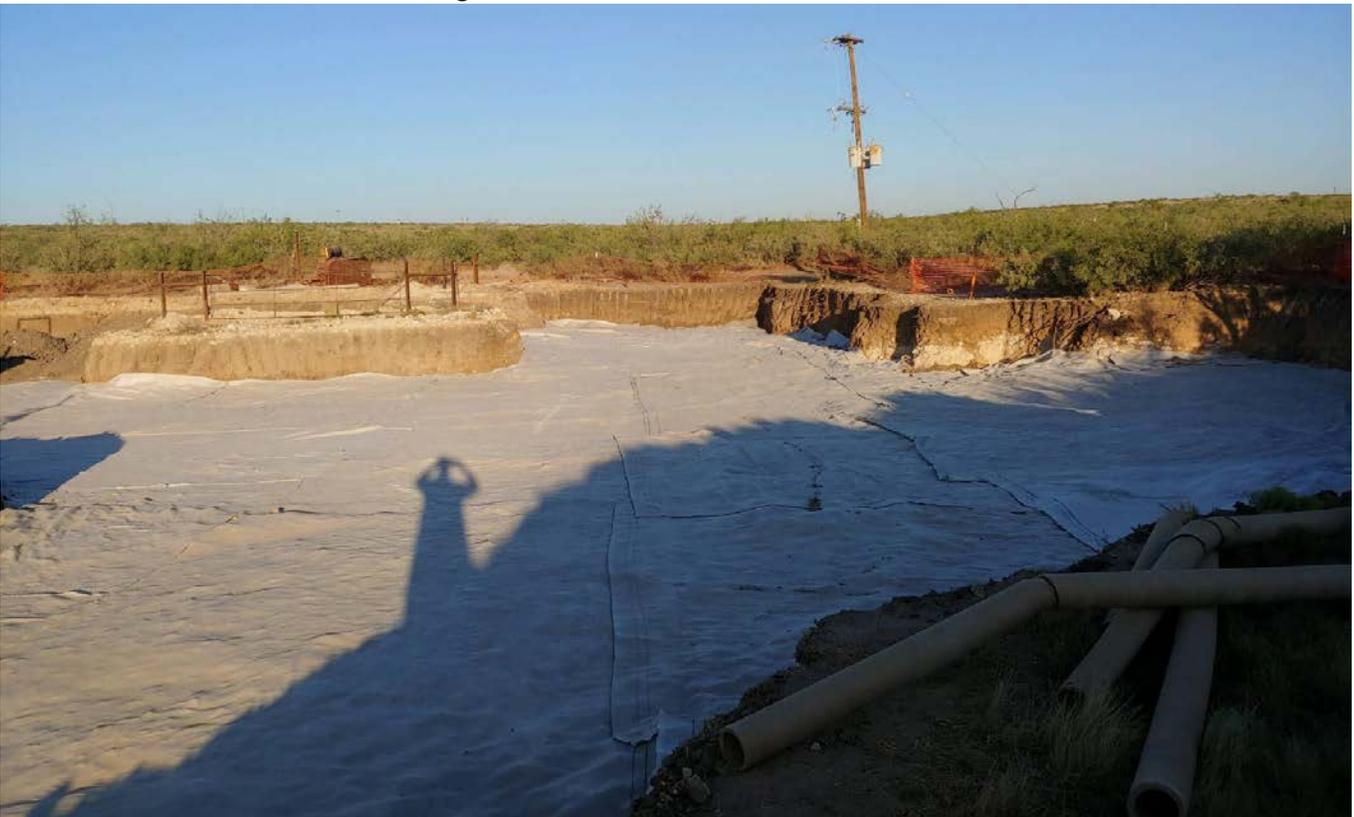
September 18, 2019

BH1, SW2, SW3 with bentonite liner Facing West

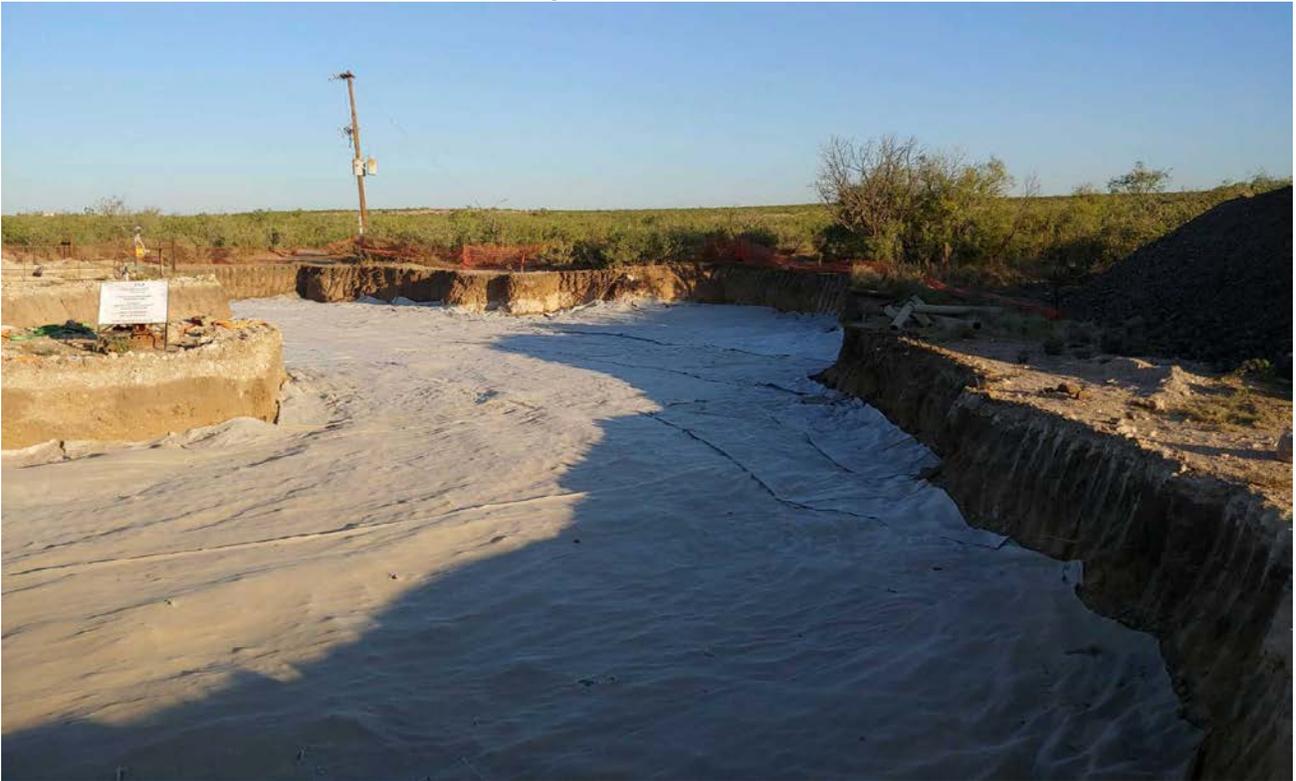
September 18, 2019

BH2, BH3, BH4, SW3, SW4 with bentonite liner facing Northwest

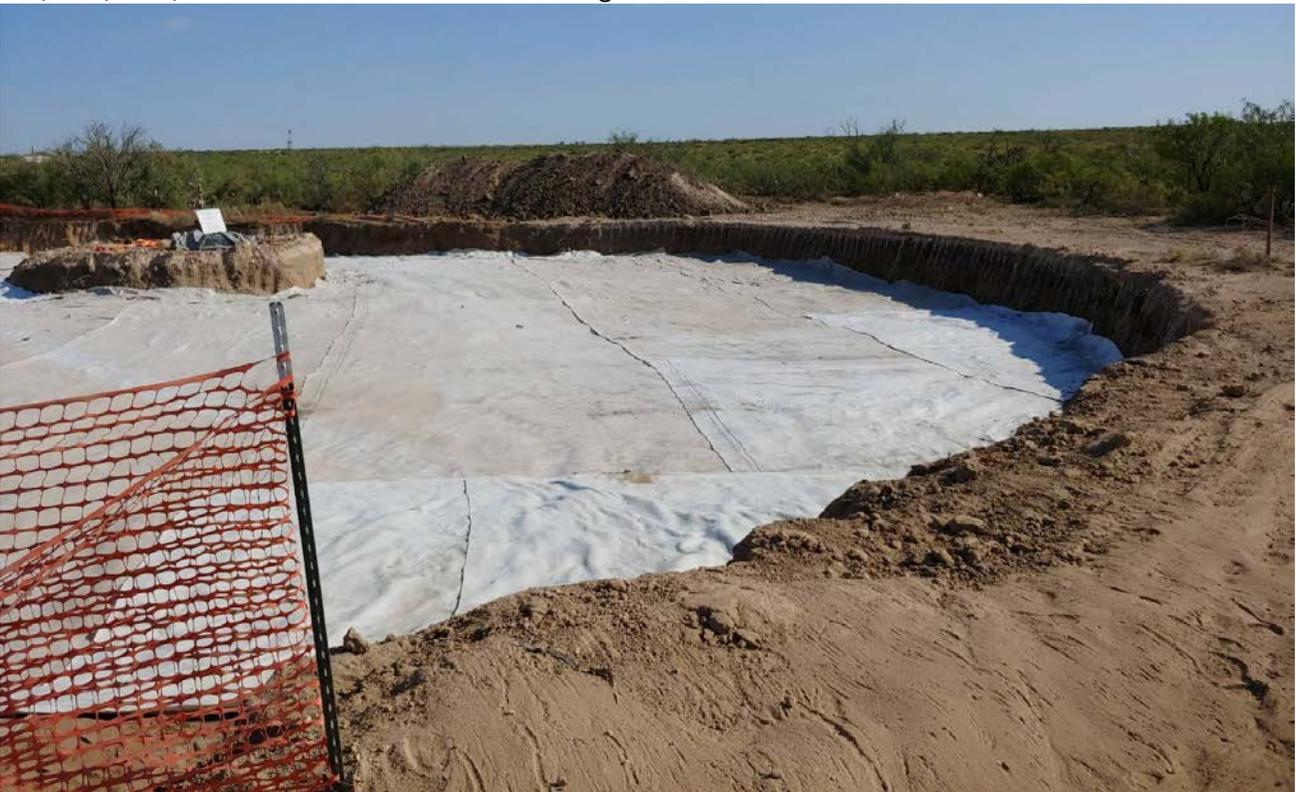
September 17, 2019

BH3, BH4, BH5, SW4, and SW5 with bentonite liner facing Northeast

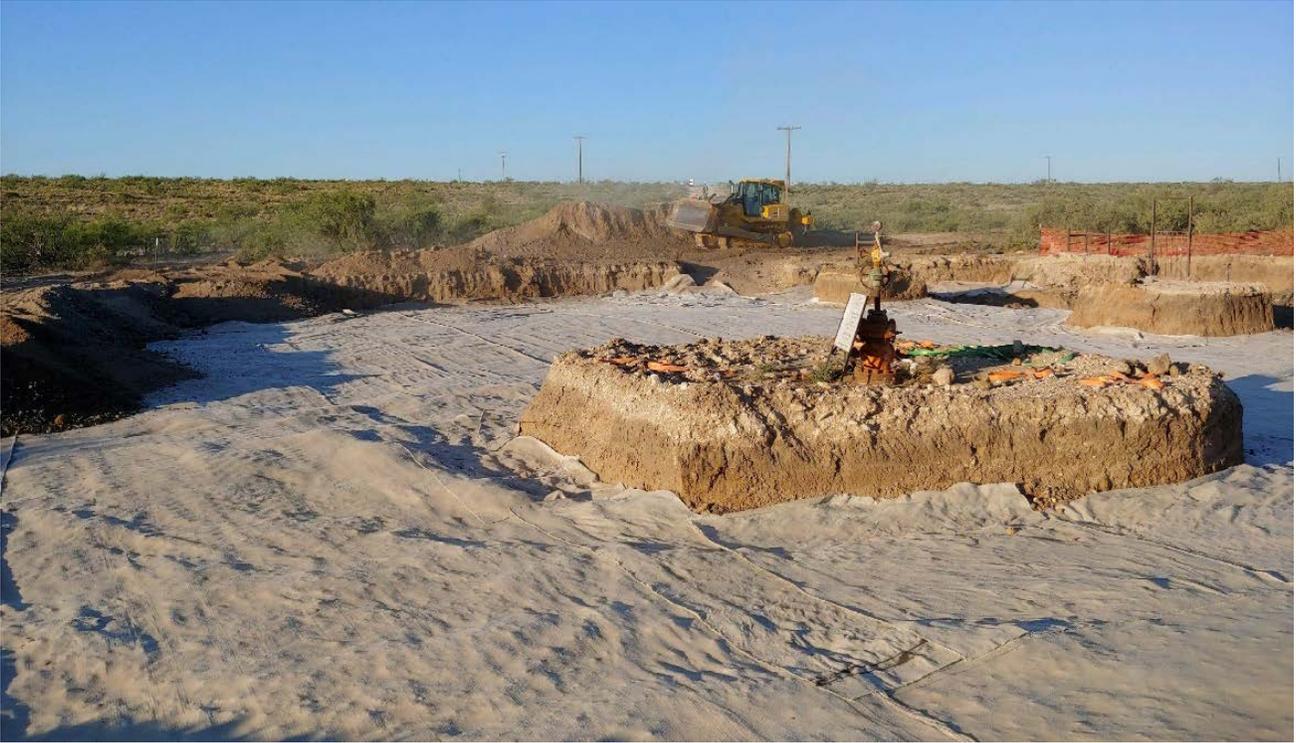
September 18, 2019

BH4, BH5, BH6, SW5 & SW6 with bentonite liner facing south
