# Remediation Summary and Site Closure Request

**White Federal Com #001H  
(2RP-5470)**

COG Operating, LLC.  
600 W Illinois Avenue  
Midland, TX 79701

TRC Environmental Corporation  
10 Desta Dr. STE 150E  
Midland, TX 79705

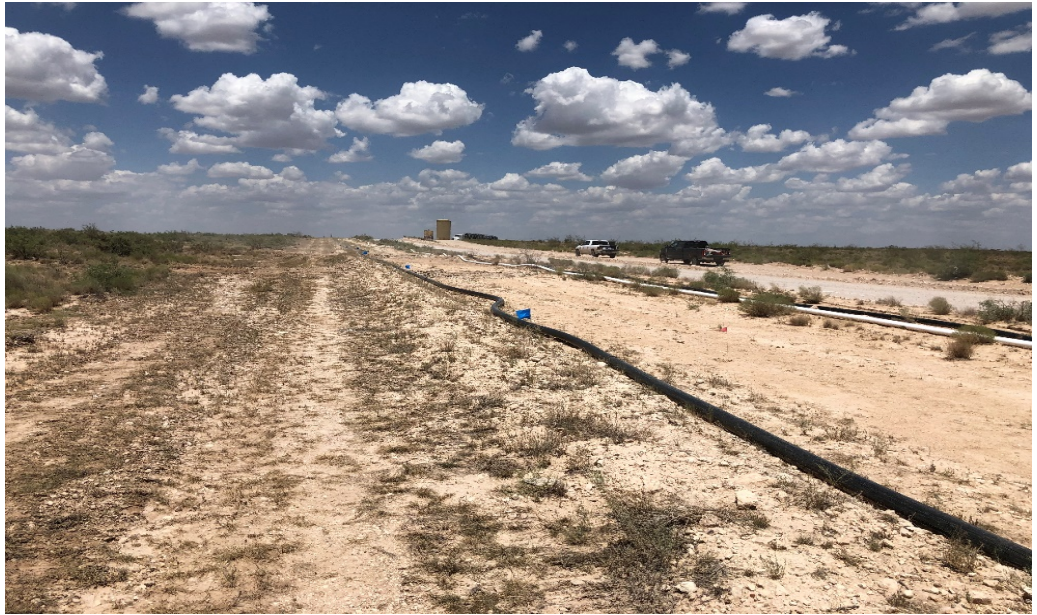
**Photographic Documentation****Photograph No. 1****Date:****7/30/2019****Direction:****North****Description:****View of the  
Release area  
prior to  
remediation.**

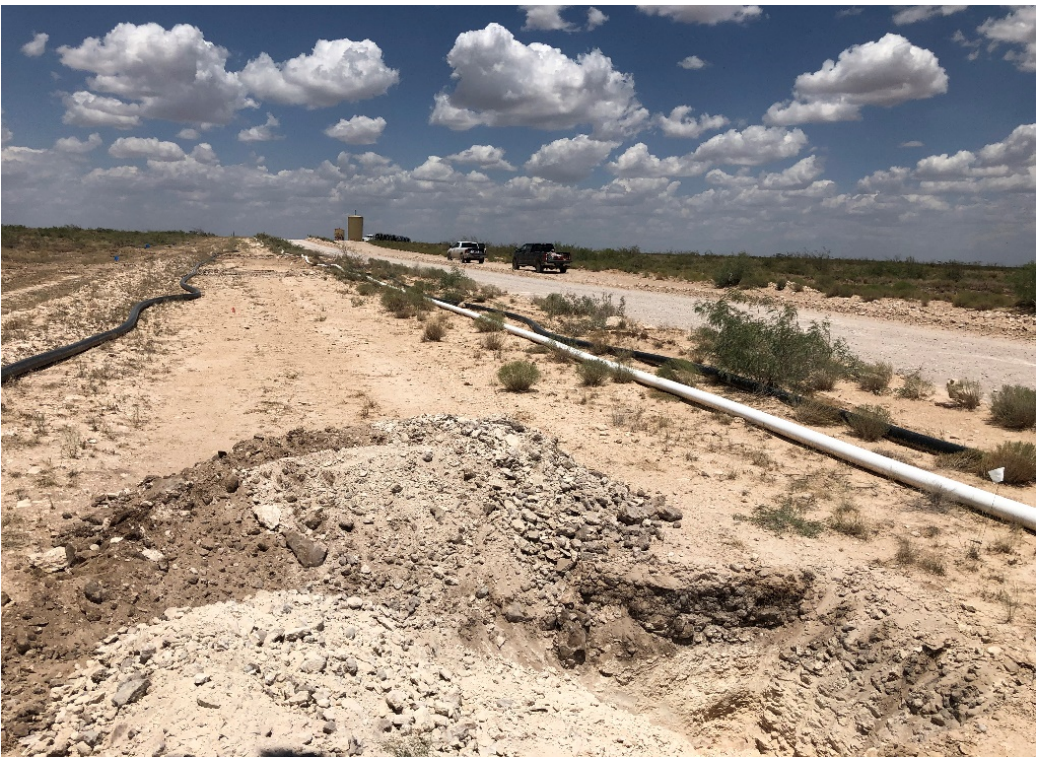
**Photograph No. 2****Date:****7/30/2019****Direction:****North****Description:****View of  
delineation  
trench prior to  
remediation.**

On July 30, 2019, an initial investigation was conducted at the Release Site. During the initial investigation activities, three (3) test trenches (TT-1, TT-2, and TT-3) were advanced within the

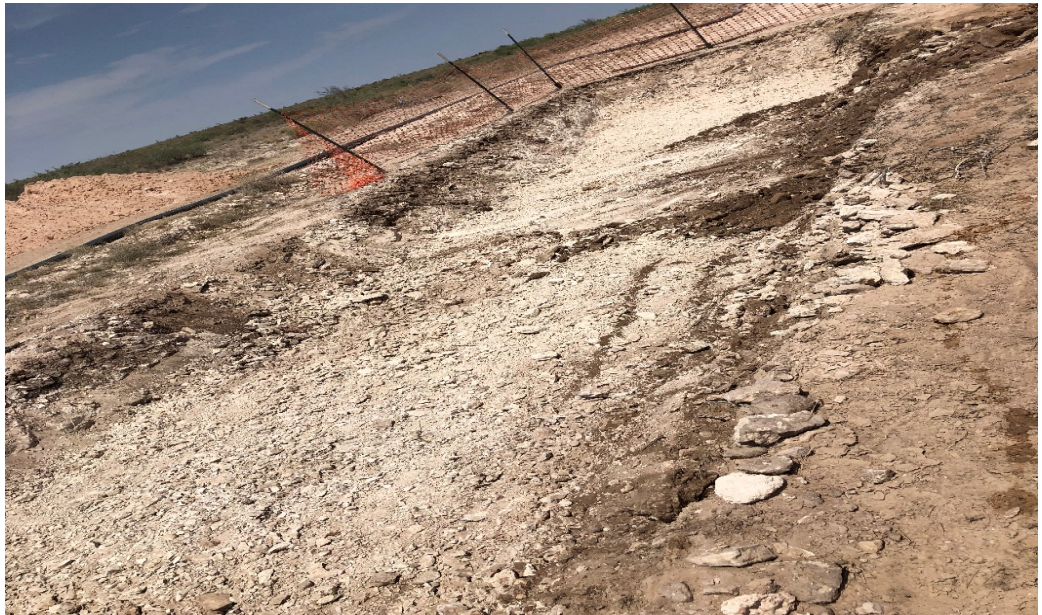
**View of excavated area.**

On August 2, 2019, remediation activities commenced at the Release Site. The area represented by test trench location TT-1 was excavated to a depth of approximately thirty (30) inches bgs. The northern portion of the area represented by test trench TT-2 was excavated to a depth of approximately twelve (12) inches bgs. Excavated soil was stockpiled on a plastic liner, pending disposition at an NMOCD approved disposal facility. Seven (7) five-point composite floor confirmation soil samples (FL-1-2.5, FL-2-2.5, FL-3-2.5, FL-4-2.5, FL-5-2.5, FL-6-2.5, FL-7-1) were collected from the base of the excavation. Five (5) five-point composite sidewall confirmation soil samples (SW-N1-1.25, SW-E1-1.25, SW-W1-1.25, SW-W2-0.5, and SW-E2-0.5) were collected from the excavation walls. The sidewall represented by soil sample SW-E1-1.25 was advanced to the east to the maximum extent practicable without interfering with the adjacent surface flowlines and a high traffic lease road. To characterize the area between the sidewall and the lease road, two (2) grab samples (SW-E1B-1.25 and SW-E1C-1.25) were collected adjacent to SW-E1-1.25 at 1.25 feet bgs. Collected soil samples were submitted to Xenco Laboratories in Midland, TX for chloride and/or TPH and BTEX analyses. TPH and BTEX concentrations were below laboratory reporting limits in each sample submitted for TPH and BTEX analyses. Chloride concentrations were below NMOCD regulatory guidelines in each submitted soil sample, with the exception of soil samples SW-E1-1.25, SW-E1B-1.25, and SW-E1C-1.25. Excavation continued to the south and the remainder of the area represented by soil sample TT-2 was excavated to twelve (12) inches bgs and the area represented by soil sample TT-3 was excavated to eighteen (18) inches bgs.

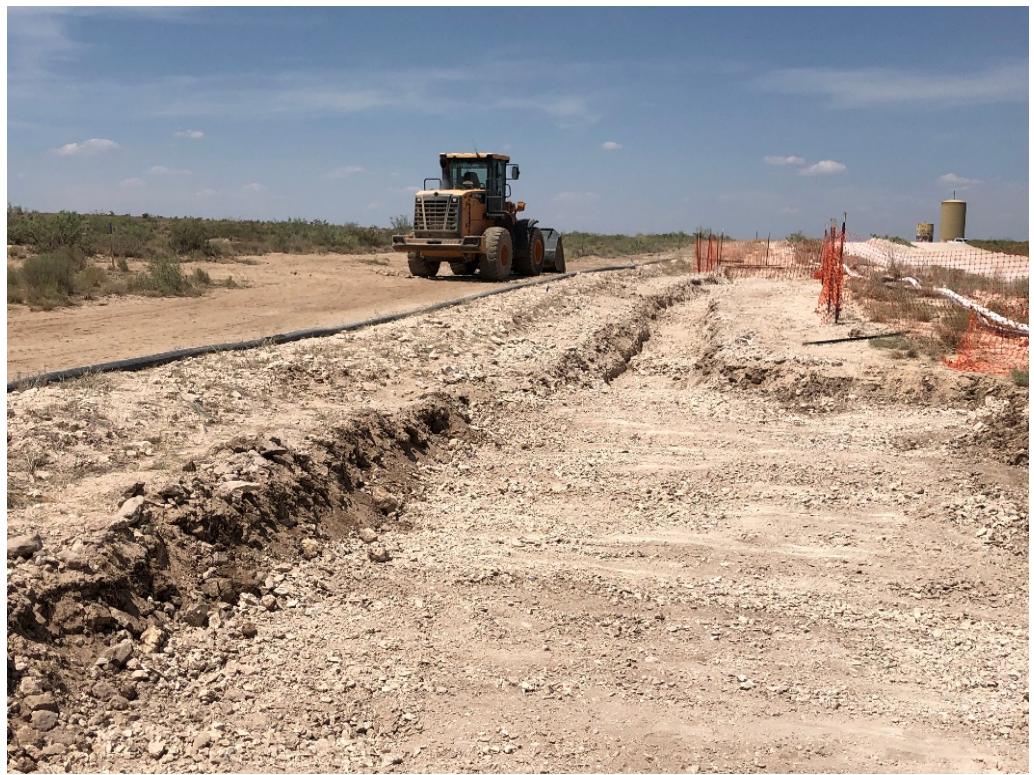
**Photograph No. 4**

**View of excavated area.**

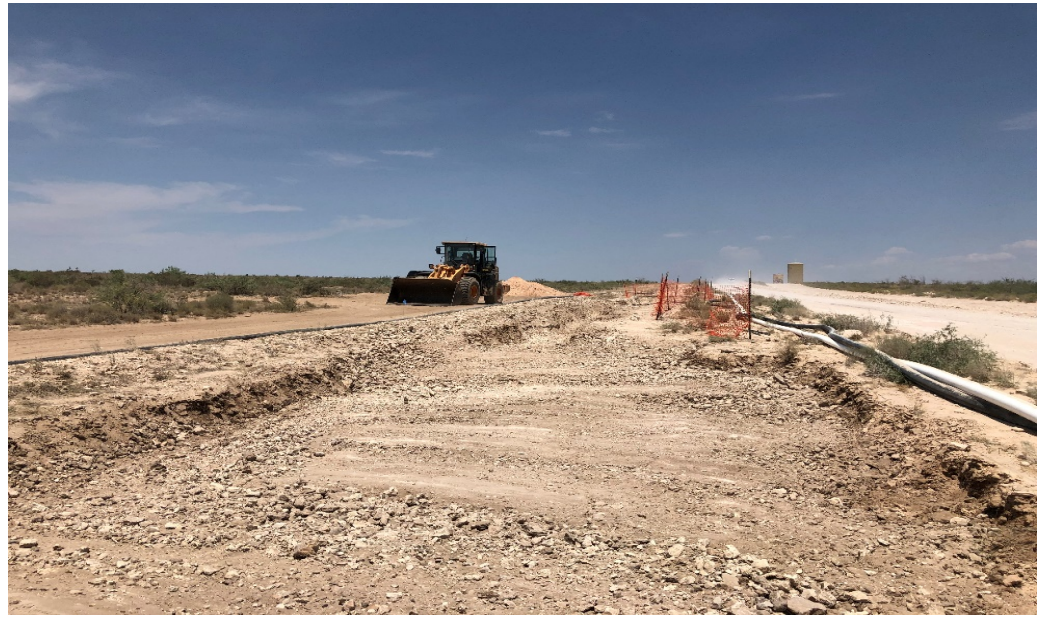
**Photographic Documentation****Photograph No. 5****Date:**  
8/6/2019**Direction:**  
North**Description:**  
View of  
excavated area.

On August 6, 2019, one (1) five-point composite sidewall confirmation soil sample (SW-E4R-0.75) was collected from the sidewall, which was laterally advanced due to the exceedance of NMOCD regulatory guidelines in soil sample SW-E4-0.75. The soil sample was submitted to Xenco Laboratories for chloride analysis. The analytical results indicated the soil sample exhibited a chloride concentration below NMOCD regulatory guidelines.

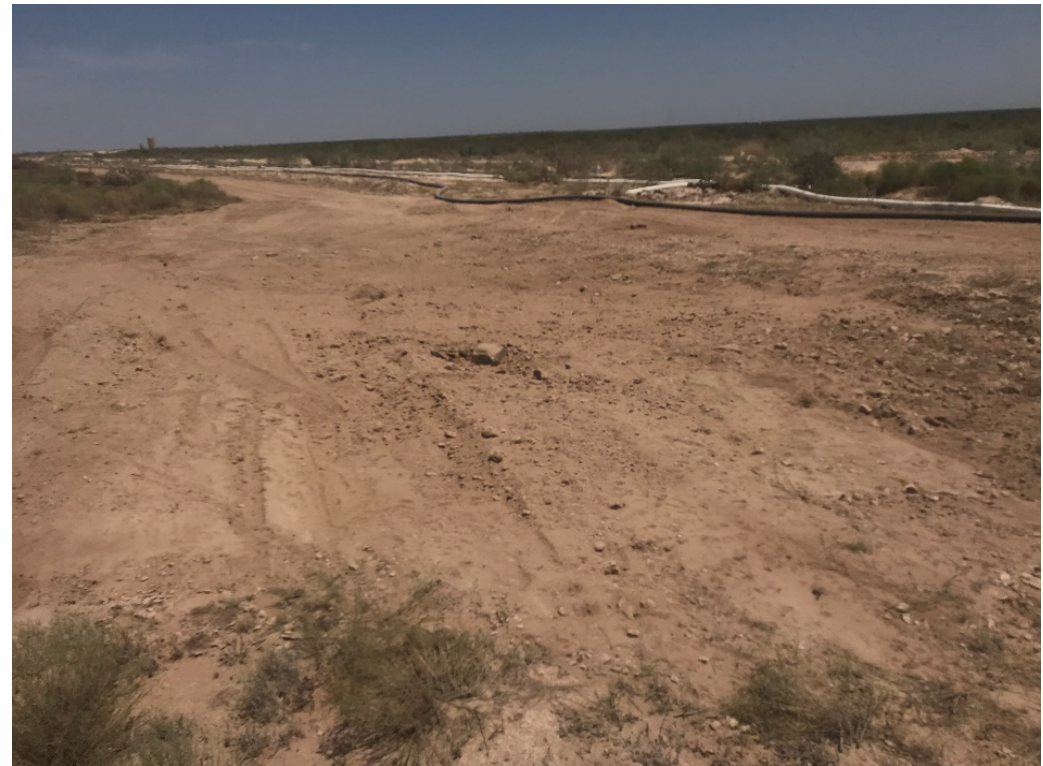
**Photograph No. 6****Date:**  
8/8/2019**Direction:**  
Northeast**Description:**  
View of the  
remediated area.

The excavated material was transported under manifest to the R360 Red Bluff Facility for final disposition. The excavation was backfilled to grade with locally sourced, non-impacted 'like' material. A review of the analytical results indicated the collected soil samples exhibited concentrations below NMOCD regulatory guidelines for each constituent of concern, with the exception of soil samples SW-E1-1.25, SW-E1B-1.25, and SW-E1C-1.25. A deferral request was submitted to the BLM and NMOCD to allow the area represented by soil samples SW-E1-1.25, SW-E1B-1.25 and SW-E1C-1.25 in place.

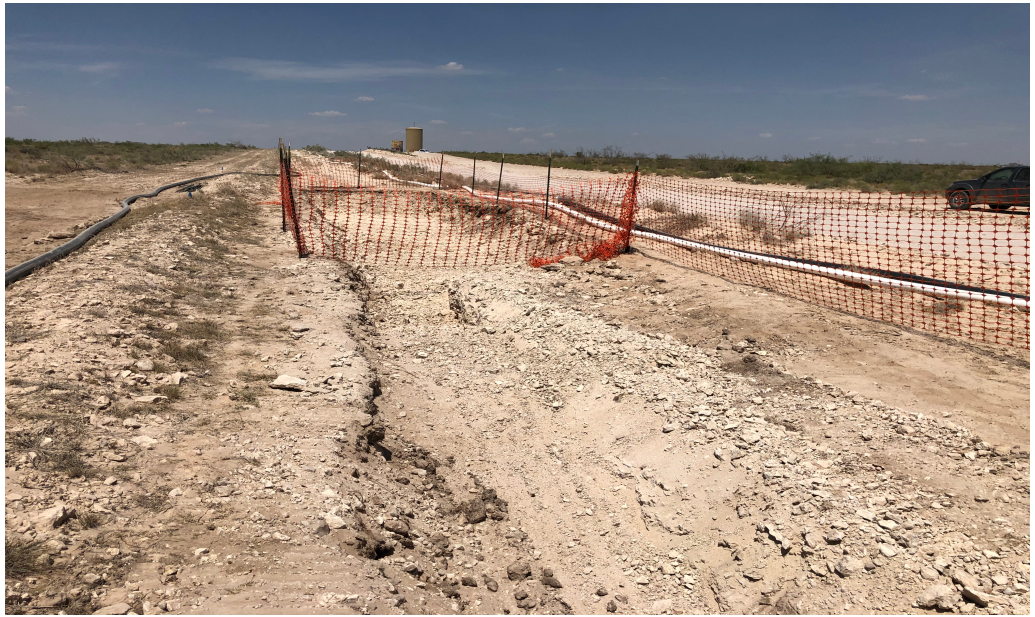
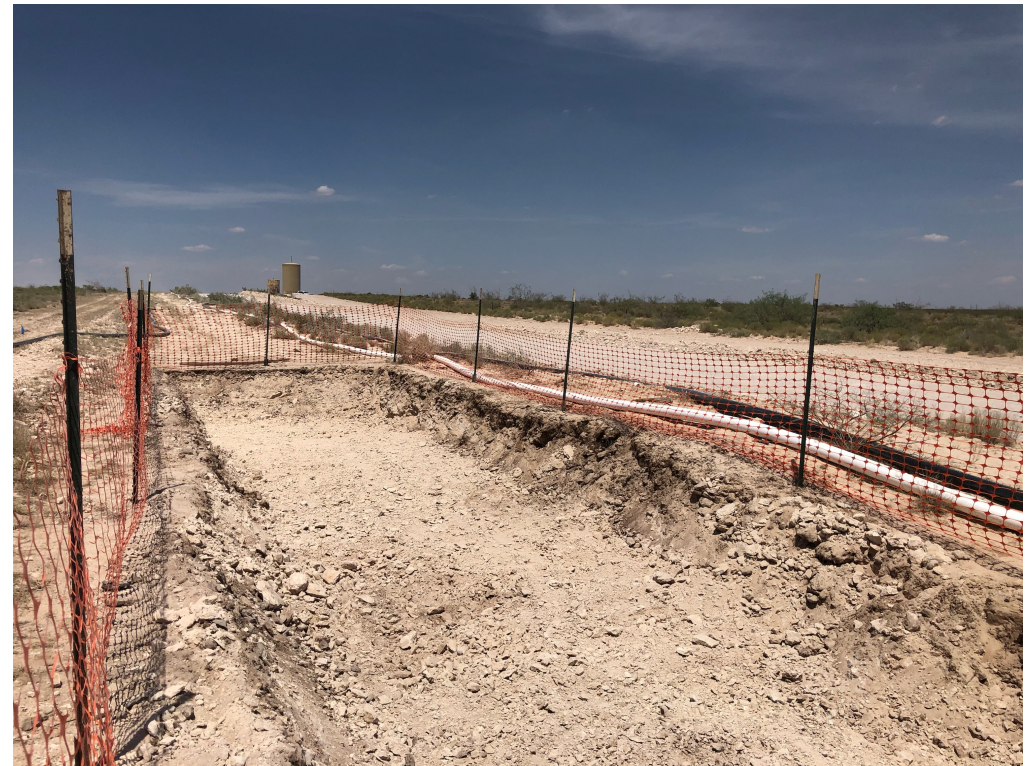
**Photographic Documentation****Photograph No. 7****Date:****8/6/2019****Direction:****North****Description:****View of  
excavated area  
adjacent to  
requested  
deferral area.**

**Photograph No. 8****Date:****8/6/2019****Direction:****Northeast****Description:****View of  
excavated area  
adjacent to  
requested  
deferral area.**

The deferral request was denied by both the BLM and the NMOCD. The BLM and NMOCD requested the area represented by soil samples SW-E1-1.25, SW-E1B-1.25 and SW-E1C-1.25 be excavated.

On October 23, 2019, the area underlying the surface flowlines and represented by soil samples SW-E1-1.25, SW-E1B-1.25, and SW-E1C-1.25 was excavated to a depth of approximately three (3) feet bgs, spanning from the previous excavation to the edge of the lease road. Following the excavation activities, two (2) five-point composite soil samples (FL-15-3 and FL-16-3) were collected from the base of the excavation. Three (3) five-point composite soil samples (SW-N1-1.5, SW-S1-1.5, and SW-E1D-1.5) were collected from the sidewalls of the excavation. The soil samples were submitted to the laboratory for chloride analysis. Each submitted soil sample exhibited chloride concentrations below NMOCD regulatory guidelines, with the exception of SW-E1D-1.5, which exhibited a chloride concentration of 695 mg/kg. The excavation could not be laterally advanced to the east, as the sidewall was at the margin of the lease road. Subsequently, the area represented by SW-E1D-1.5 was left in-situ.
