CLOSURE REPORT

**Grama Ridge Release
S5, T22S, R34E
Lea County, New Mexico
NMOCD No. 1RP-5715**

November 14, 2019
Ensolum Project No. 03B1206009

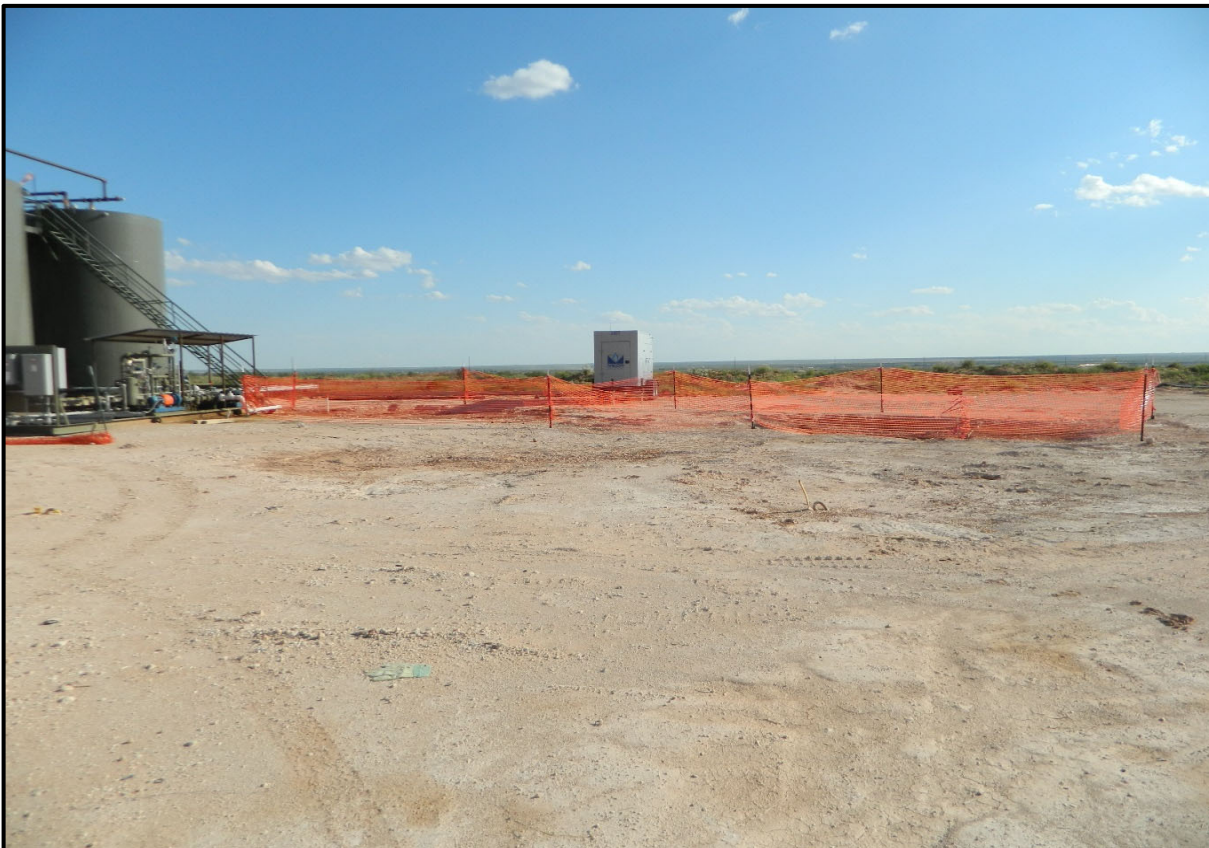
View of the release area during remediation activities, facing south.

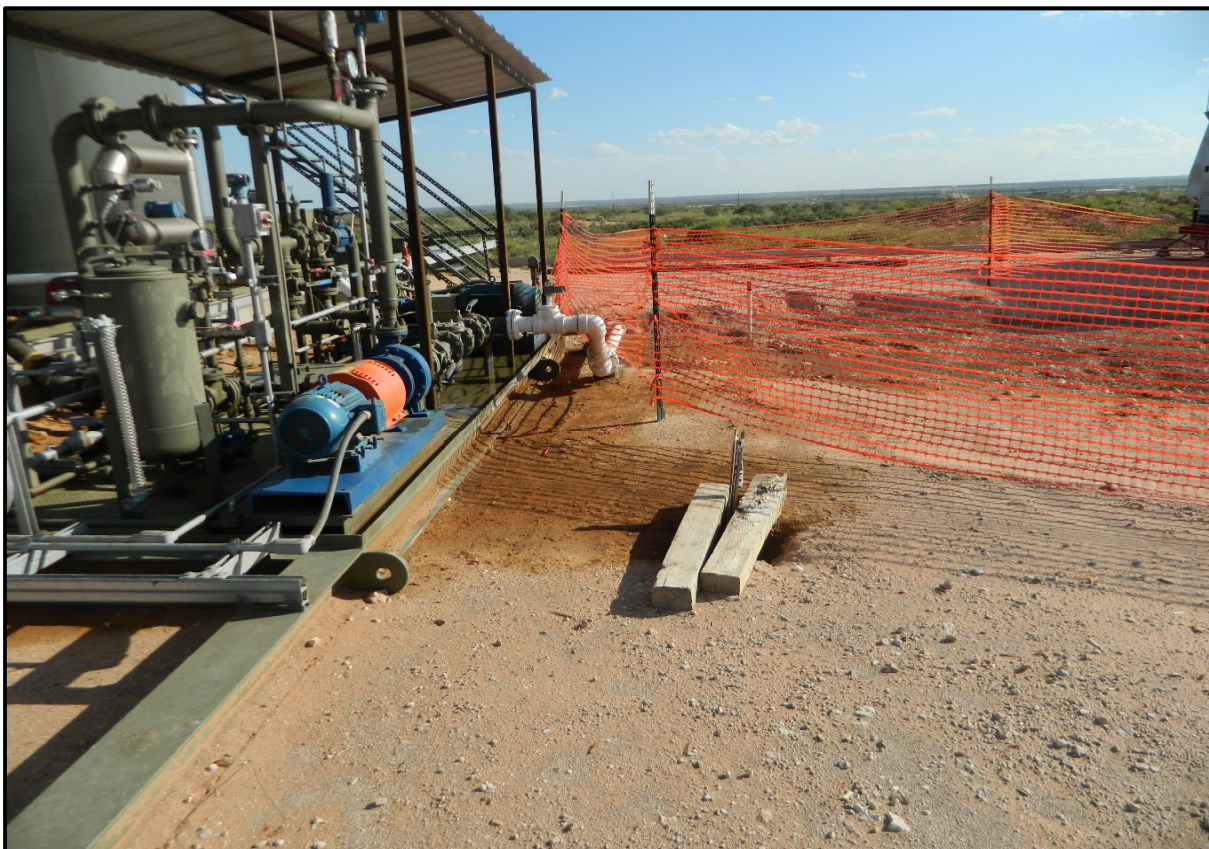
View of the release area during remediation activities, facing south.

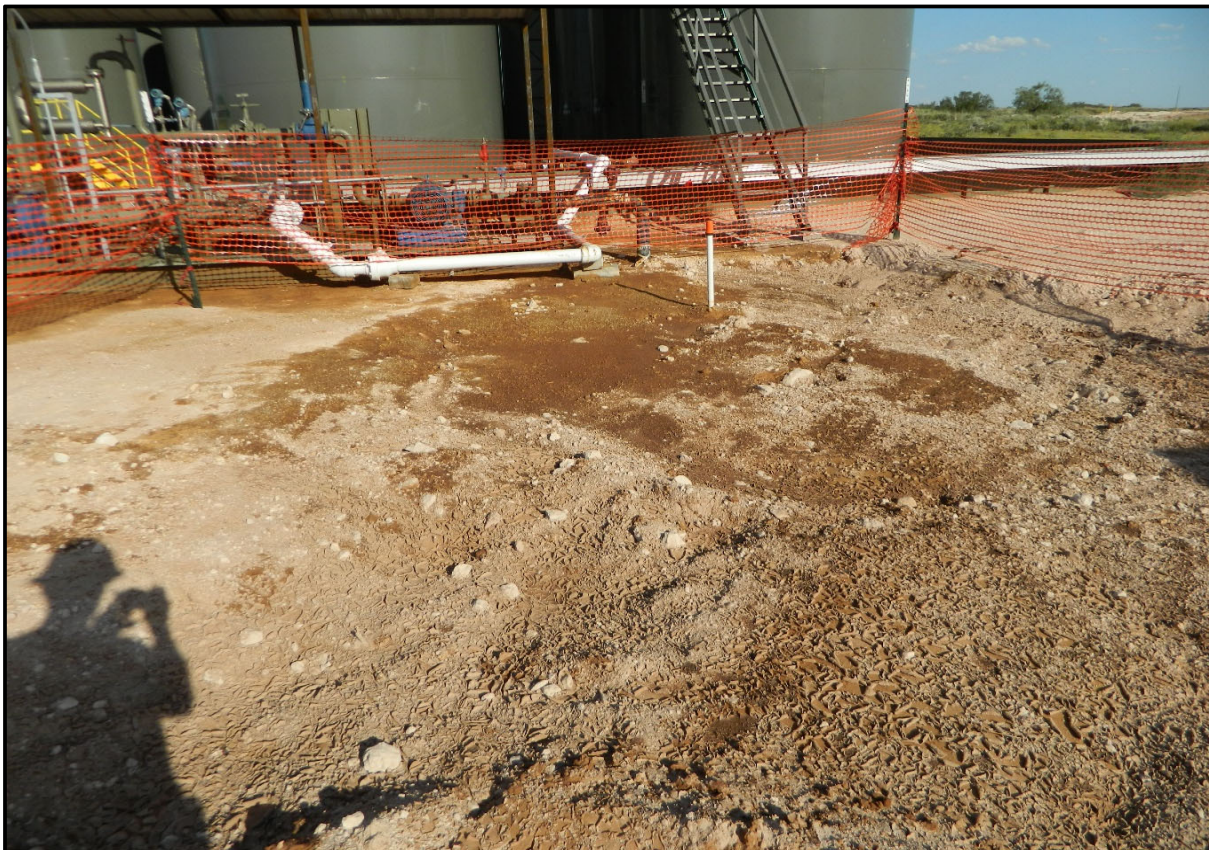
View of the release area during remediation activities, facing east.

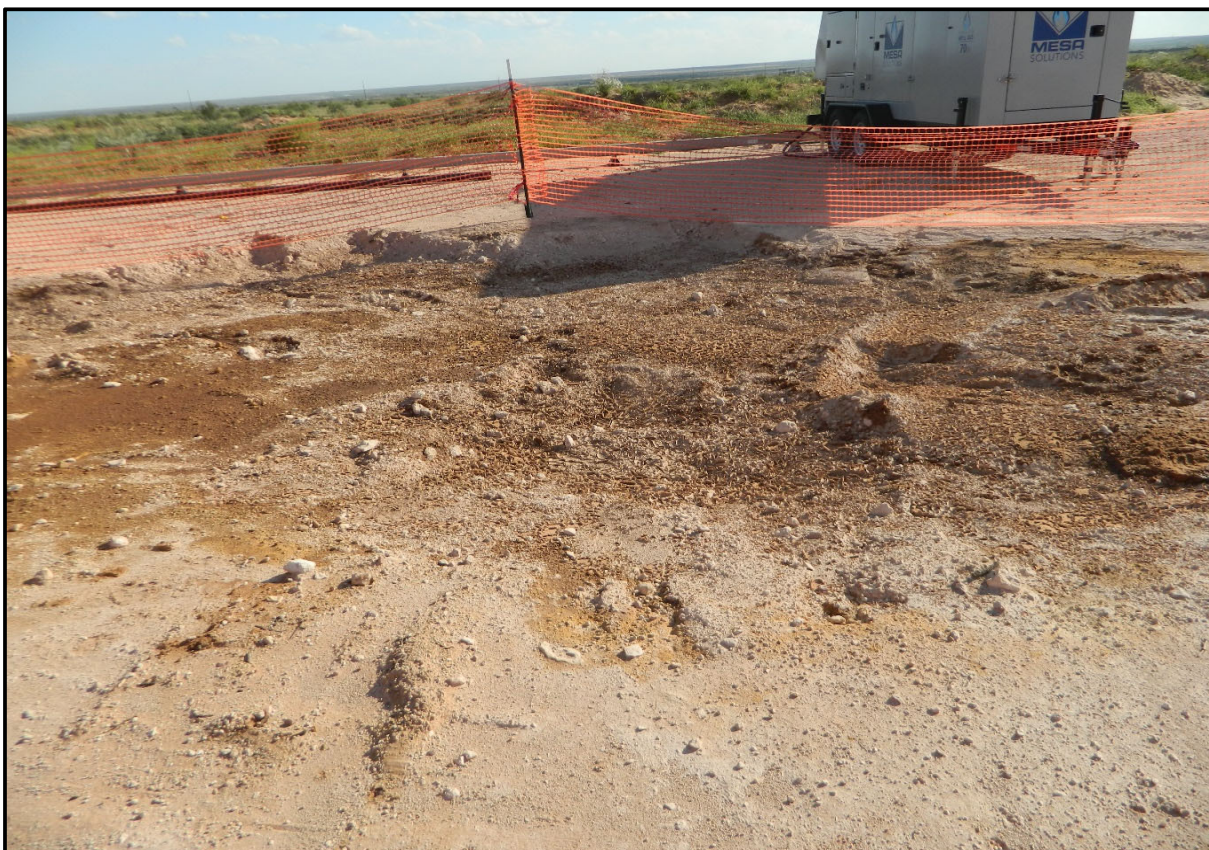
View of flow path during remediation activities, facing southwest.

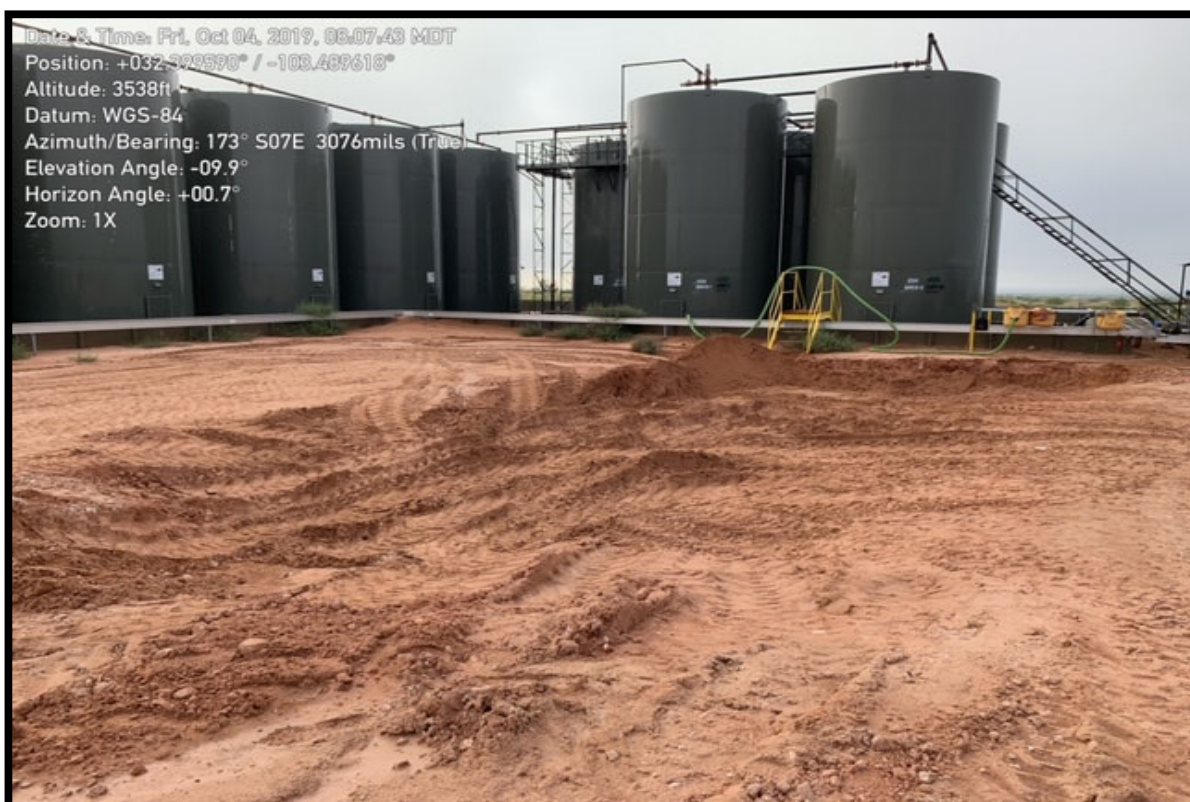
View of the release area during remediation activities, facing south.

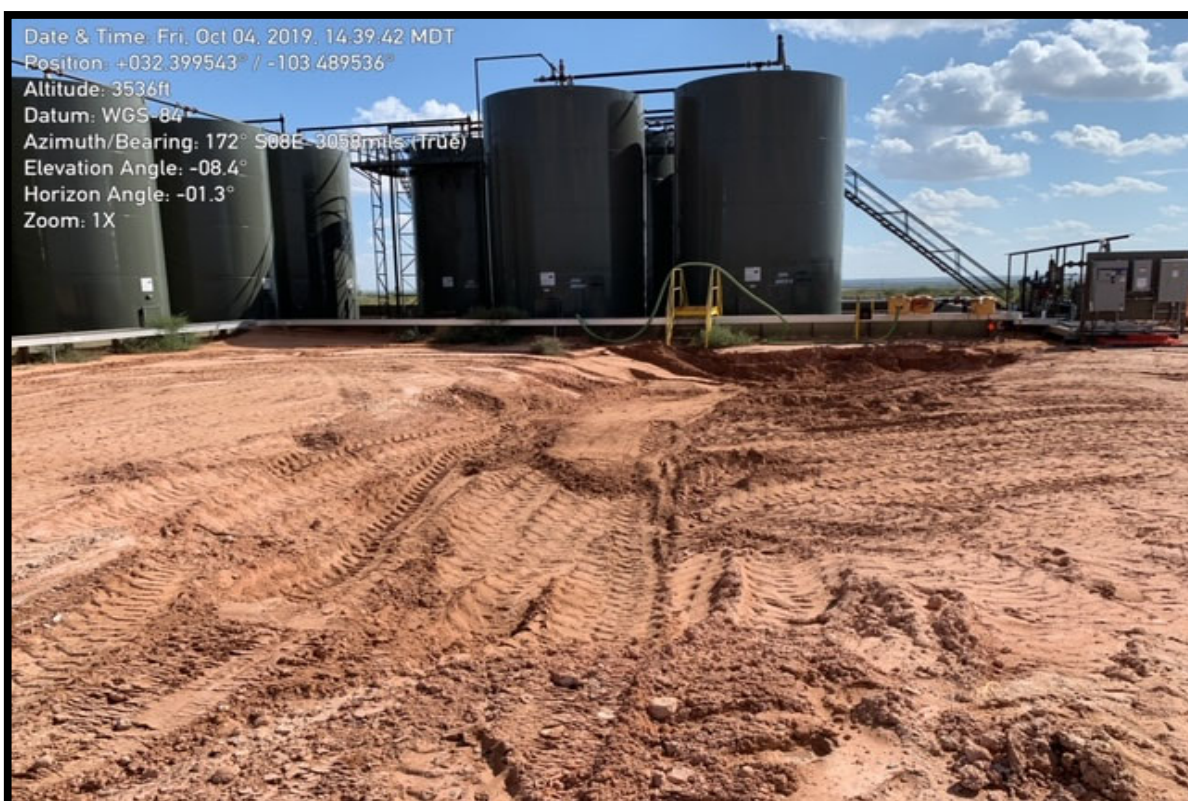
View of the release area during remediation activities, facing south.

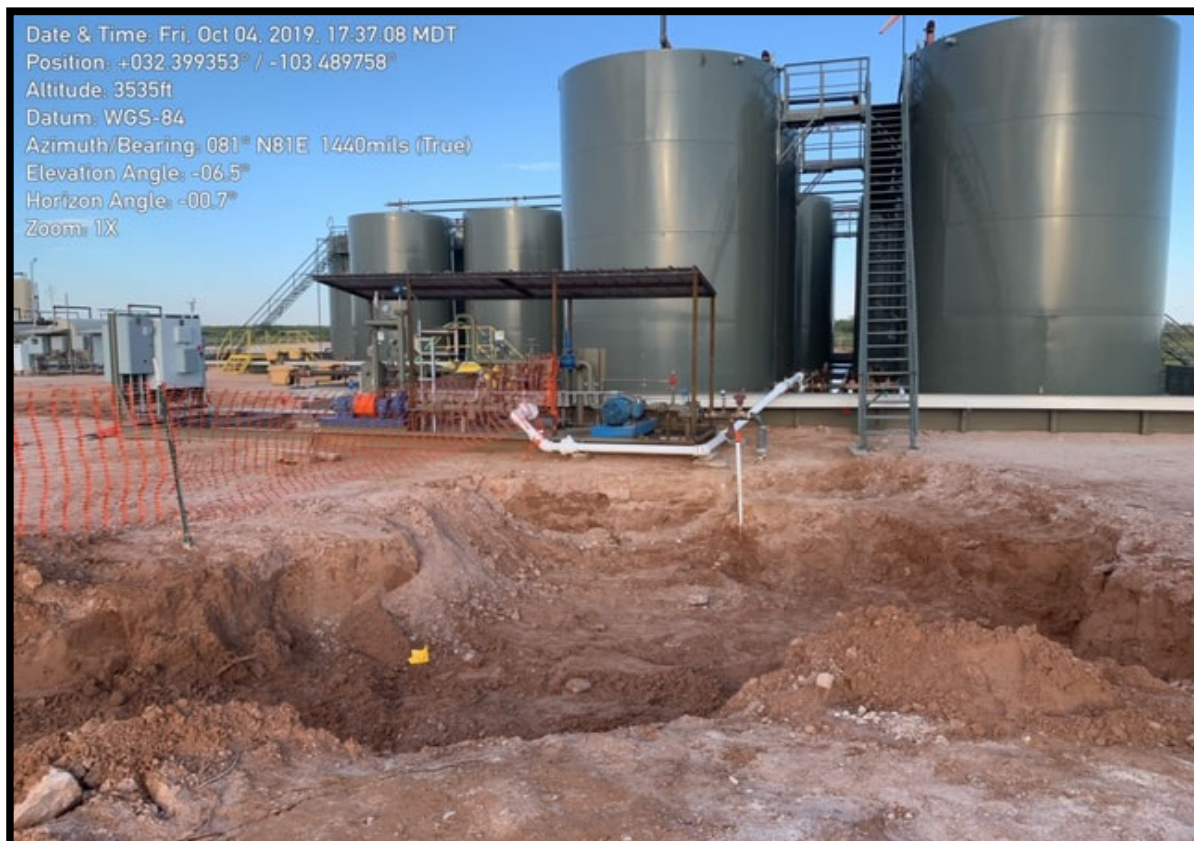
View of the release area during remediation activities, facing east.

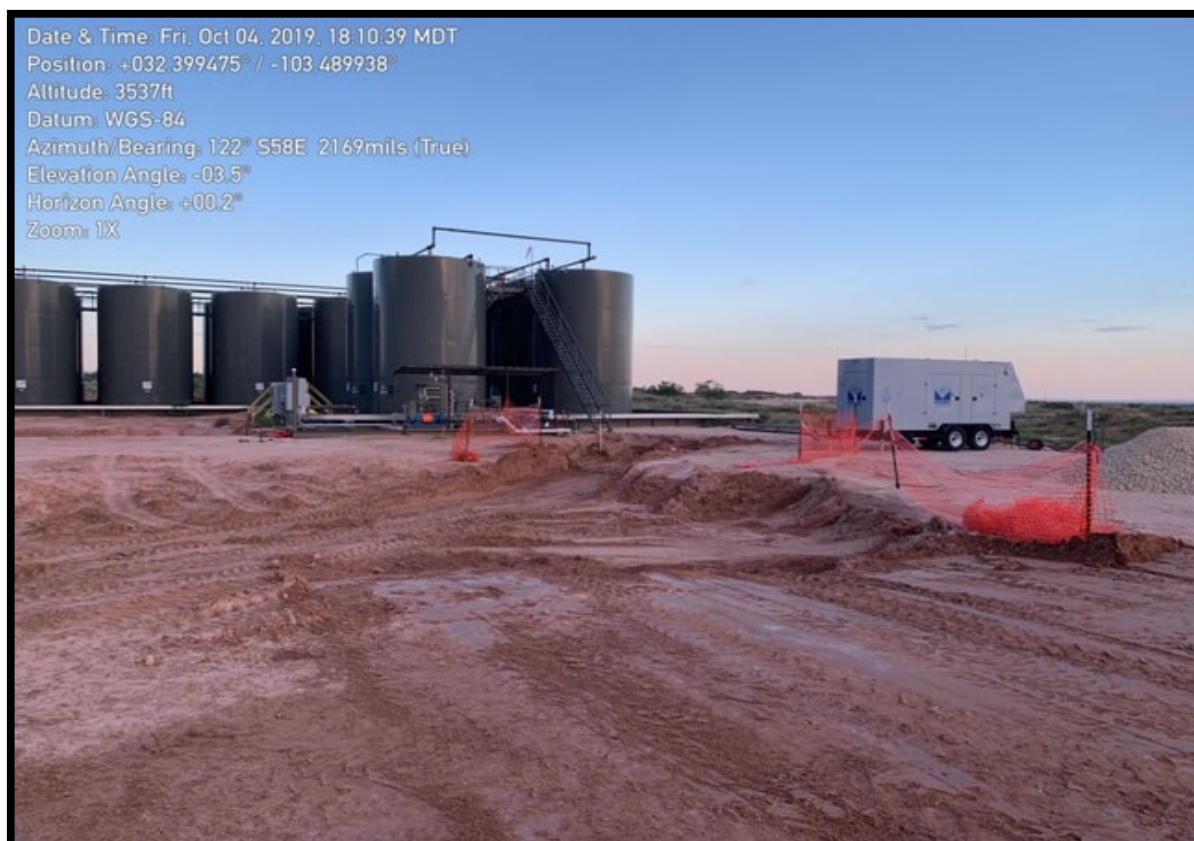
View of the release area during remediation activities, facing east.
