Site Assessment Report and Proposed Remediation Workplan

Legacy Reserves Operating, LP Hamon Fed Com A #3H

Etech Environmental & Safety Solutions, Inc. 3100 Plains Highway Lovington, New Mexico 88260

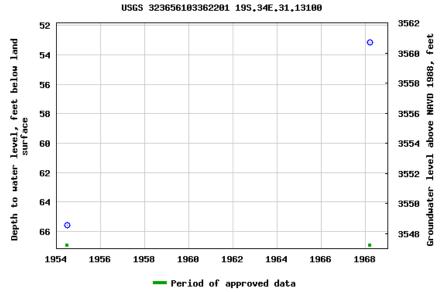
Lea County, New Mexico Hydrologic Unit Code 13060011 Latitude 32°36'56", Longitude 103°36'22" NAD27 Land-surface elevation 3,614 feet above NAVD88 This well is completed in the Alluvium, Bolson Deposits and Other Surface Deposits (110AVMB) local aquifer. **Output formats**

Breaks in the plot represent a gap of at least one year between field measurements. Download a presentation-quality graph

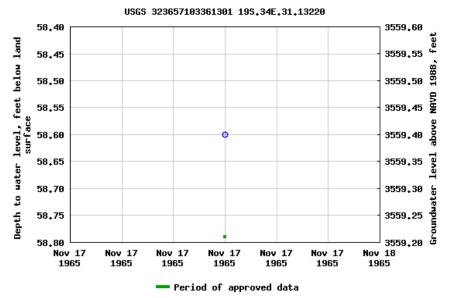
Lea County, New Mexico Hydrologic Unit Code 13060011 Latitude 32°36'57", Longitude 103°36'13" NAD27 Land-surface elevation 3,618 feet above NAVD88 The depth of the well is 66 feet below land surface. This well is completed in the Alluvium, Bolson Deposits and Other Surface Deposits (110AVMB) local aquifer. **Output formats**

Breaks in the plot represent a gap of at least one year between field measurements. Download a presentation-quality graph

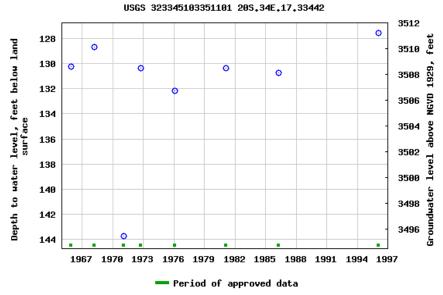
Lea County, New Mexico Hydrologic Unit Code 13060011 Latitude 32°34'00", Longitude 103°35'14" NAD27 Land-surface elevation 3,639.00 feet above NGVD29 The depth of the well is 160 feet below land surface. This well is completed in the Chinle Formation (231CHNL) local aquifer.

Breaks in the plot represent a gap of at least one year between field measurements. Download a presentation-quality graph
