**Pit or Below-Grade Tank Registration or Closure**

Re: Drilling Pit Closure of EOG Resources – Meramec B4 Fee #1H  
UL 'A' Sec. 4 T16S R25E Eddy County  
API # 30-015-35382

# **Closure Report**

**Meramec B4 Fee #1H**  
**API # 30-015-35382**  
**Eddy County, NM**

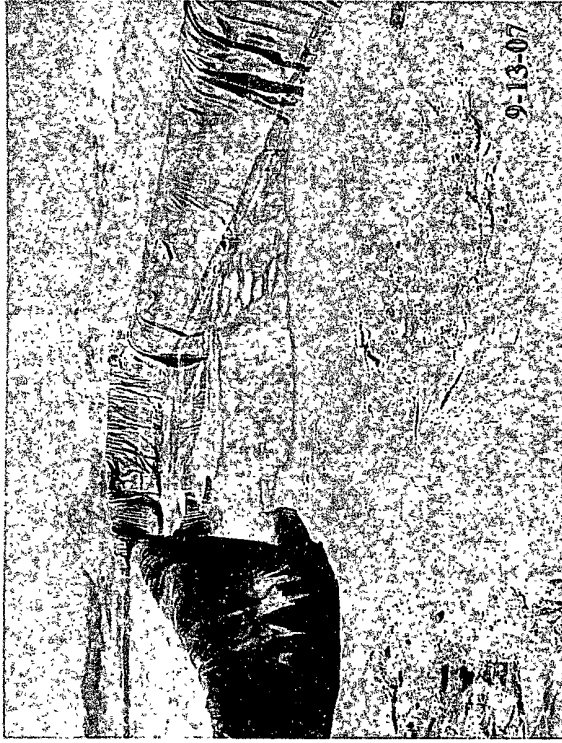
Drilling pit before closure.

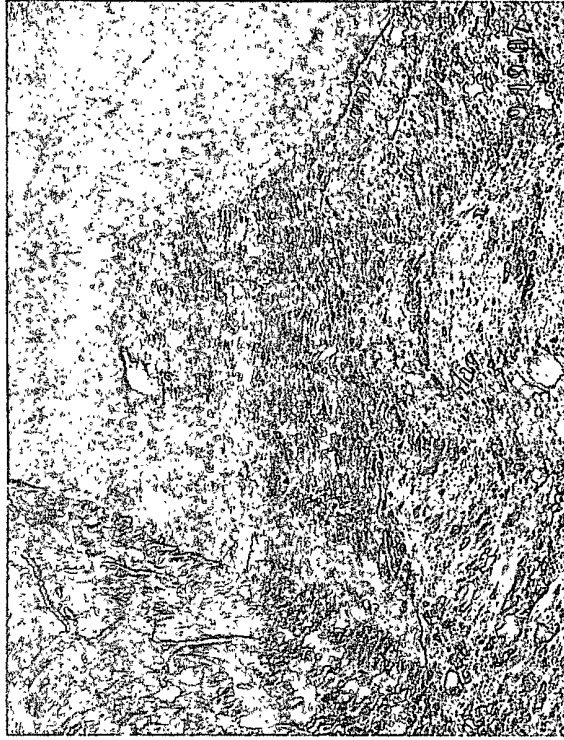
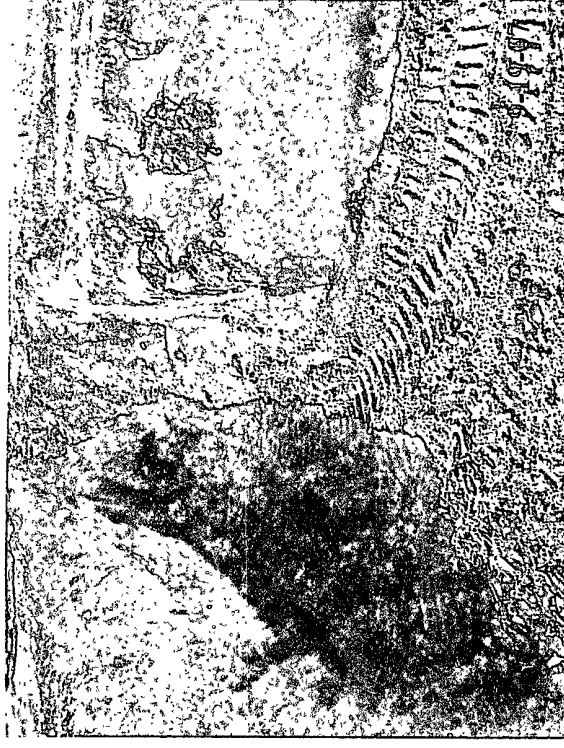
Drilling pit after removal of mud and liner.
